VERMONT YANKEE NUCLEAR POWER CORPORATION

REFERENCE: Operating License DPR-28
Docket No. 50-271
Reportable Occurrence No. LER 91-14

LICENSEE EVENT REPORT (LER)

TITLE (4) REACTOR SCRAM DUE TO LOSS OF 345KV Switchyard Caused by Defective Off-Site Carrier Equipment

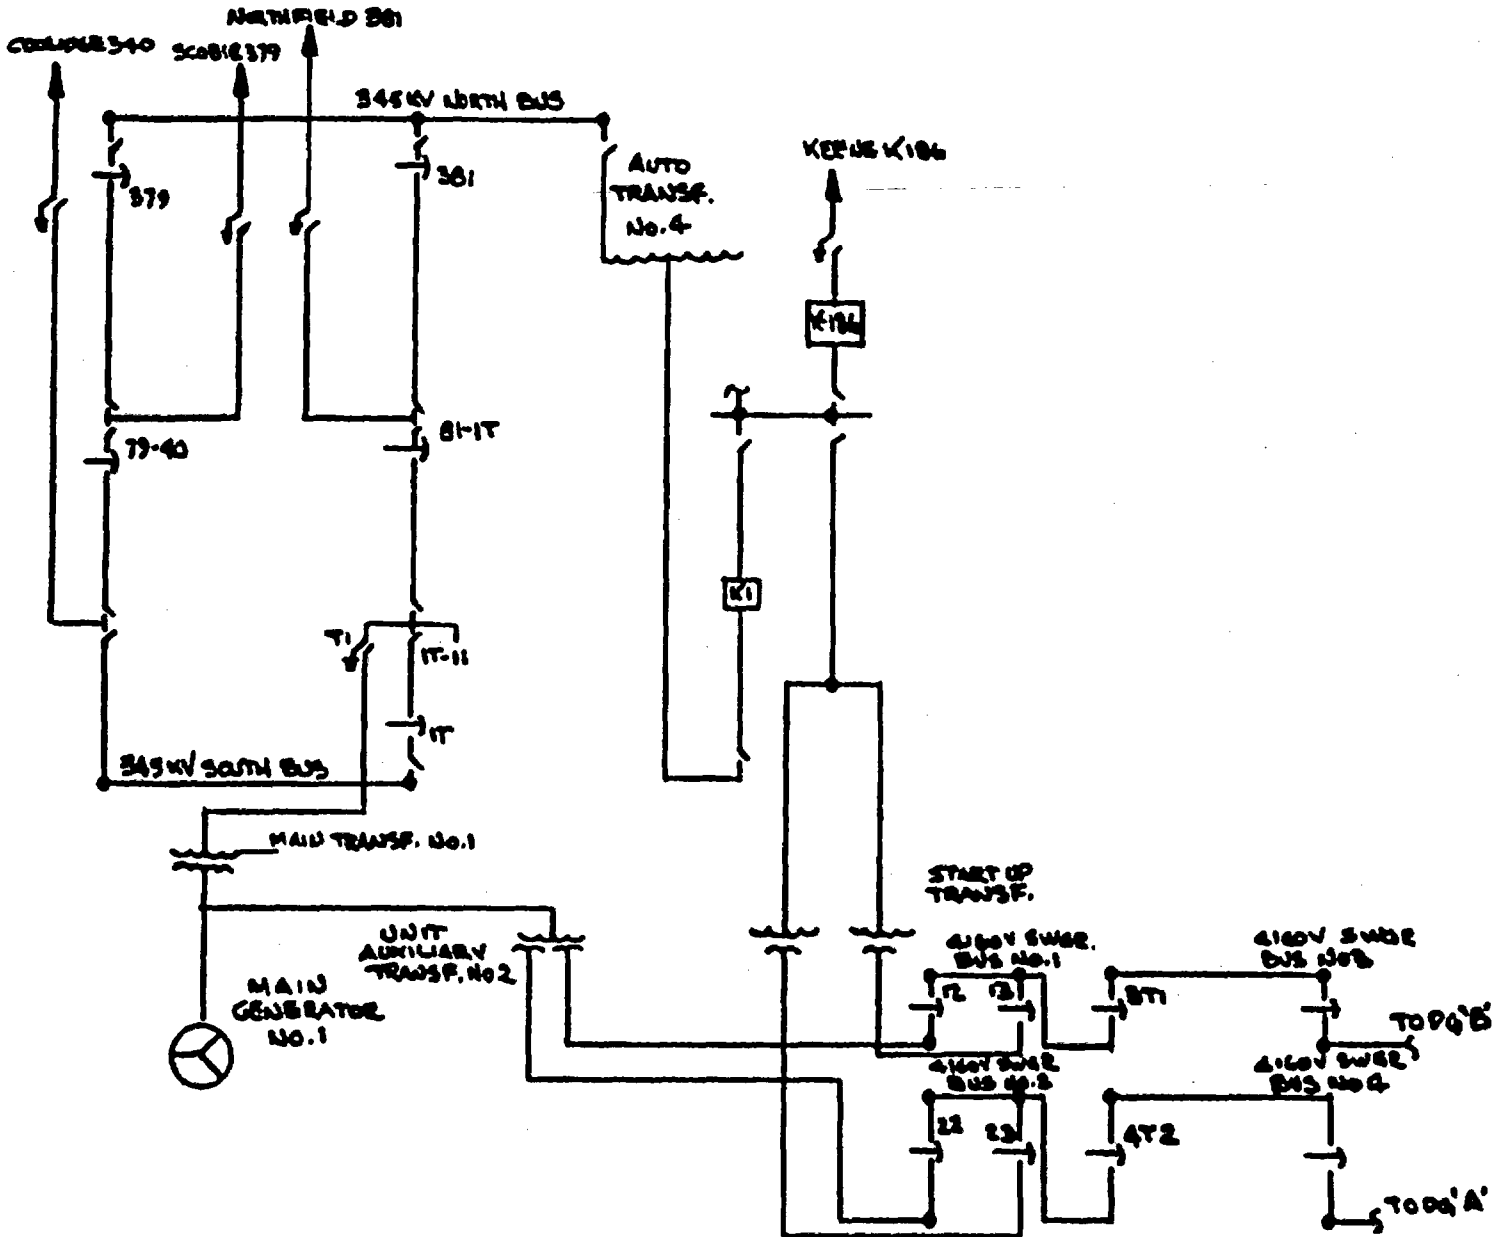
SWITCHYARD DISTRIBUTION

The Root Cause of this event is a defective (shorted) transistor in offsite (Scobie Pond) Protective Relaying System Carrier equipment. The lightning strike which occurred on the "B" phase of the 381 Transmission line between VY and Northfield, Ma. would normally have only resulted in an isolation of the 381 line. However, the defective component in the Scobie Pond Carrier equipment caused a subsequent loss of the 379 line. This routed the full Generator output through the 340 (Coolidge) line. The Coolidge line cannot handle full generator output and tripped out on overload which resulted in a loss of the 345KV yard and caused the Reactor to Scram on Generator Load Reject.

After the plant Scram, an extensive testing and troubleshooting effort was performed by Vermont Yankee and New England Power Service Co. (NEPSCO) to determine the cause of the Scobie Line Carrier trip. It was found that the the equipment on the VY end operated as designed and sent a Carrier block signal to Scobie to prevent tripping. Although the signal was received at Scobie Pond, the trip signal was not blocked. A failed transistor in the Carrier equipment logic section prevented the blocking signal from reaching the tripping logic. Since the tripping logic did not see a blocking signal it caused the Scobie line to trip at Scobie Pond and Vermont Yankee.

Immediate corrective actions included recovering from the reactor scrams, troubleshooting and repair of the Scobie Pond equipment, and reactor stabilization utilizing appropriate plant procedures.

VY Maintenance Department and VELCO Switchyard Engineers will evaluate testing requirements for Switchyard Carrier systems.
