RE: Materials License #21-26580-01, 30-day Event Report

The gauge is a Troxler 3430 Model, serial number 30135 containing Cs 137 0.30 GBQ (8.0 mci), Am-241: BE 1.48 GBQ (40.0 mci).

Subject: Troxler Damage

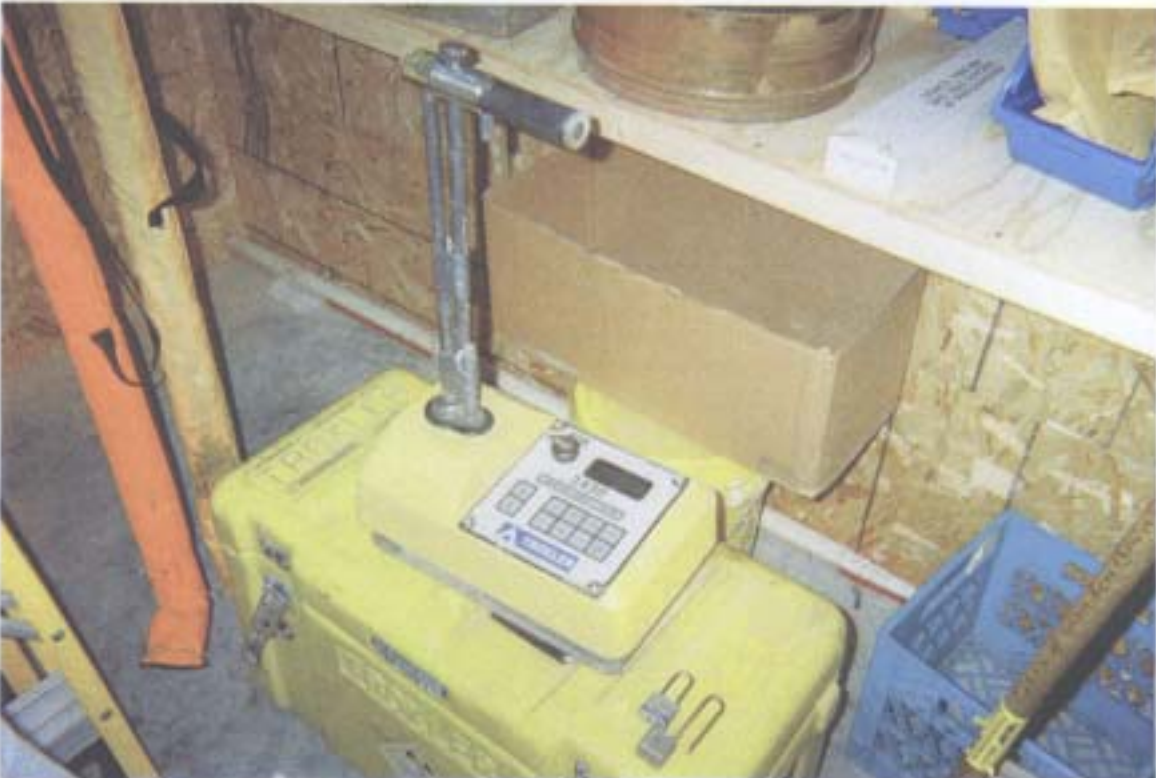
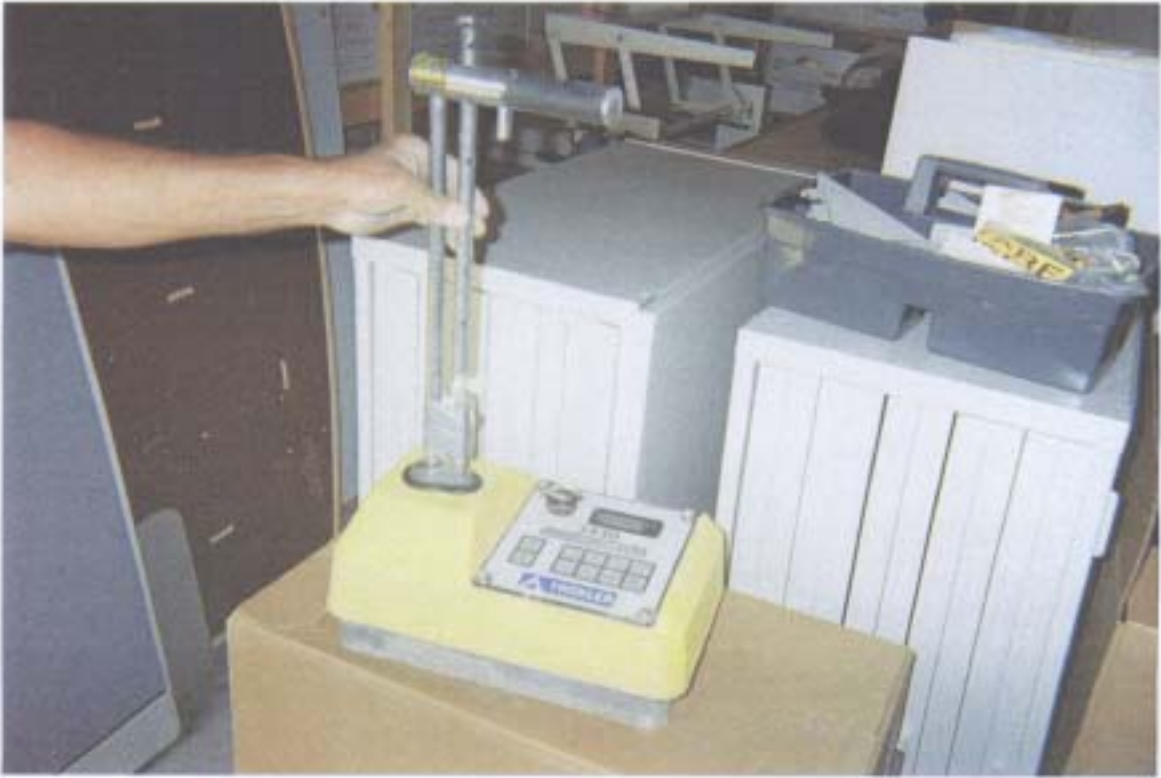
Photos showing secured source rod

Mr. Vannoy and I loaded the gauge into the transport container and brought it back to our storage facility. I spoke with the gauge manufacturer regarding the radiation survey meter readings and damage to the gauge. They were in agreement that the readings were normal and instructed us on how to secure the source rod and prepare for shipment to their facility. We secured the source rod (see attached photo) and completed a leak test. The leak test sample was sent by overnight mail to the gauge manufacturer.

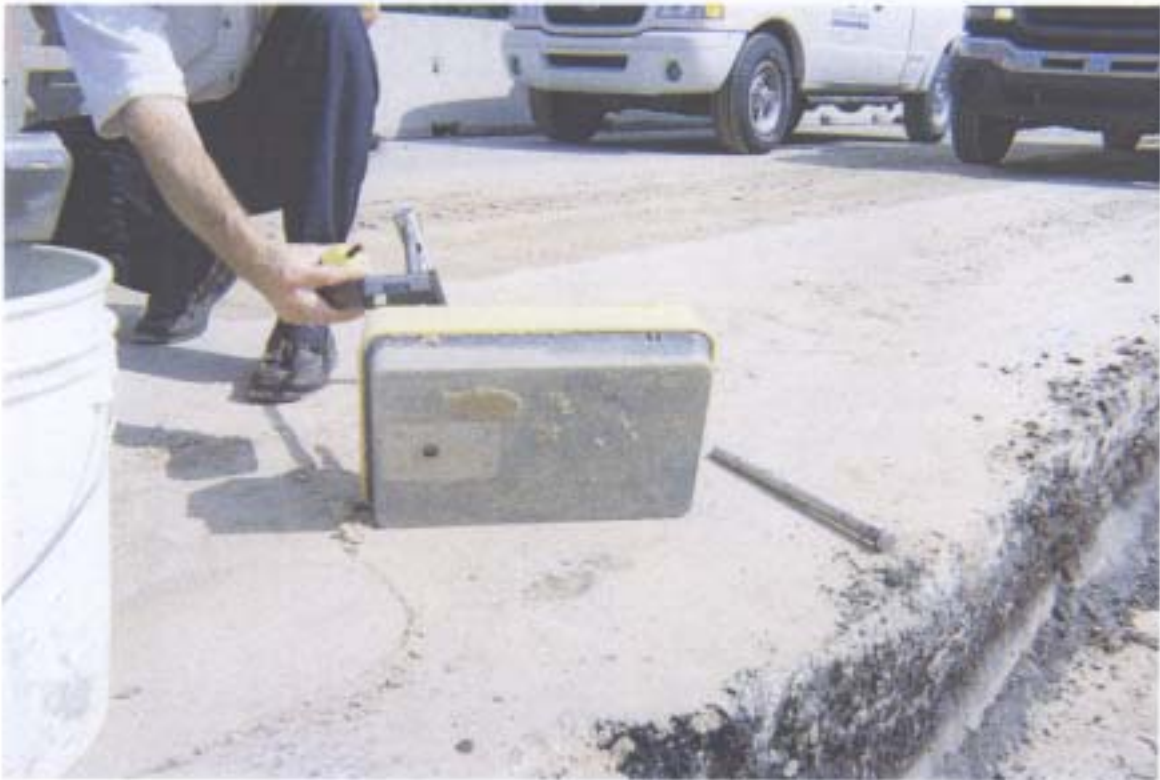
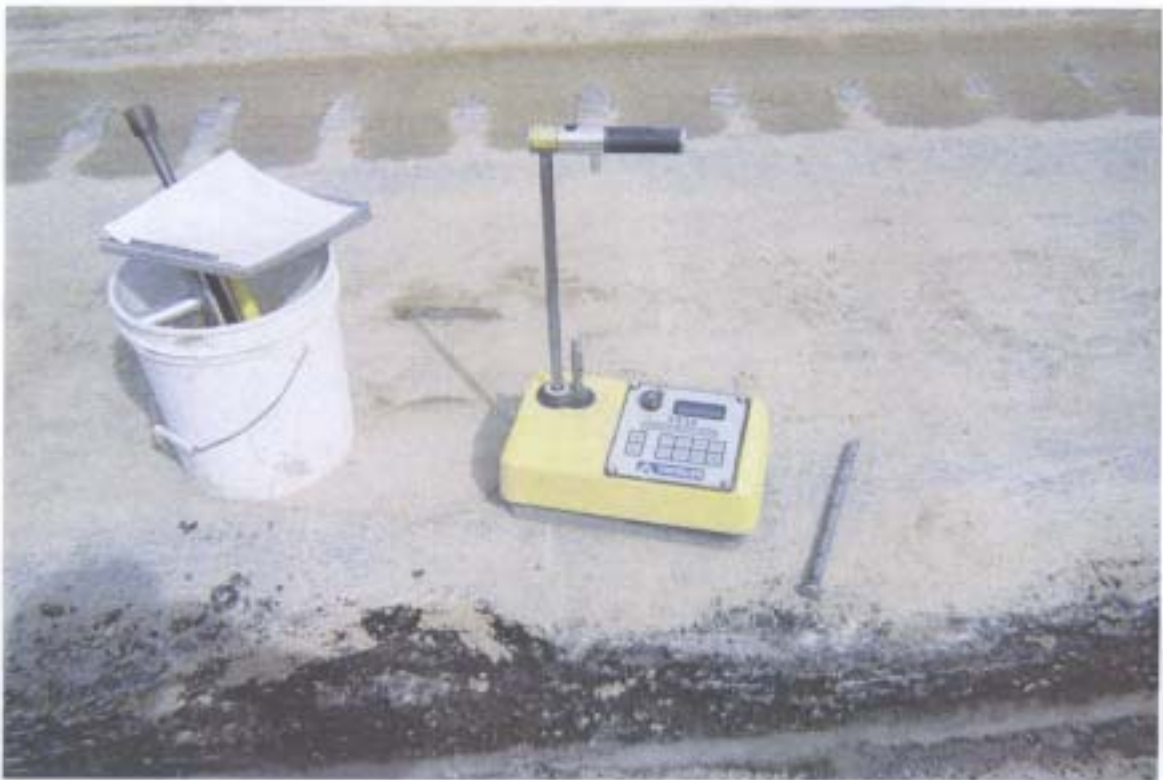
The gauge was intrude by our certified operator Mr. Phil Vannoy, who was checking soil density along a grading operation on I-96 just west of the Mid-Michigan Railroad Bridge in Grand Rapids, Michigan. The grader operator, who was aware that Mr. Vannoy was testing in the area, apparently lost track of his location and began backing the grader towards Mr. Vannoy and the gauge. Mr. Vannoy tried unsuccessfully to get the operators attention and pulled the gauge out of the way and backed away as the grader passed. The tire of the grader hit the gauge and knocked it out of Mr. Vannoy's hand, breaking the index rod. At the time of the hit, the source was retracted into the gauge and there was no apparent damage other than the index rod. Mr. Vannoy left the gauge in place, secured the area and called our office.

Photos at site of accident
