FLEIS & VANDENBRINK

RE: Materials License #21-26580-01, 30-day Event Report

Subject: Troxler Damage

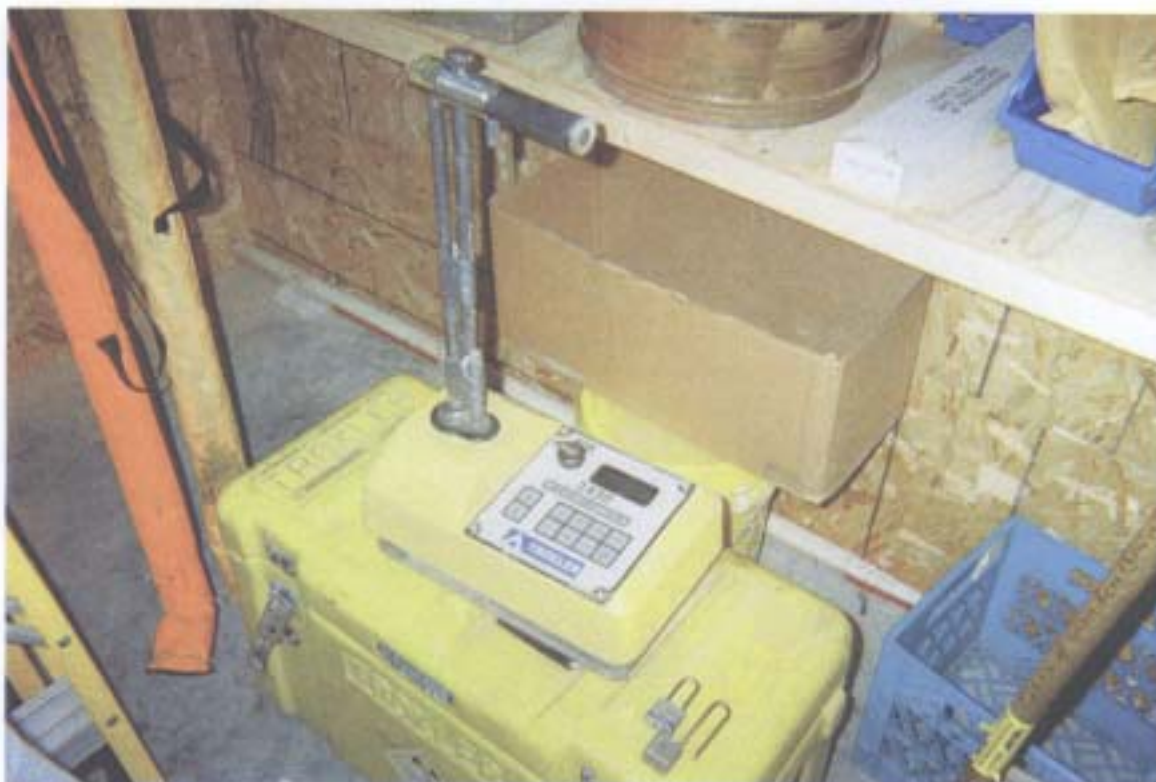
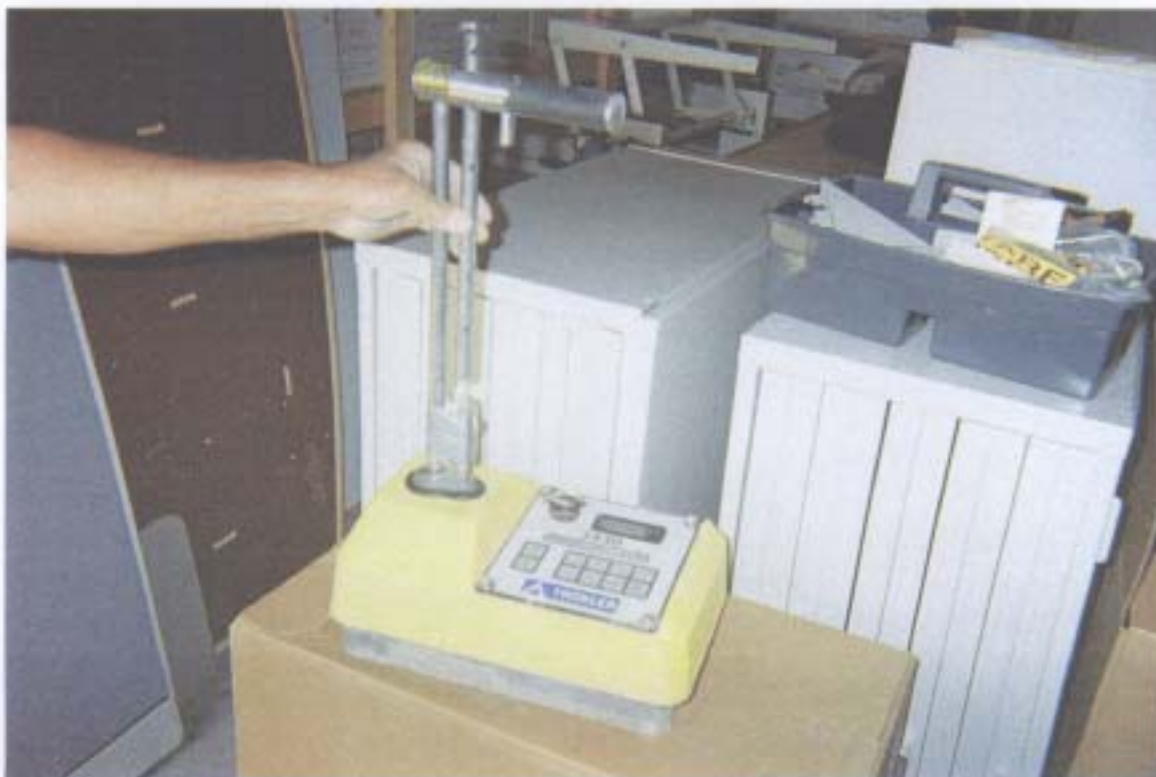
Photos showing secured source rod

Mr. Vannoy and I loaded the gauge into the transport container and brought it back to our storage facility. I spoke with the gauge manufacturer regarding the radiation survey meter readings and damage to the gauge. They were in agreement that the readings were normal and instructed us on how to secure the source rod and prepare for shipment to their facility. We secured the source rod (see attached photo) and completed a leak test. The leak test sample was sent by overnight mail to the gauge manufacturer.
