Subject: **Docket No. 50-361**
Licensee Event Report No. 2006-003
San Onofre Nuclear Generating Station, Unit 2

LICENSEE EVENT REPORT (LER)

4. TITLE
Potential emergency diesel generator trip after a seismic event due to an electrical ground fault in a non-seismic circuit

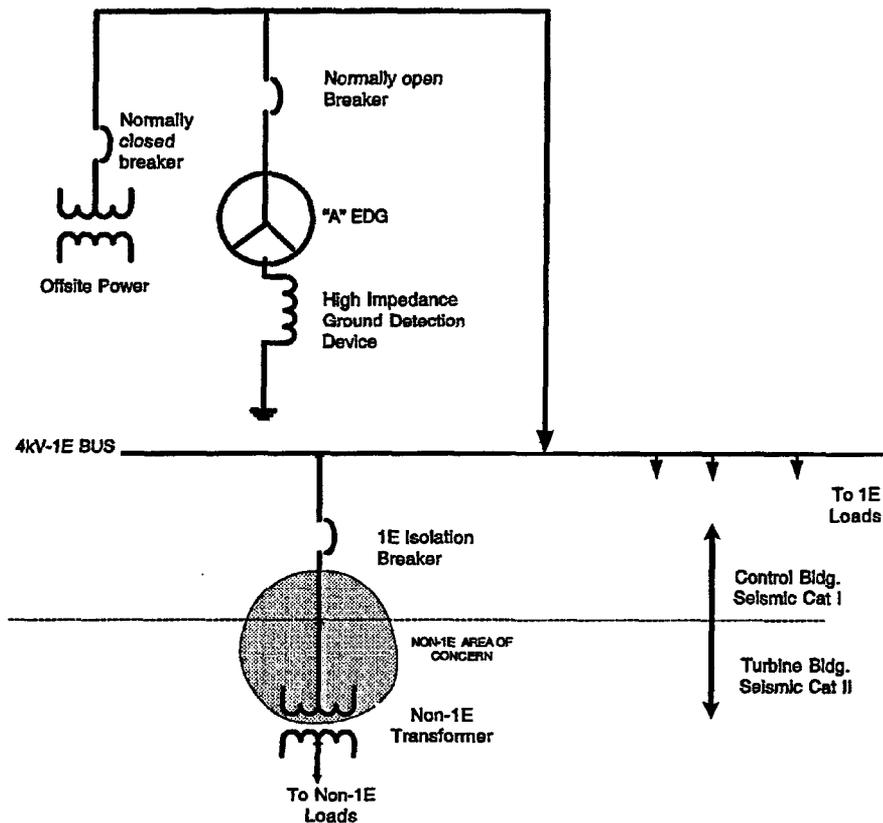
"A" EDG Circuitry

San Onofre Units 2 and 3 each have two emergency diesel generators (EDGs) [EK] to provide emergency AC power if preferred (offsite) AC power is unavailable. The "A" train EDGs provide standby power directly to safety related (1E) and one non-safety related (non-1E) 4 kV transformer; whereas, the "B" train EDGs supply standby power directly only to 1E-4kV loads. Consistent with NRC Regulatory Guide (RG) 1.75, "Physical Independence of Electric Systems," the "A" train EDGs are protected by a 1E isolation breaker [BKR] and a non-1E transformer [XFMR]. The 1E breaker isolates the non-1E loads from the EDG if there is a phase-to-phase fault in the non-1E circuitry. The non-1E transformer isolates the non-1E loads from the EDG if there is a ground fault on the secondary side of the transformer. See the attached drawing.

In January 2005, SCE recognized that a ground fault on the non-1E 4 kV circuit on the primary side of the non-1E transformer would not trip the 1E isolation breaker to isolate the non-1E circuit from the emergency diesel generator (EDG). Therefore, if there was a loss of offsite power with no SIAS and a coincidental or resulting ground in the non-1E circuitry on the primary side of the transformer, the "A" train EDGs could be tripped by the ground detection device before the 1E isolation breaker could isolate the EDG from the faulted non-1E circuit.

If a seismic event had occurred followed by a loss of offsite power and a ground fault on the primary side of the non-1E transformer, it is possible the "A" train EDG could have been tripped. If this had occurred during an EDG "B" train outage, both EDG trains would have been unavailable to perform their required safety function. At times in the past, a "B" train EDG has been taken out of service for planned work as allowed by the Technical Specifications. Based on the guidance provided in NRC NUREG-1022, on July 20, 2006 (discovery date), SCE concluded this past condition is reportable in accordance with 10CFR50.73(a)(2)(v)(A) and (B), as an event or condition that could have prevented fulfillment of a safety function required to maintain the reactor in a safe shutdown condition and to remove residual heat.

In 1983, SCE modified the original design to attach a non-1E circuit to a 1E bus. At that time the 1E isolation breaker was installed consistent with RG 1.75 requirements. However, it was not realized that the ground fault protective trip on the EDG was faster than the 1E isolation breaker. Due to the passage of time, it is not clear why this design did not preclude this condition.

In 2005, the EDG stator ground protection scheme was modified to immediately isolate the non-1E circuit when a line-to-ground fault is detected and to add a 5-second delay to the EDG ground fault protective trip. If the fault is cleared within 5 seconds of isolation of the non-1E circuit, the stator ground relay will reset and the EDG will not trip. If the fault has not cleared after 5 seconds, the EDG will trip. This change provides sufficient time for the existing non-1E circuit to separate from the 1E bus without affecting the EDG.
