2CAN090601

Subject: Response to Request for Additional Information on ANO-2 Steam Generator  
Tube Inservice Inspection Report  
Arkansas Nuclear One – Unit 2  
Docket No. 50-368  
License No. NPF-6

**Response to NRC Request for Additional Information on  
Steam Generator Tubing Inservice Inspection Report**

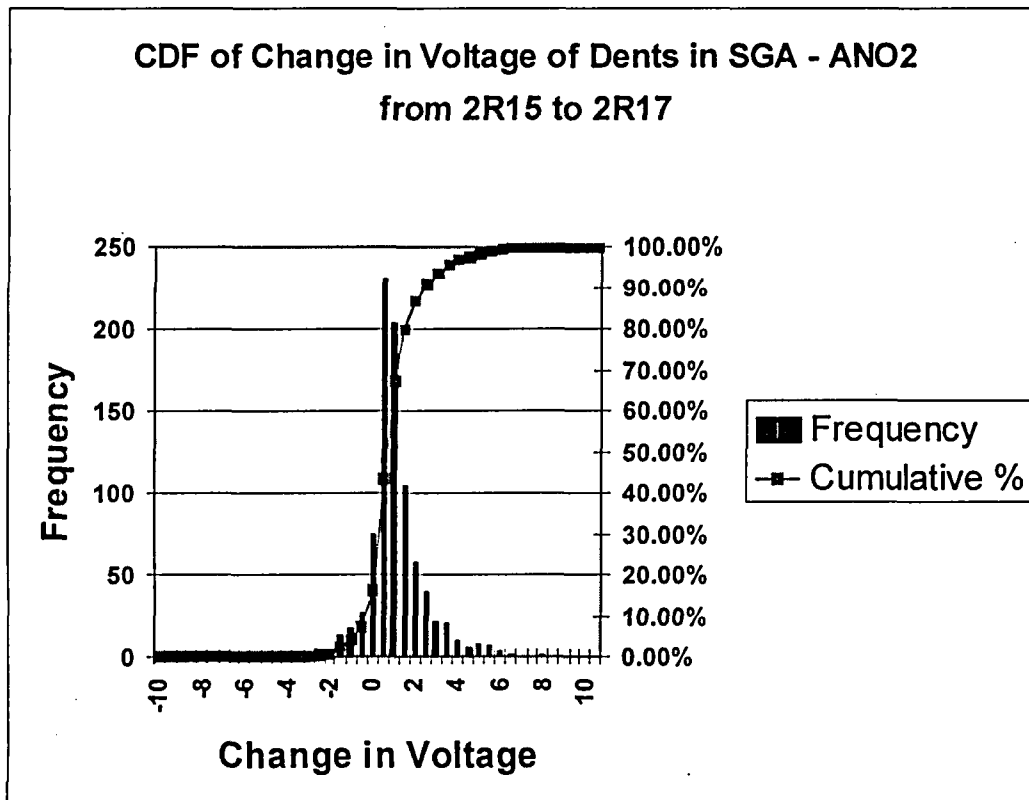
Dents/dings are identified with the bobbin campaign. The scope from 2R17 was 54% of the tube population. A review was performed to compare the dents/dings from 2R15 (spring 2002) to 2R17 (spring 2005). 2R15 was the first inservice inspection (ISI) after one cycle of operation and included 100% of the tubing. Both generator results were consistent with steam generator A (SGA) having the largest population of dents. Therefore, for this report, SGA data is being reported. A cumulative distribution factor (CDF) of the change in voltage for dents identified in both outages was performed. The mean change was approximately 0.6 volts which is considered an insignificant change based on the technique. This is presented in the graph below:

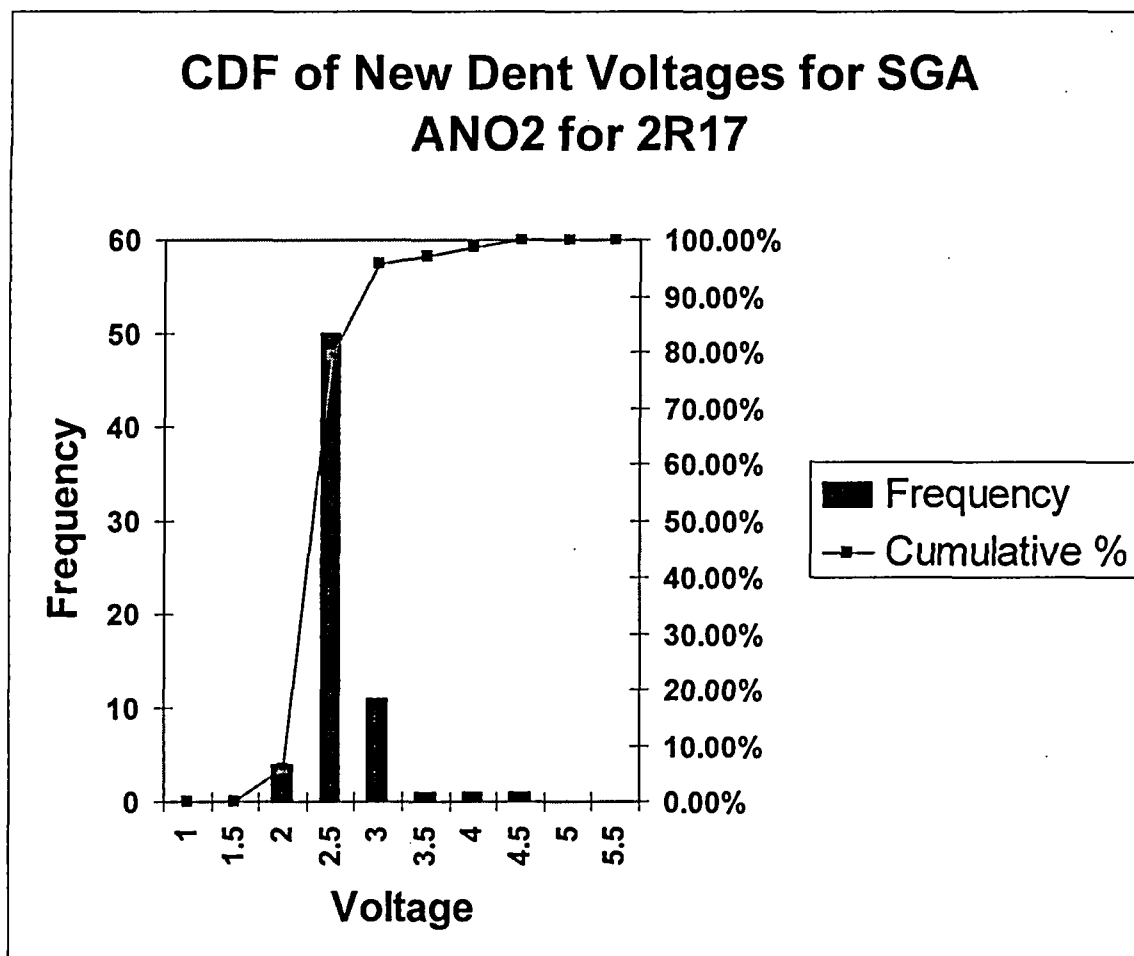
A review was performed of newly identified dents in 2R17. These were determined to be a function of the threshold limit of 2.0 volts as the vast majority of the newly reported dents were at this value. From the graph below, the majority of the dents remain at or near the detection threshold. Based on this data, the relative condition of the dents in the ANO-2 steam generators is not changing.
