**OPERATION REPORT
FEDERAL ENERGY REGULATORY COMMISSION
New York Regional Office**

For the period October 28, 1998 to June 24, 2002

Licensee: USGen New England, Inc. (USGen) Project No.: 1904-VT/NH
 NATDAM No.: NH00097

Project Name: Vernon

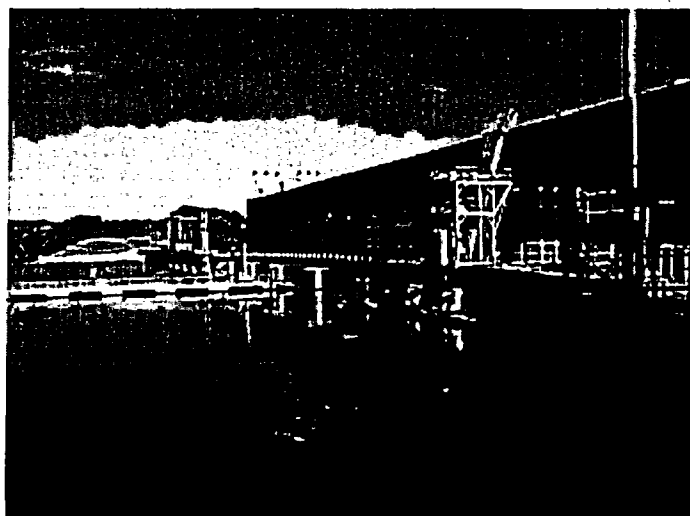
The powerhouse and intake structure appeared to be in good condition and well maintained. (Photo Nos. 10 thru 11). The fish ladder on the downstream side of the powerhouse was also in good condition (Photo No. 13).

Photo No. 10 - Looking across the upstream side of the powerhouse/intake structure.

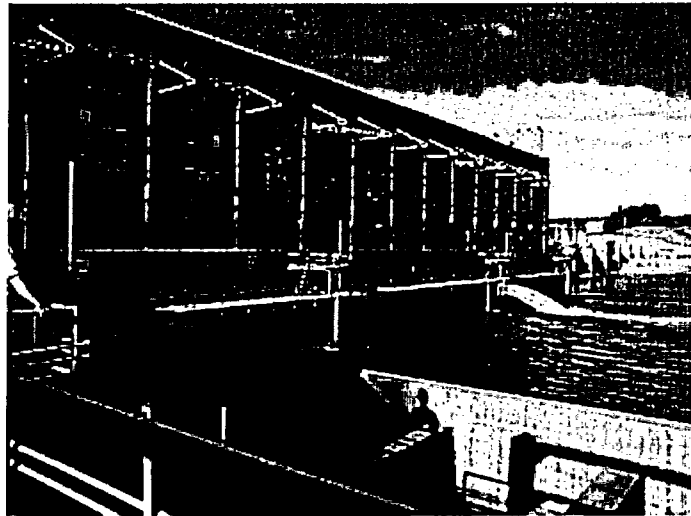
Photo No. 11 - Looking from the fish ladder towards the downstream side of the powerhouse.

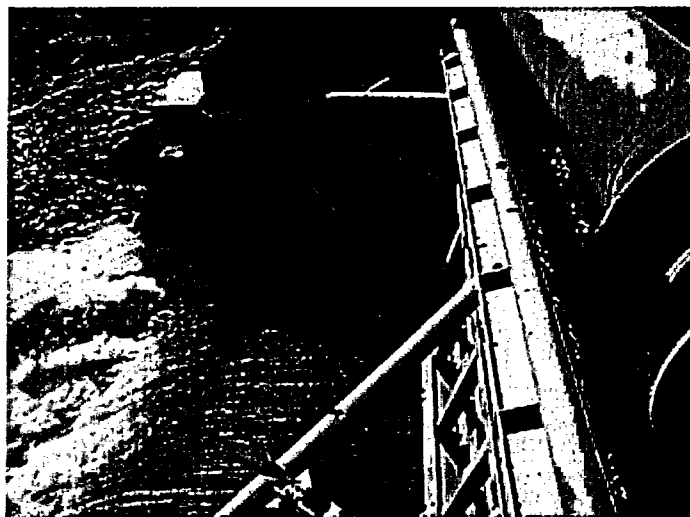
During the inspection, Tainter Gate No. 2 was operated by the emergency generator (Photo No. 12).

No problems occurred during the gate operation. An automatic Emergency Generator test is performed once per month. At the time of the inspection, all gates were reported to be operational. They appeared to be structurally sound. Rust spots were observed on the tainter gate that will be painted during the 2003 maintenance season.

Photo No. 12 - A typical Tainter Gate. This is Gate No. 2 being operated using power from Emergency Generator. Some rust spots were noted. The Licensee's representative stated the rust spots will be painted during the 2003 maintenance season.
