**OPERATION REPORT
FEDERAL ENERGY REGULATORY COMMISSION
New York Regional Office**

For the period October 28, 1998 to June 24, 2002

Licensee: USGen New England, Inc. (USGen) Project No.: 1904-VT/NH
NATDAM No.: NH00097
Project Name: Vernon
Location: Connecticut River Windham/Cheshire VT/NH
(Waterway or reservation) (County) (State)
License issued: June 25, 1979 Expires: April 30, 2018 Type: MON
Date of last amendment: May 8, 2002 (Order Granting Extension of Time Under Article 301)
Inspected by: Liza Vélez and Michael Monahan Date: June 24, 2002
Parts of project inspected: Powerhouse, dam and fishway
Weather: Sunny; high 80's
Accompanied by: Bruce Davin, Director of Hydro operation; Justin Donaghy, Hydro engineer; Earl
Brissele, Maintenance Planner; John Ragonese, FERC License Manager.

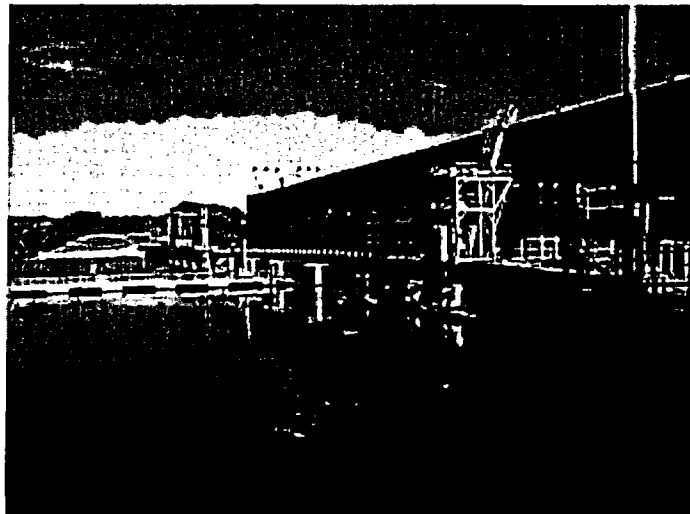
The powerhouse and intake structure appeared to be in good condition and well maintained. (Photo Nos. 10 thru 11). The fish ladder on the downstream side of the powerhouse was also in good condition (Photo No. 13).

Photo No. 10 – Looking across the upstream side of the powerhouse/intake structure.

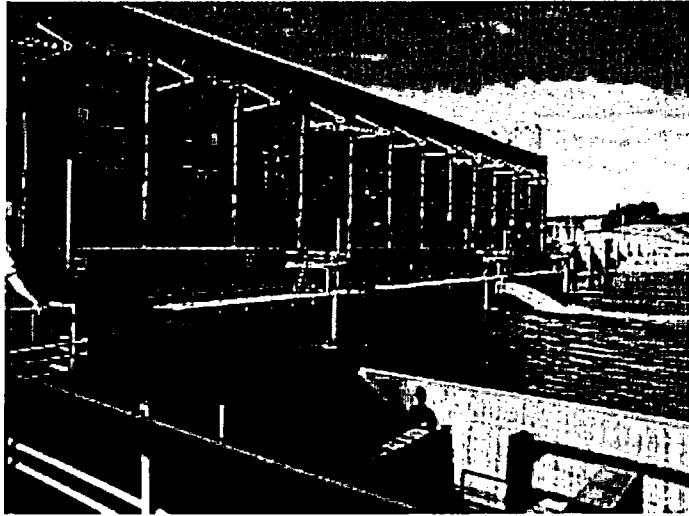
Photo No. 11 - Looking from the fish ladder towards the downstream side of the powerhouse.

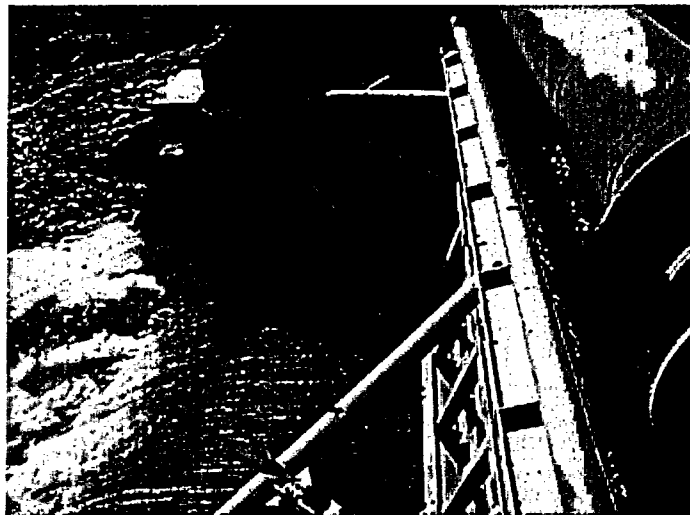
During the inspection, Tainter Gate No. 2 was operated by the emergency generator (Photo No. 12).

No problems occurred during the gate operation. An automatic Emergency Generator test is performed once per month. At the time of the inspection, all gates were reported to be operational. They appeared to be structurally sound. Rust spots were observed on the tainter gate that will be painted during the 2003 maintenance season.

Photo No. 12 - A typical Tainter Gate. This is Gate No. 2 being operated using power from Emergency Generator. Some rust spots were noted. The Licensee's representative stated the rust spots will be painted during the 2003 maintenance season.
