SIXTH QUINQUENNIAL SAFETY INSPECTION
VERNON PROJECT
FERC PROJECT NO. 1904

New England Power Company
25 Research Drive
Westborough, Massachusetts 01582

Project 92067
October 19, 1992

SIXTH QUINQUENNIAL SAFETY INSPECTION

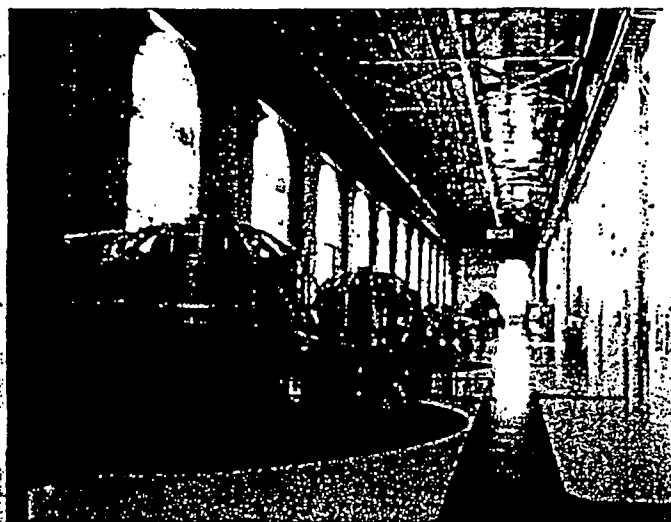
Photo No. 1

The powerhouse superstructure brickwork, structural steel, and roof are in very good condition. Refer to Figs. 3, 4, 5, and 6 for powerhouse features. The gantry crane appeared in good operating condition. The El. 226.38 generator floor was in very good condition (see Photo No. 1), with only minor floor cracks. The substructure was observed with no evidence of structural displacement or severe cracking. The unit wheel pits are in generally good condition. Unit No. 8 turbines (triple runner style) are no longer operational; therefore, the unit is decommissioned leaving nine operational turbine generators at this project. The turbine pits appear unchanged from conditions noted in the 1982 Quinquennial Inspection Report (4).

Powerhouse Generator Hall

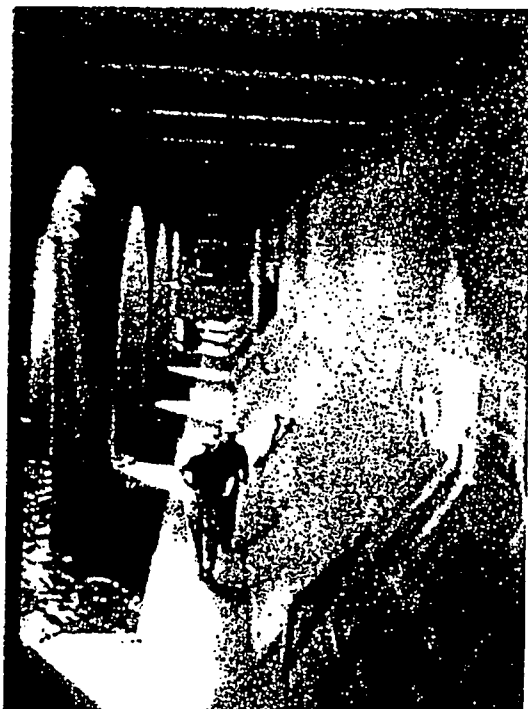
Photo No. 3

The El. 189.13 walkway over the draft tubes was observed. The 1987 observed concrete erosion on the downstream piers at the water line was not visible due to high tailwater. However, the piers for Units 1-4 are scheduled for concrete work before the next 5-year inspection. On the exterior wall of the tailrace gallery at Units 7 and 8, the concrete is heavily spalled with patterned cracks and efflorescence (see Photo No. 2). These conditions are surficial and have not changed since the 1987 Report. In 1991, NEP installed a new downstream migrant fish by-pass conduit between Units 4 and 5 in the old exciter unit draft tubes (see Photo No. 3).

El. 189.13 Power-
house Tailrace
Gallery - Note:
Migrant Conduit

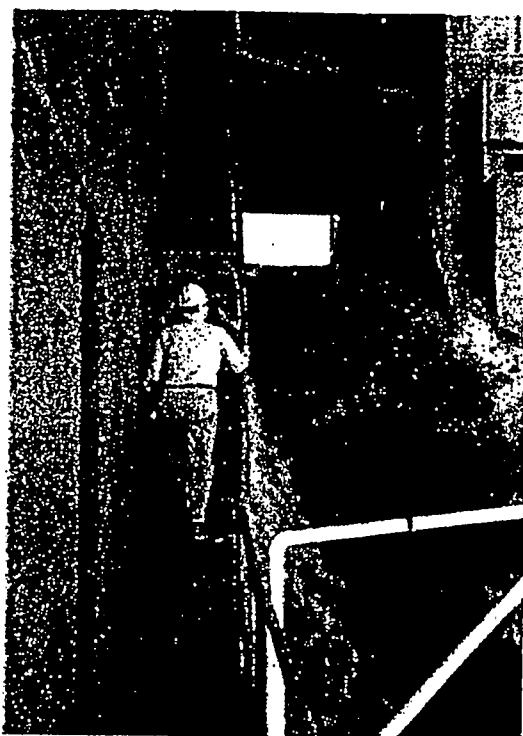
The sluice was operational during the inspection (see Photo No. 4 and Fig. 1 for location). The El. 226.38 deck, upstream and downstream piers are in good condition. The 1987 inspection reported a light to moderate spalled ogee, and chute and concrete erosion on the powerhouse wall below the stairs was not observable due to discharge flows.

Operational Trash
Sluice Flow Down-
stream

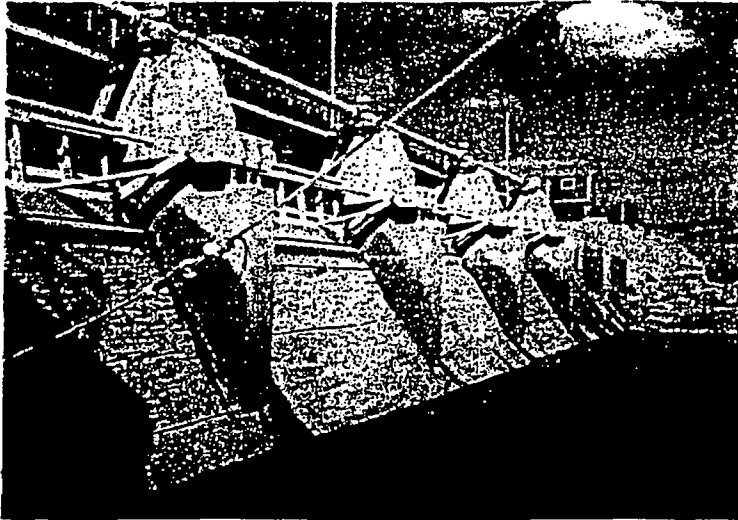
Photo No. 7

The two east deep tainter gates (Nos. 1 and 2) were closed. The gate, seals, mechanical equipment, and hoisting mechanism are in good condition. In 1990, NEP installed stanchion beams and stoplogs in the three former pin flashboard controlled spillway bays. The beams, release mechanisms, and timber boards were in good condition (see Photo No. 6). Nominal leakage was observed between the boards and at the concrete spillway contact. The six hydraulic controlled flashboard spillway bays were in closed position and showed no signs of significant leakage. The gates, seals, and mechanical equipment were in good condition (see Photo No. 7). The steel grated and plate girder spillway bridge was in good condition.

Westerly Tainter
Gate Spillway Bay
