**From:** "Hamer, Mike" <mhamer@entergy.com>  
**To:** "Jonathan Rowley" <JGR@nrc.gov>  
**Date:** Thu, Sep 7, 2006 12:02 PM  
**Subject:** VHS reports

SEISMIC DESIGN CONSIDERATIONS FOR THE VERNON DAM  
AND THE VERMONT YANKEE REACTOR BUILDING

FIFTH QUINQUENNIAL SAFETY INSPECTION  
VERNON PROJECT

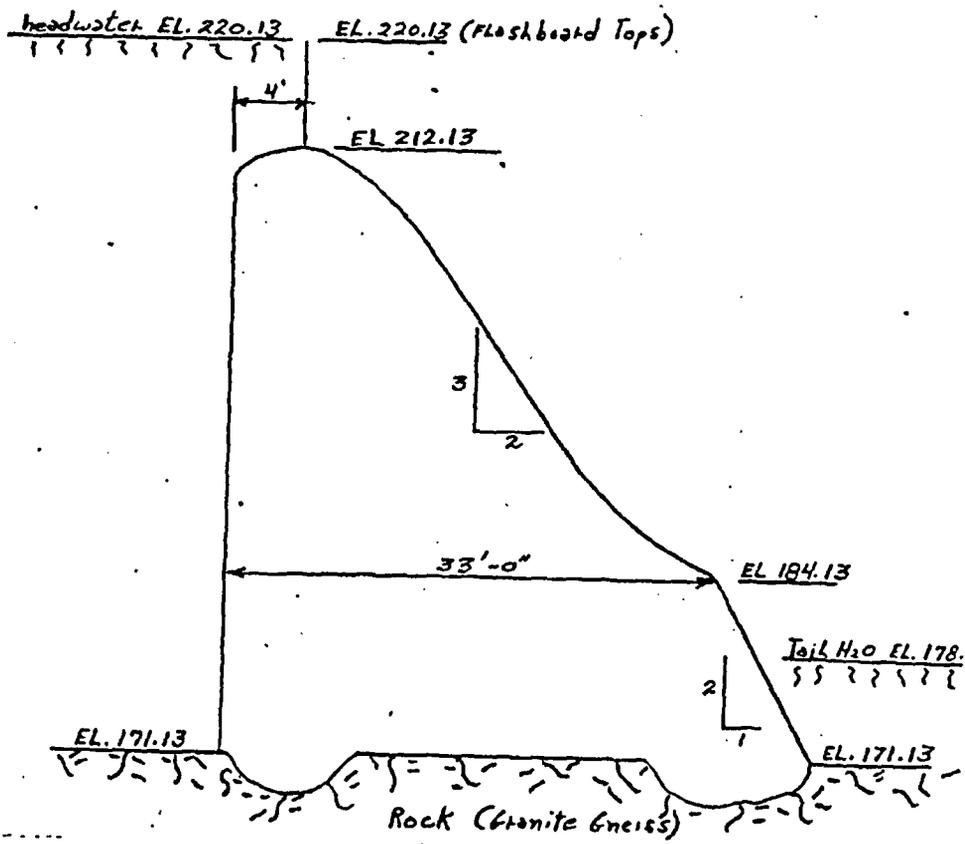
SKETCH 1

1) Typical Dam Section (Base El 171.13) - (See Sketch 1)

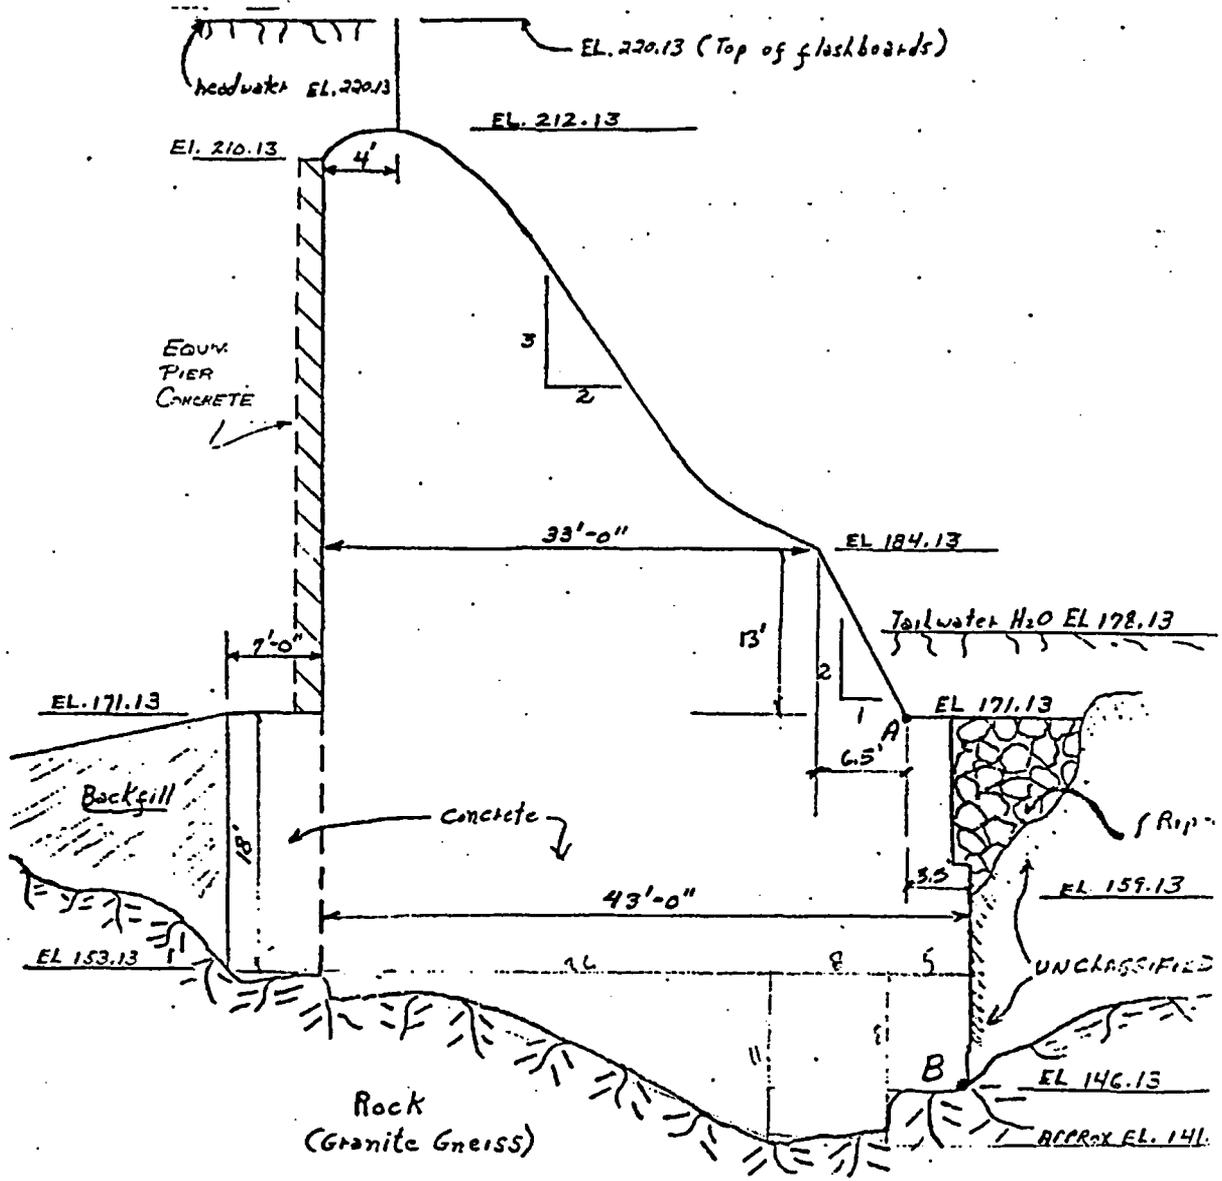
SKETCH 2

## a) East-End Section - (See Sketch 2)

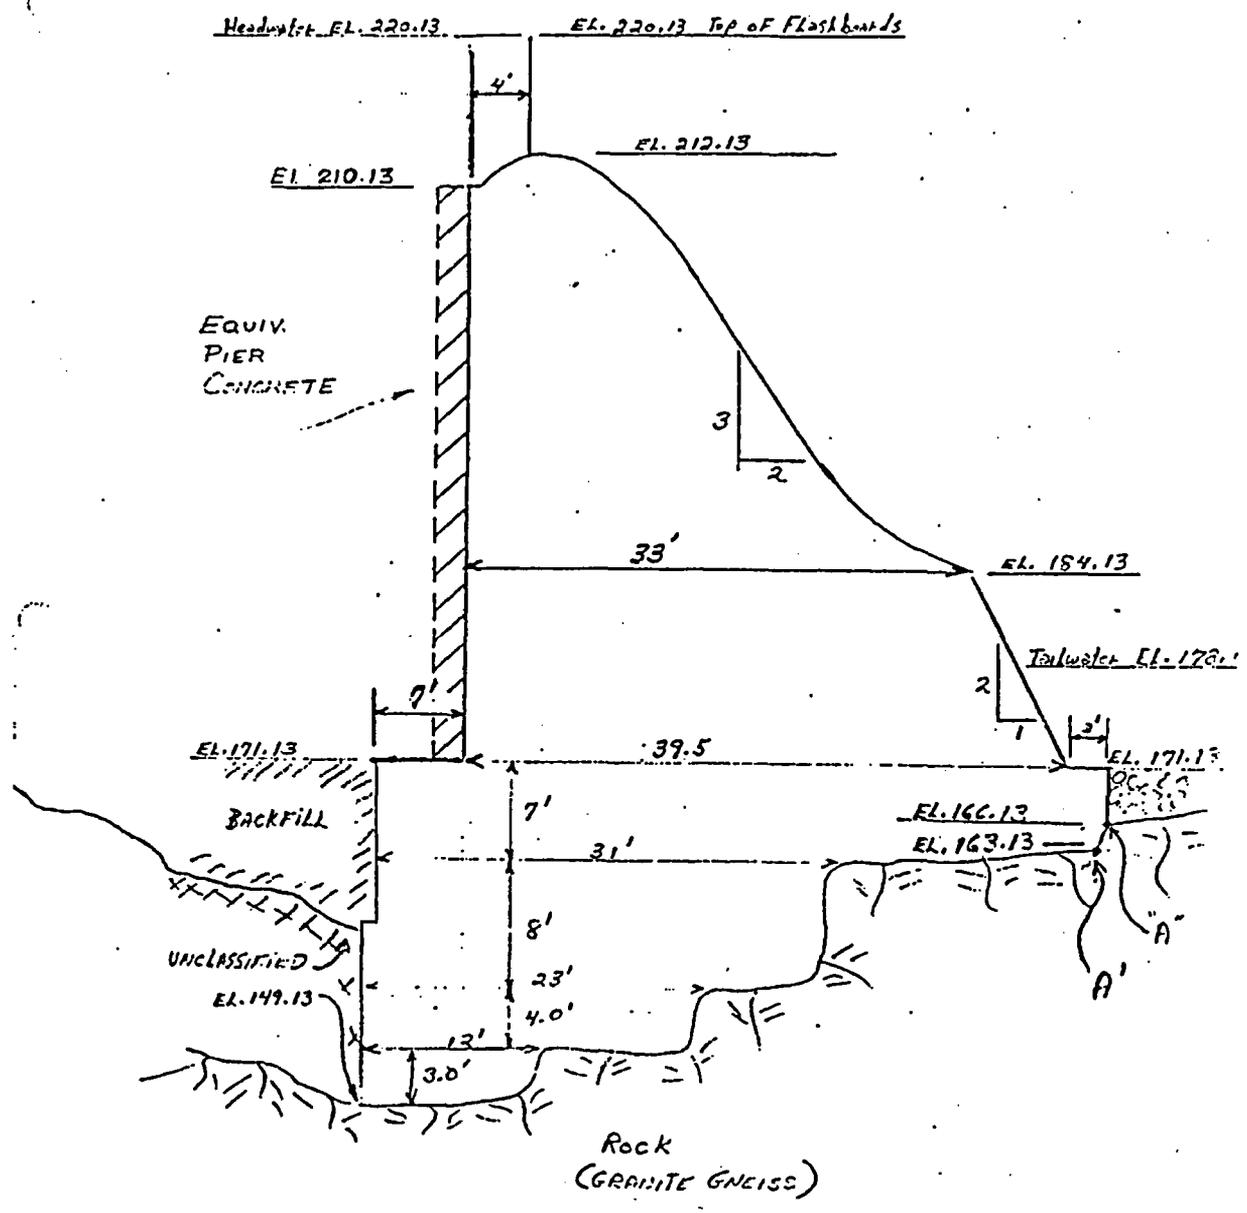
SKETCH 3

## b) West-End Section - (See Sketch 3)

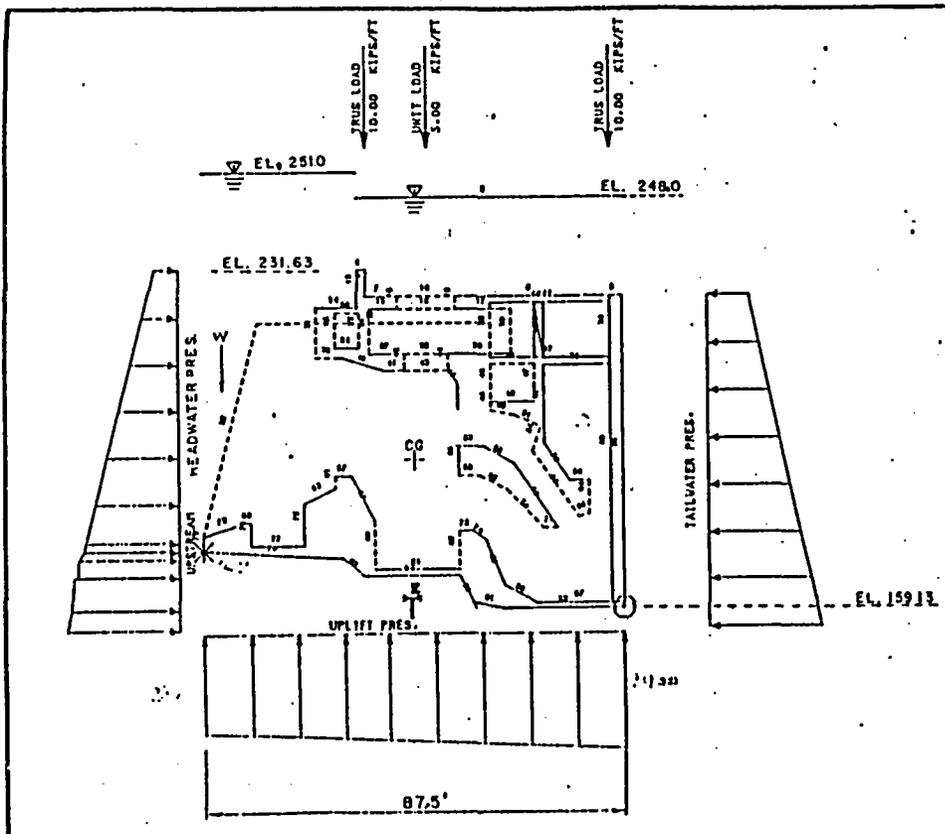
GEOTECHNICAL ENGINEERS INC. WILMINGTON • MASSACHUSETTS	Project 87123	Oct. 30, 1987 Fig. C

LOADING CONDITION NO. 6  
 PMF HEADWATER LEVEL = 251.0

$\Sigma MFH = -96.90$   
 $\Sigma MFV = 1828.32$   
 $\Sigma MFH / \Sigma FV = 0.05$   
 $SSF = 607.10$   
 RESULTANT AT X = 43.38  
 $\Sigma MR = 688678.75$   
 $\Sigma MO = -608021.75$   
 $\Sigma MR / \Sigma MO = 1.13$   
 BASE STRESS (PSI)  
 6.20 AT X = 0.00  
 5.89 AT X = 87.50

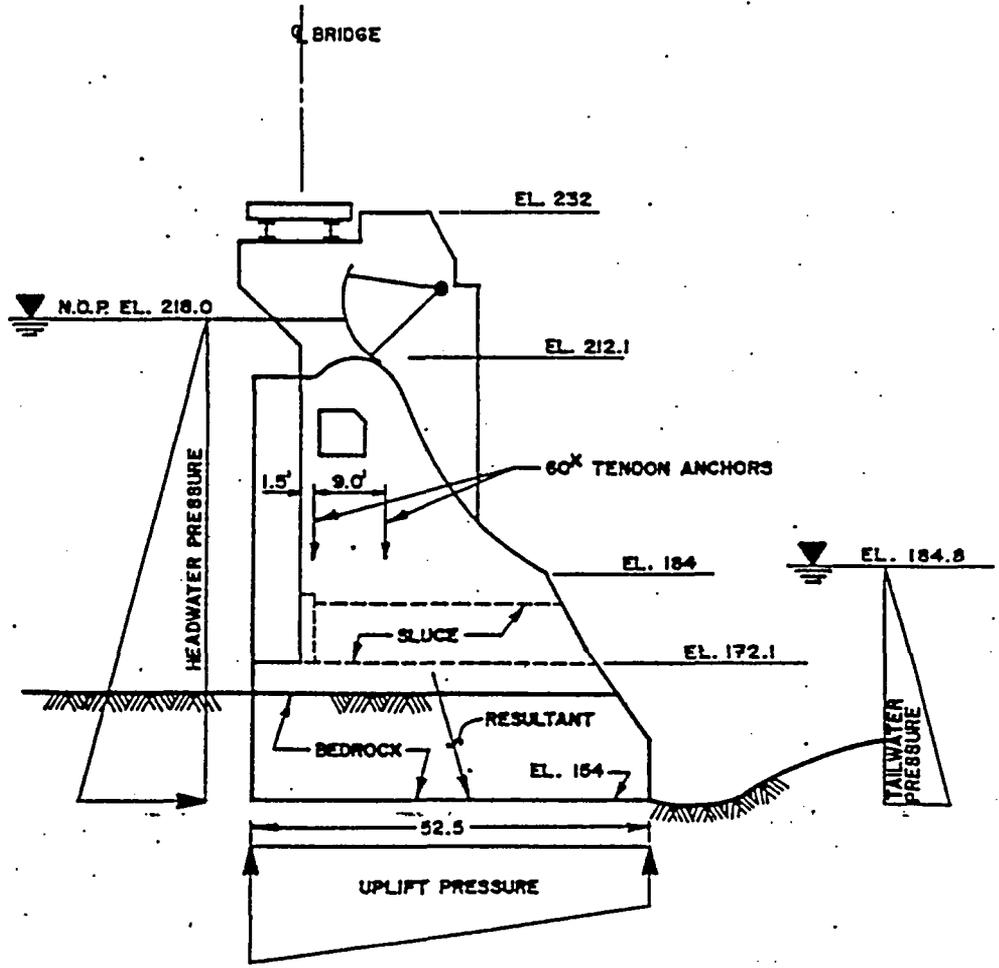
**CASE 1: NORMAL OPERATING POOL**

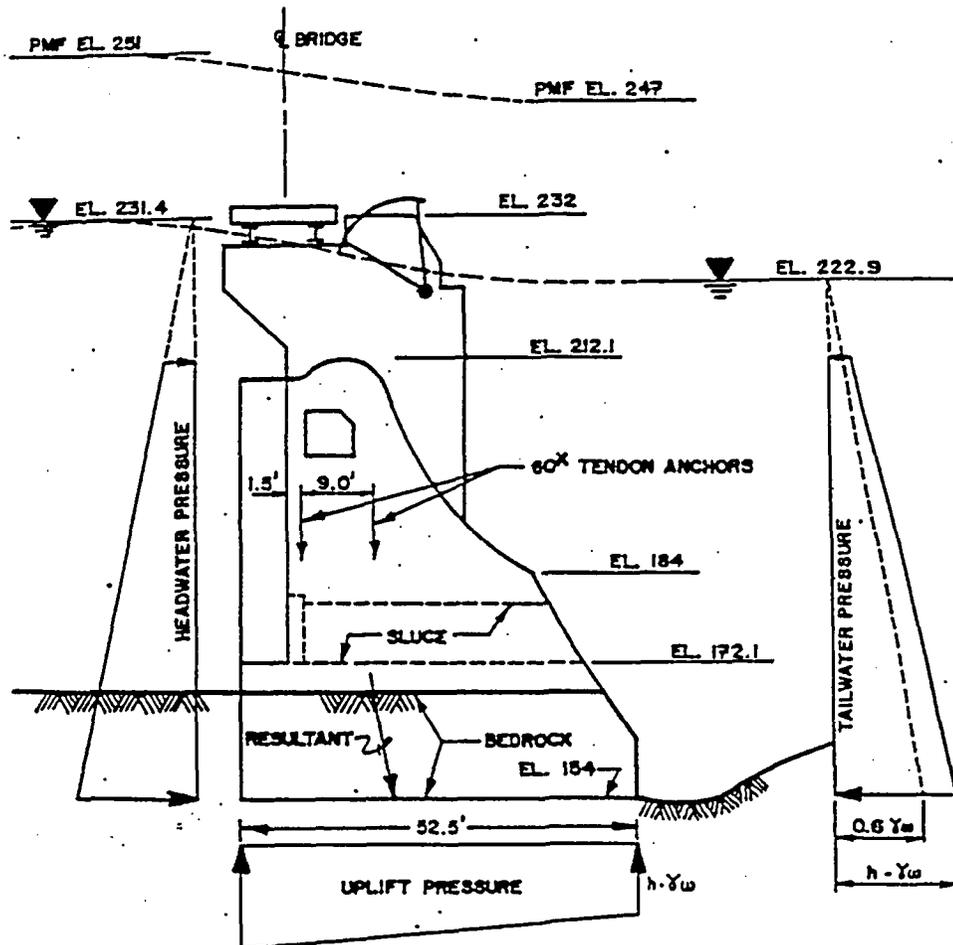
**CASE V: FLOOD OF RECORD**
