VERMONT YANKEE NUCLEAR POWER CORPORATION

SEISMIC DESIGN CONSIDERATIONS FOR THE VERNON DAM  
AND THE VERMONT YANKEE REACTOR BUILDING

FIFTH QUINQUENNIAL SAFETY INSPECTION  
VERNON PROJECT

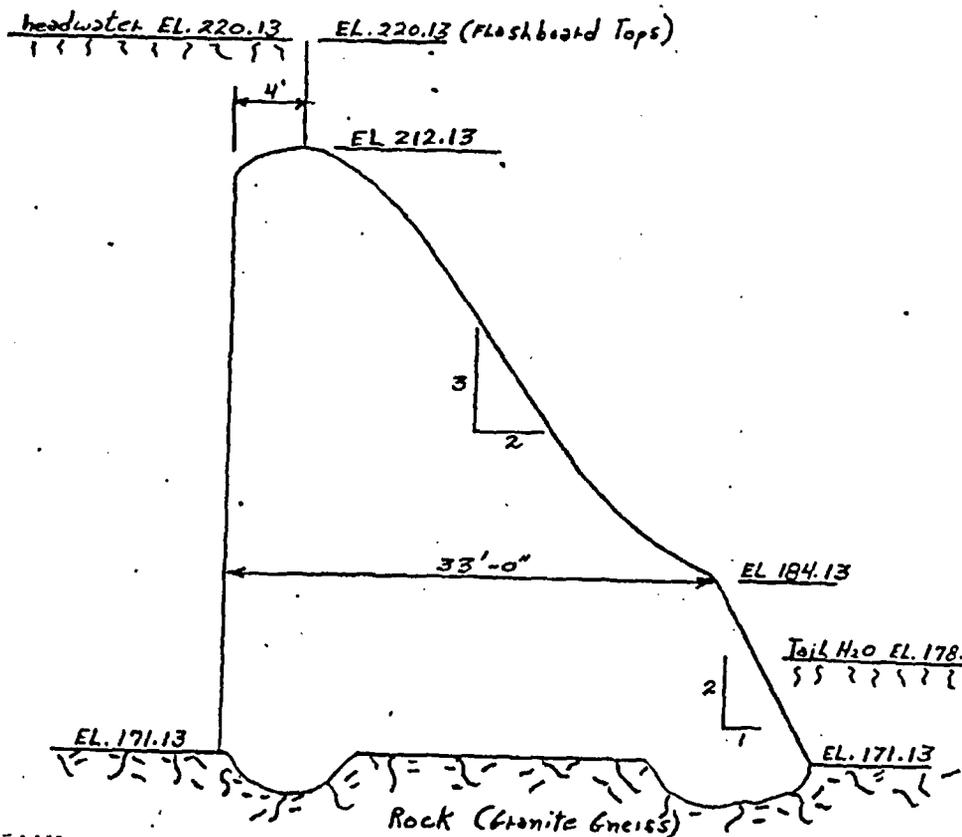
SKETCH 1

1) Typical Dam Section (Base El 171.13) - (See Sketch 1)

The static headwater force against the dam was computed between normal water level (El 220.13) and base elevation (El 171.13). Tailwater calculations were computed between minimum tailwater (El 178.13) and base elevation (El 171.13).

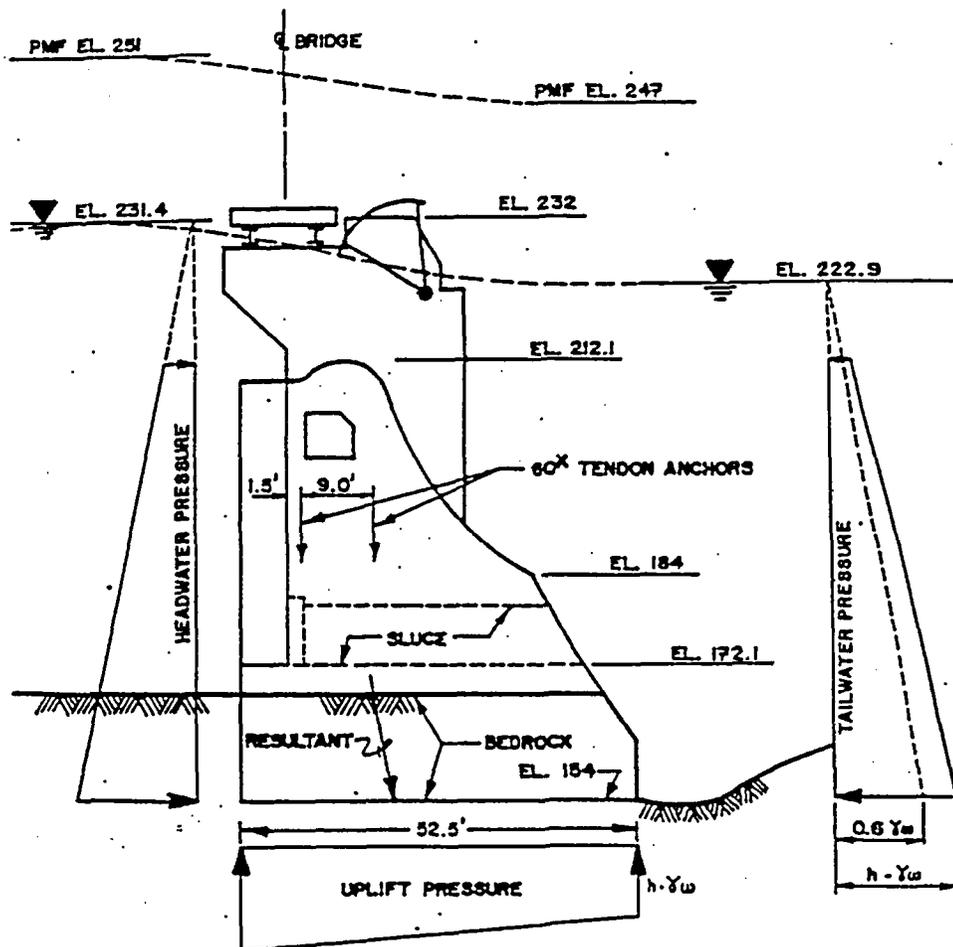
**CASE V: FLOOD OF RECORD**

- 1) WEIGHT OF BRIDGE, PIER AND GATE = 9.4 K/FT. OF DAM.
- 2) SLUICE GATE SECTION IS 18 FEET LONG.
