SIXTH QUINQUENNIAL SAFETY INSPECTION
VERNON PROJECT
FERC PROJECT NO. 1904

Project 92067
October 19, 1992

SIXTH QUINQUENNIAL SAFETY INSPECTION

VERNON PROJECT

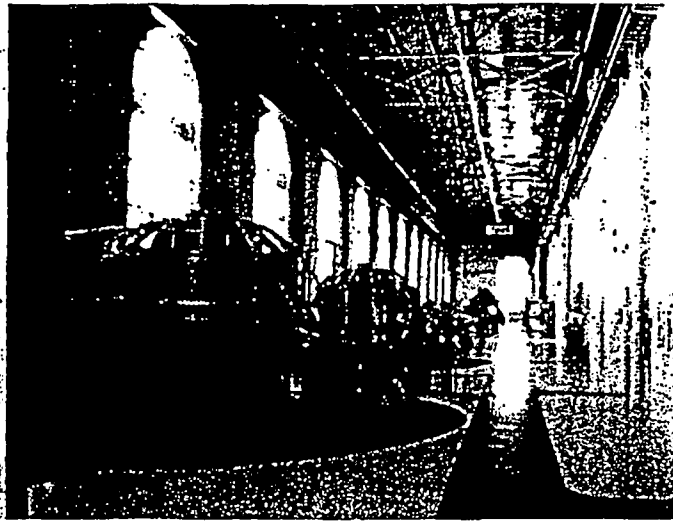
Photo No. 1

The powerhouse superstructure brickwork, structural steel, and roof are in very good condition. Refer to Figs. 3, 4, 5, and 6 for powerhouse features. The gantry crane appeared in good operating condition. The El. 226.38 generator floor was in very good condition (see Photo No. 1), with only minor floor cracks. The substructure was observed with no evidence of structural displacement or severe cracking. The unit wheel pits are in generally good condition. Unit No. 8 turbines (triple runner style) are no longer operational; therefore, the unit is decommissioned leaving nine operational turbine generators at this project. The turbine pits appear unchanged from conditions noted in the 1982 Quinquennial Inspection Report (4).

Powerhouse Gener-
ator Hall

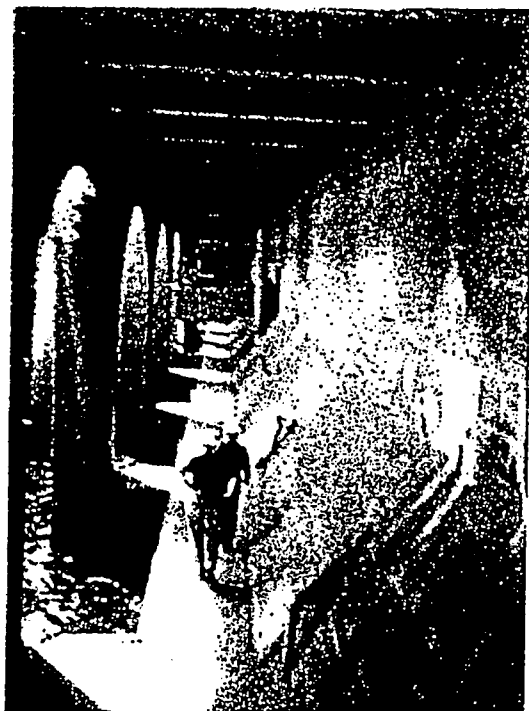
Photo No. 3

The El. 189.13 walkway over the draft tubes was observed. The 1987 observed concrete erosion on the downstream piers at the water line was not visible due to high tailwater. However, the piers for Units 1-4 are scheduled for concrete work before the next 5-year inspection. On the exterior wall of the tailrace gallery at Units 7 and 8, the concrete is heavily spalled with patterned cracks and efflorescence (see Photo No. 2). These conditions are surficial and have not changed since the 1987 Report. In 1991, NEP installed a new downstream migrant fish by-pass conduit between Units 4 and 5 in the old exciter unit draft tubes (see Photo No. 3).

El. 189.13 Power-
house Tailrace
Gallery - Note:
Migrant Conduit

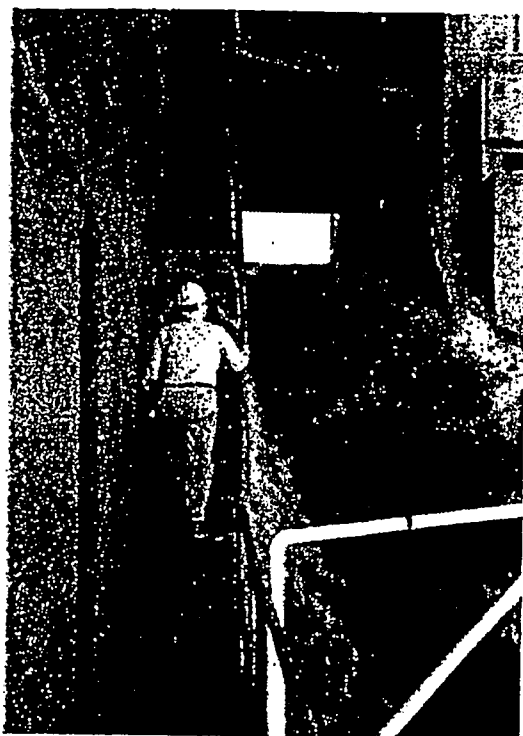
The sluice was operational during the inspection (see Photo No. 4 and Fig. 1 for location). The El. 226.38 deck, upstream and downstream piers are in good condition. The 1987 inspection reported a light to moderate spalled ogee, and chute and concrete erosion on the powerhouse wall below the stairs was not observable due to discharge flows.

Operational Trash
Sluice Flow Down-
stream

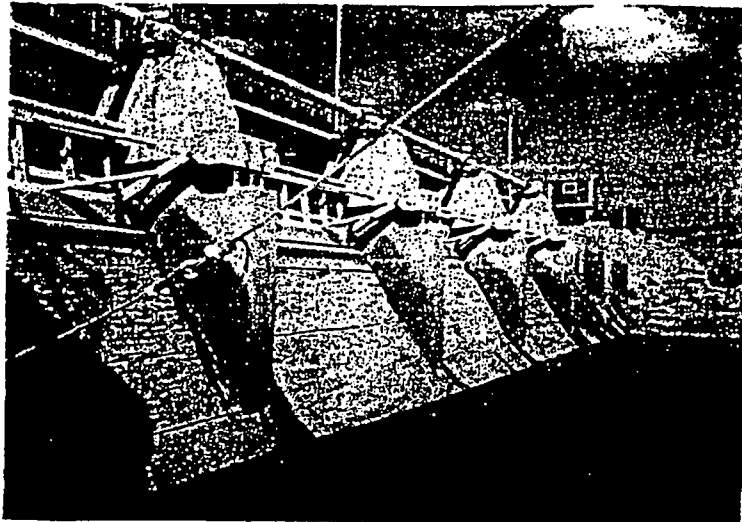
Photo No. 7

The two east deep tainter gates (Nos. 1 and 2) were closed. The gate, seals, mechanical equipment, and hoisting mechanism are in good condition. In 1990, NEP installed stanchion beams and stoplogs in the three former pin flashboard controlled spillway bays. The beams, release mechanisms, and timber boards were in good condition (see Photo No. 6). Nominal leakage was observed between the boards and at the concrete spillway contact. The six hydraulic controlled flashboard spillway bays were in closed position and showed no signs of significant leakage. The gates, seals, and mechanical equipment were in good condition (see Photo No. 7). The steel grated and plate girder spillway bridge was in good condition.

Westerly Tainter
Gate Spillway Bay
