From: "Oscar Paulson" <paulson@tribcsp.com>
To: "Stephen Cohen" <SJC7@nrc.gov>
Date: 10/03/2006 3:50:48 PM
Subject: Excavation Progress - Kennecott- Doc. 40-8584

1. Excavation Progress

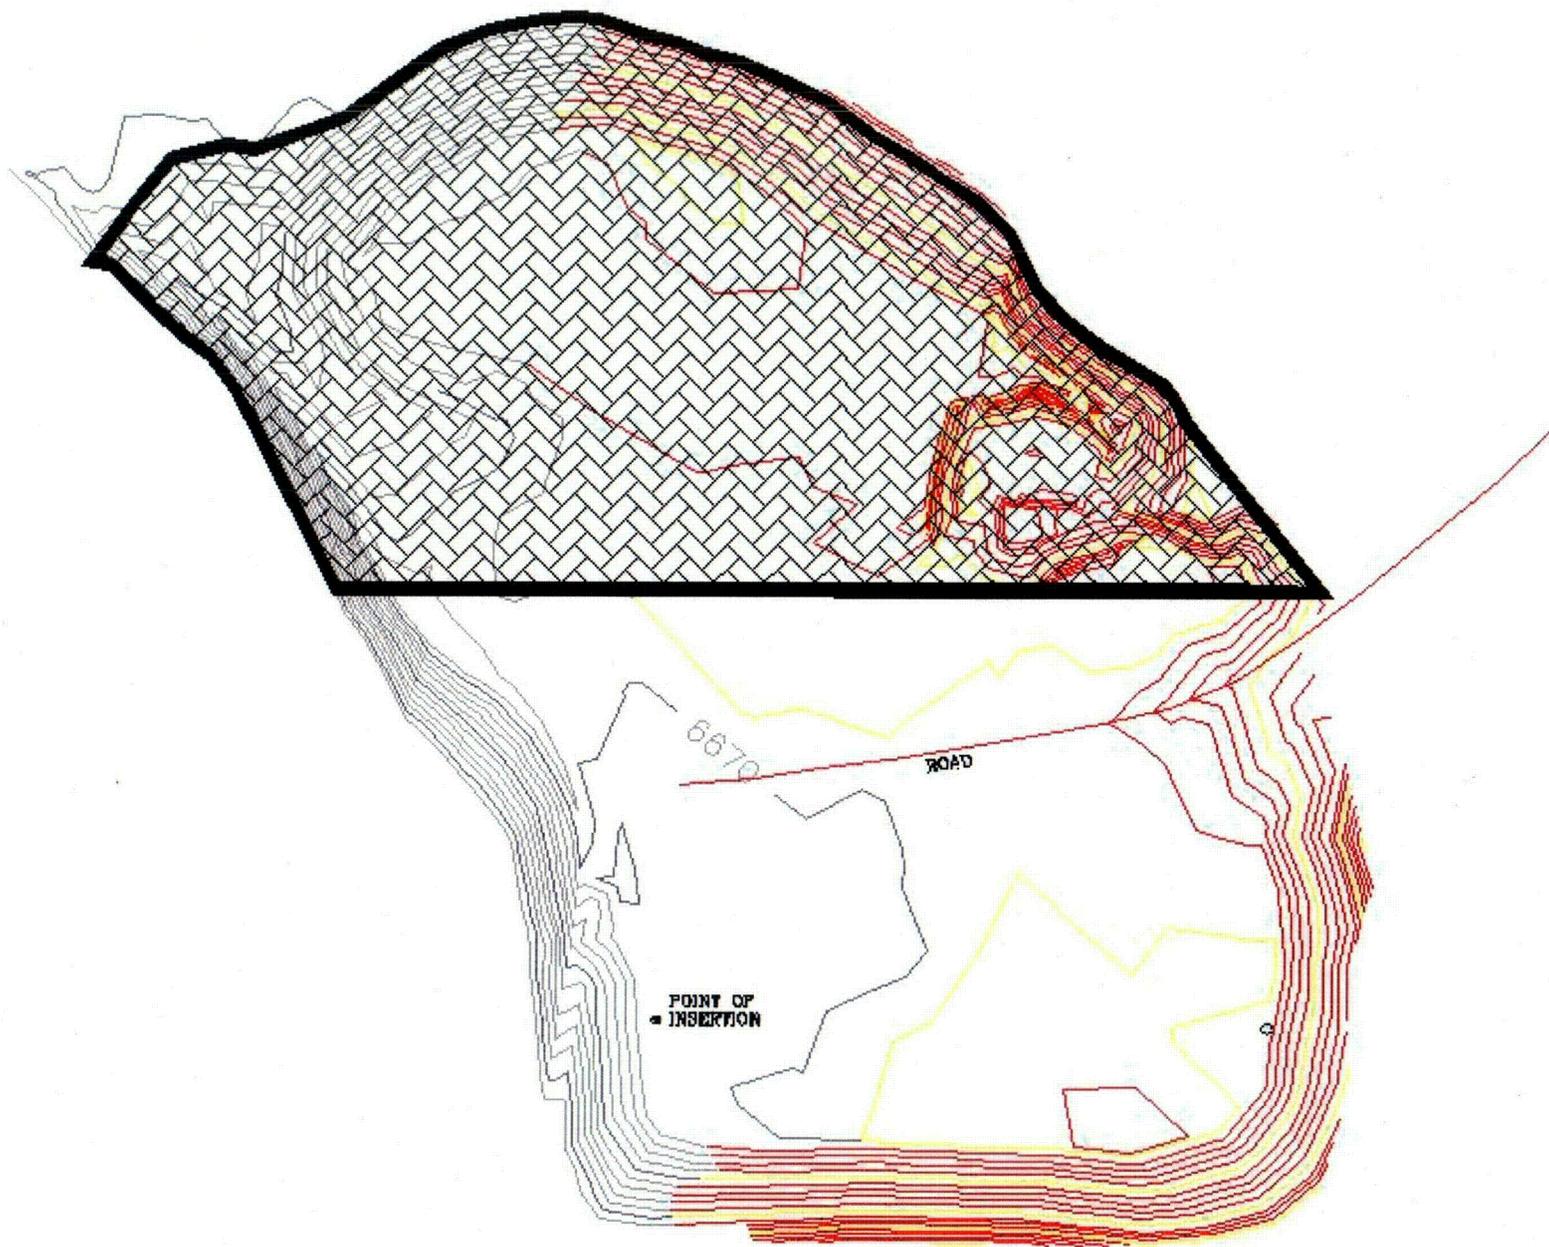
An excavation contour with a supposed ten (10) meter by ten (10) meter sampling grid is attached as the *.jpg file September_22_2006_contours.jpg. The contours are as of Friday, September 22, 2006.

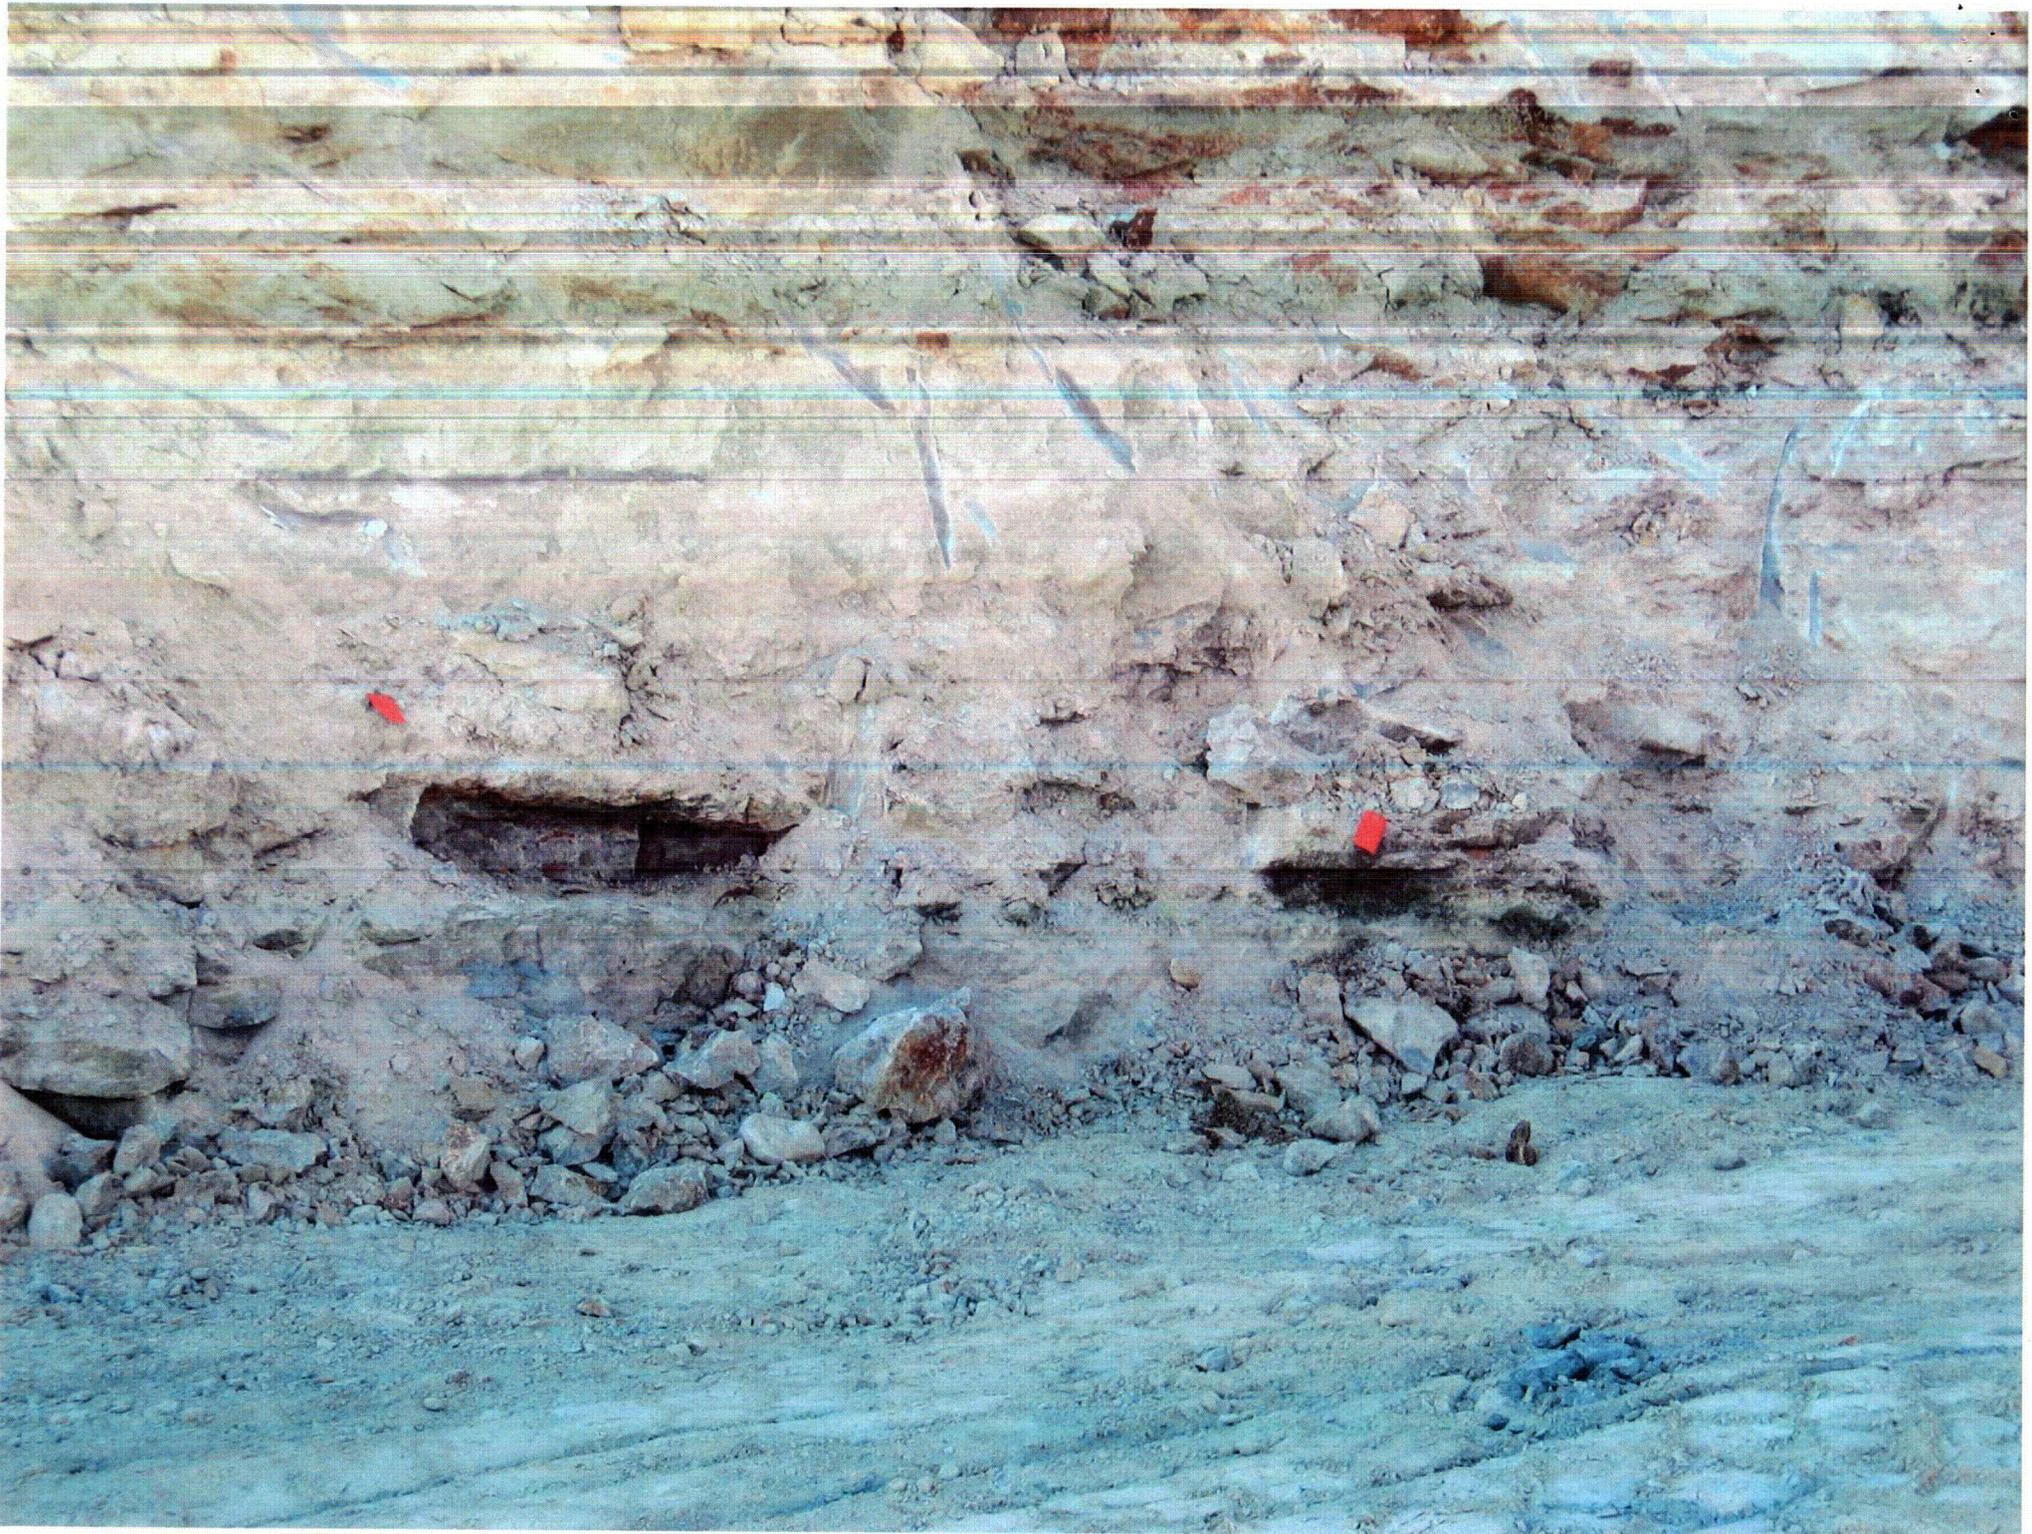
The Northern excavation extension was completed on Thursday, September 21, 2006. No detectable (by smell) hydrocarbons are present in accessible areas of the excavation extension. The highwall directly beneath the East wall of the Mill Building had two (2) kerosene seeps near the base as well as a length of sandstone smelling strongly of kerosene. These areas were sampled and surveyed. These cannot be excavated without jeopardizing the Mill Building. As per previous submittals these contaminated soils will be left in place and separated from the clean backfill by plastic sheeting. They will be remediated at final decommissioning. The two (2) seeps marked with red tags are shown in the attached *.jpg file seep_02.jpg.

The exposed contaminated unexcavatable highwall beneath the tank slab and the Mill Building will have to be separated from the clean backfill by plastic liner. It is also planned to install a fluid collection pipe in a trench against the contaminated highwalls behind the plastic curtain to collect any surface runoff (from rainfall or snowmelt) that percolates down the contaminated side of the plastic curtain. This system will consist of a perforated polyethylene pipe in a gravel filled trench connected to a tee and a pipe to the surface to facilitate removal of any accumulated fluid by pumping. We have discussed this concept. This system will replace TMW-90 and TMW-105 the perched collection wells which were destroyed by the excavation. It will prevent any downward migrating rainfall or snowmelt contaminated by passing through kerosene contaminated soils beneath slabs from reaching groundwater.

As discussed in my previous e-mail Kennecott Uranium company will not be pursuing any treatment of kerosene contaminated areas of the highwall due to the delay in backfilling that this work will cause.
