On the cleaning system incident at the Paks NPP

Dr. Lajos Vöröss

**Hungarian Atomic Energy
Authority**

— Presentation from
mid-2003

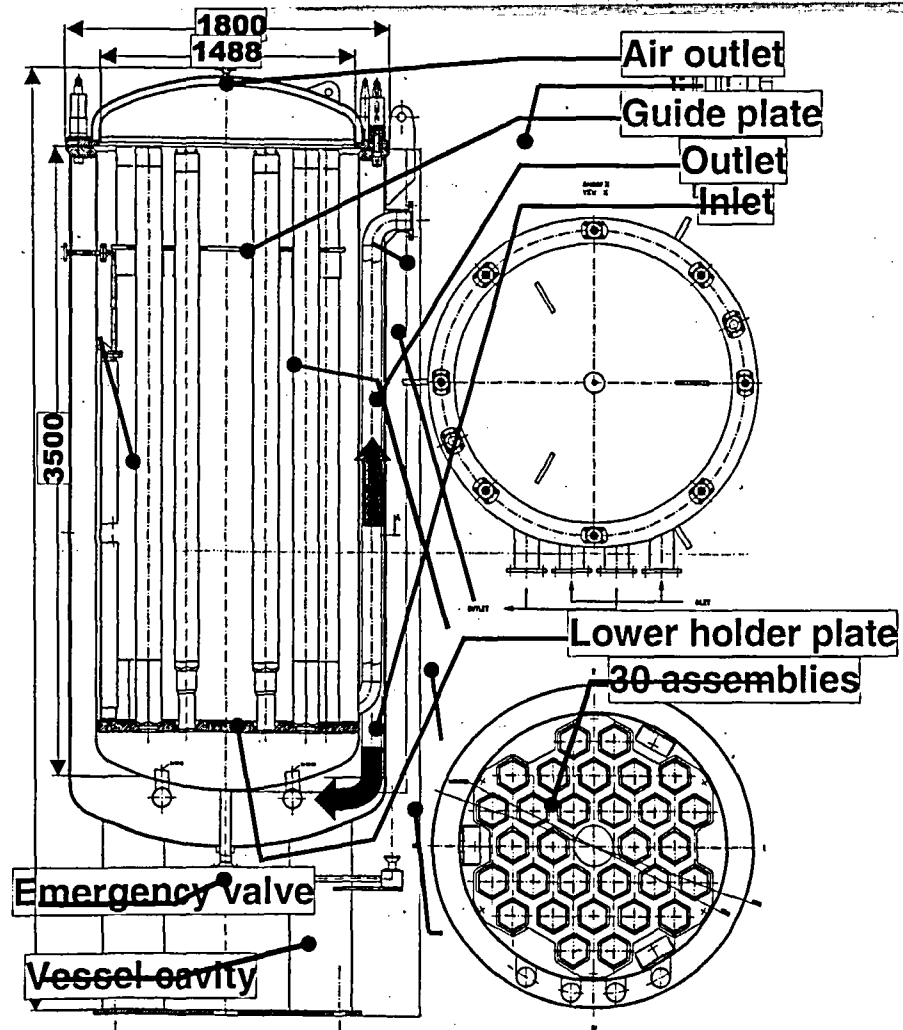
Structure of the tank

- ⌘ Post-cleaning cooling insufficient for coolant by-pass
- ⌘ Evolution of a steam-cushion
- ⌘ Gap release due to assembly dry-out
- ⌘ Thermal shock or steam explosion after lid opening crushes the assemblies

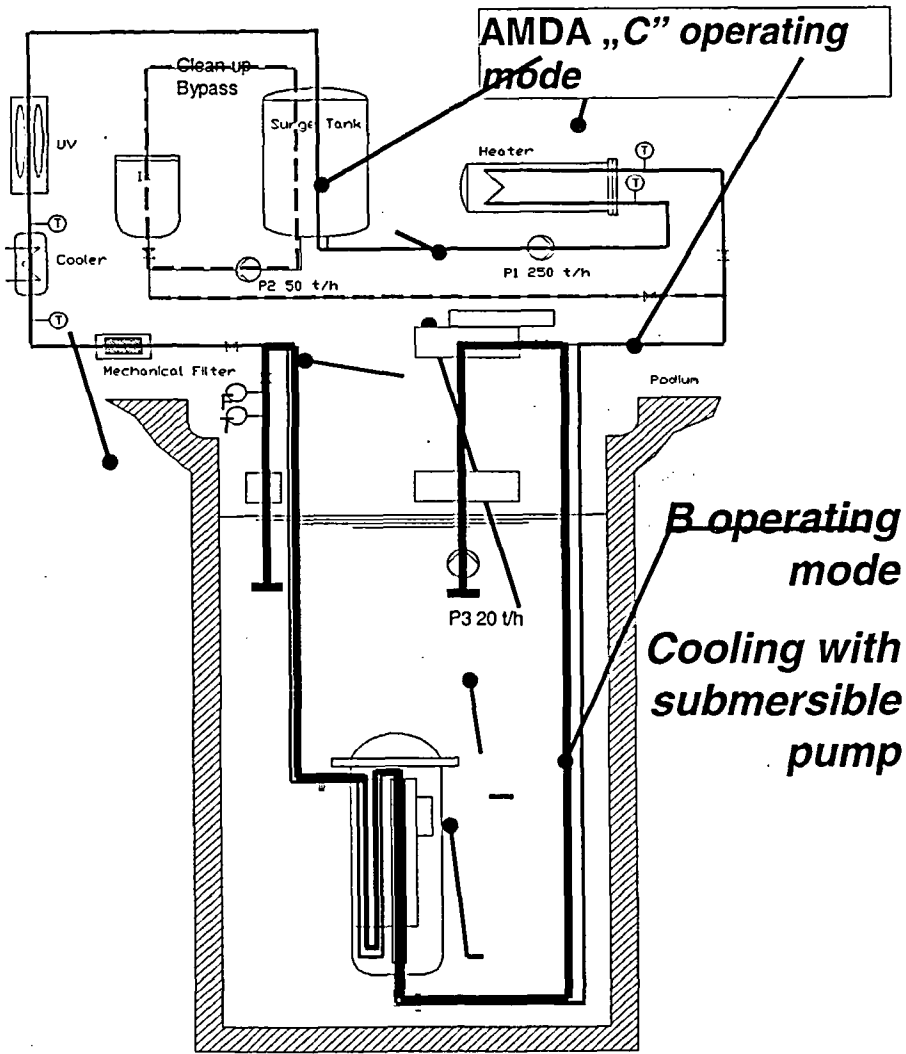
Functional layout of the system

- ⌘ Immediate cause: insufficient cooling
- ⌘ Plans have not secured sufficient cooling for every possible case
- ⌘ Safety analysis has not covered in-vessel flow-patterns for B-mode cooling
- ⌘ Plans for system-parameter control have not guaranteed recognition of insufficient cooling

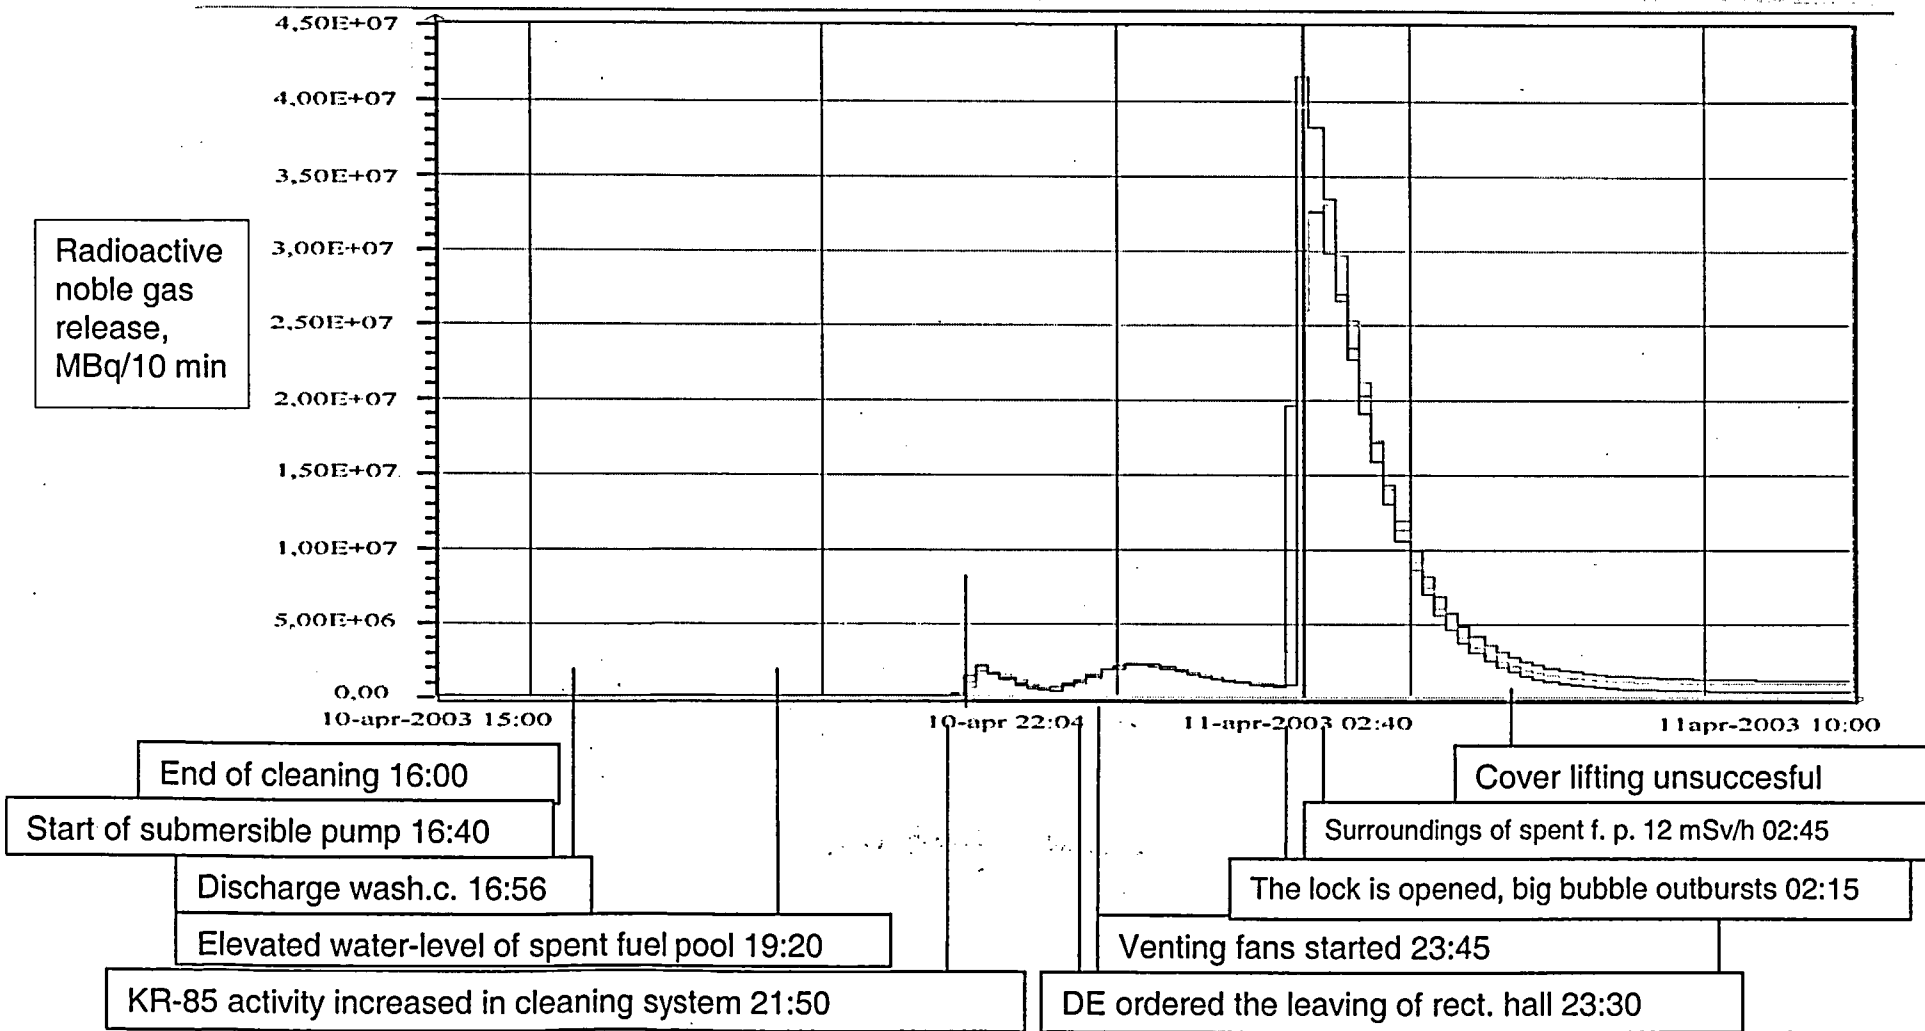
Events during the incident

- ⌘ 10.04. 22:00 - increase of Kr-85 dose rate detected
- ⌘ 11.04. 02.15 - Lid lock opened, bubble outburst
- ⌘ 11.04. 04:20 - unsuccessful attempt to open the vessel-lid (rope rupture), vessel semi-open
- ⌘ Elevated release of noble gases and iodine through the NPP stack
- ⌘ Elevated, but <500 nSv/h dose rate at one of the 9 near-station monitors for a short period (background value: ~ 100 nSv/h)
- ⌘ No other off-site effect detected
- ⌘ Classified to INES level 2
- ⌘ Extensive field exploration and monitoring initiated

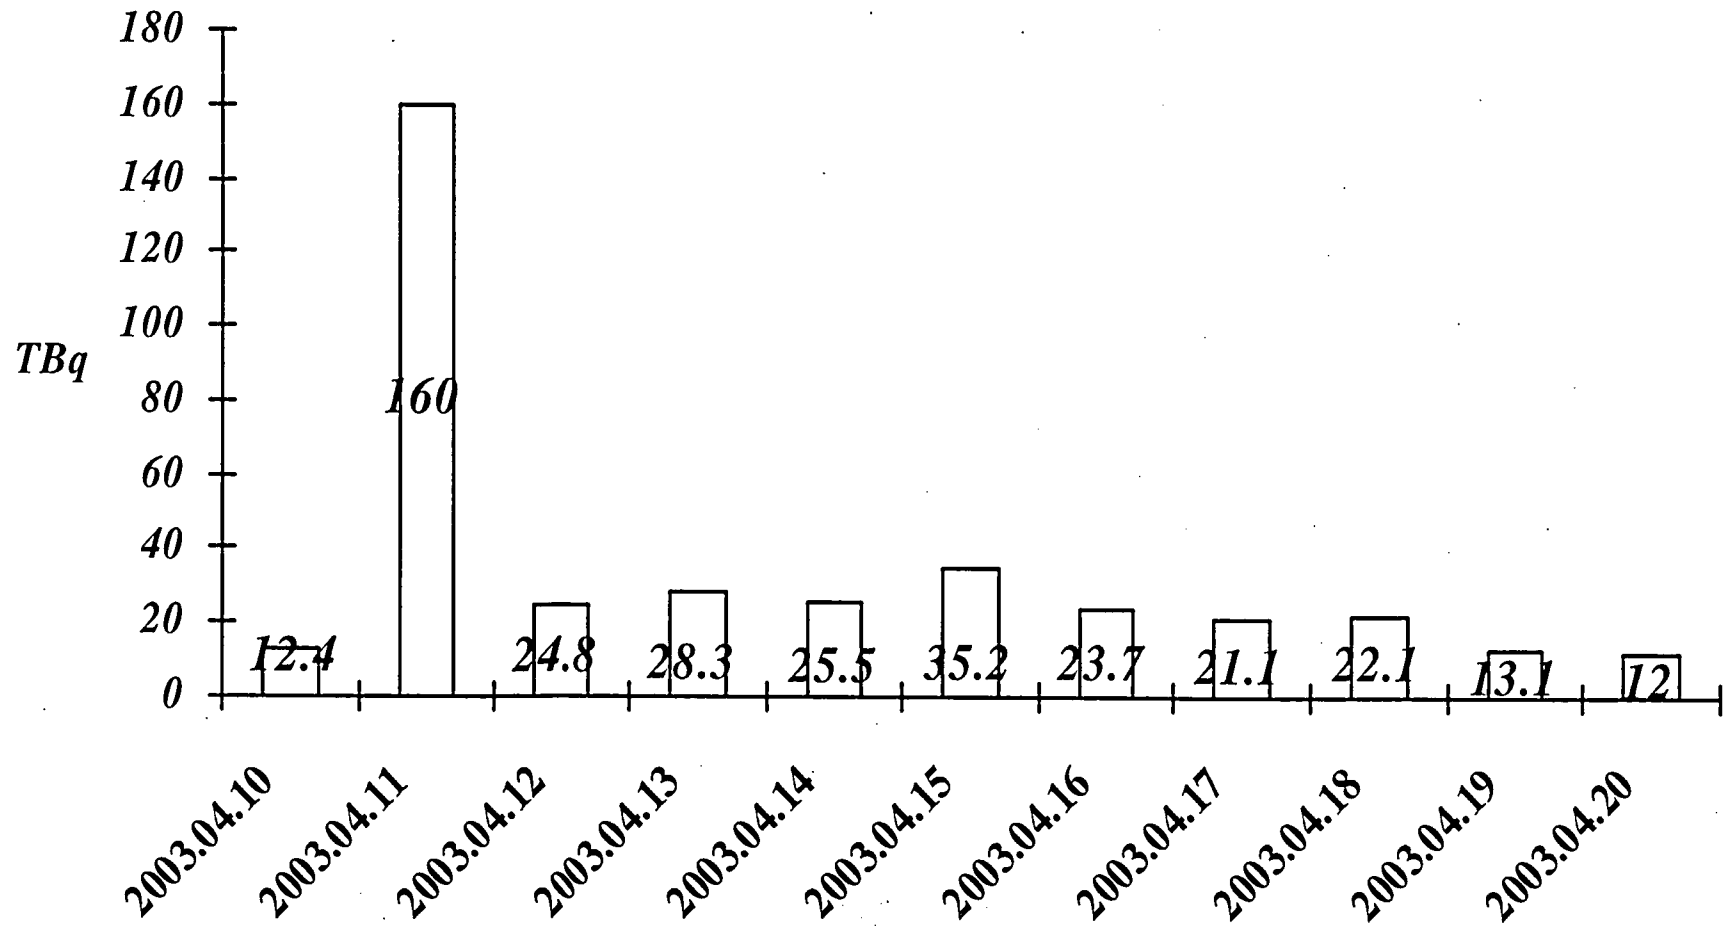
Noble-gas release

Period	Noble gases [TBq]	Iodine (¹³¹ I) equivalent [GBq]
10 th April	12	143
11 th April	160	204
12 th April	25	7.0
13-19 April	179*	5.7*
20-26 April	38*	0.8*

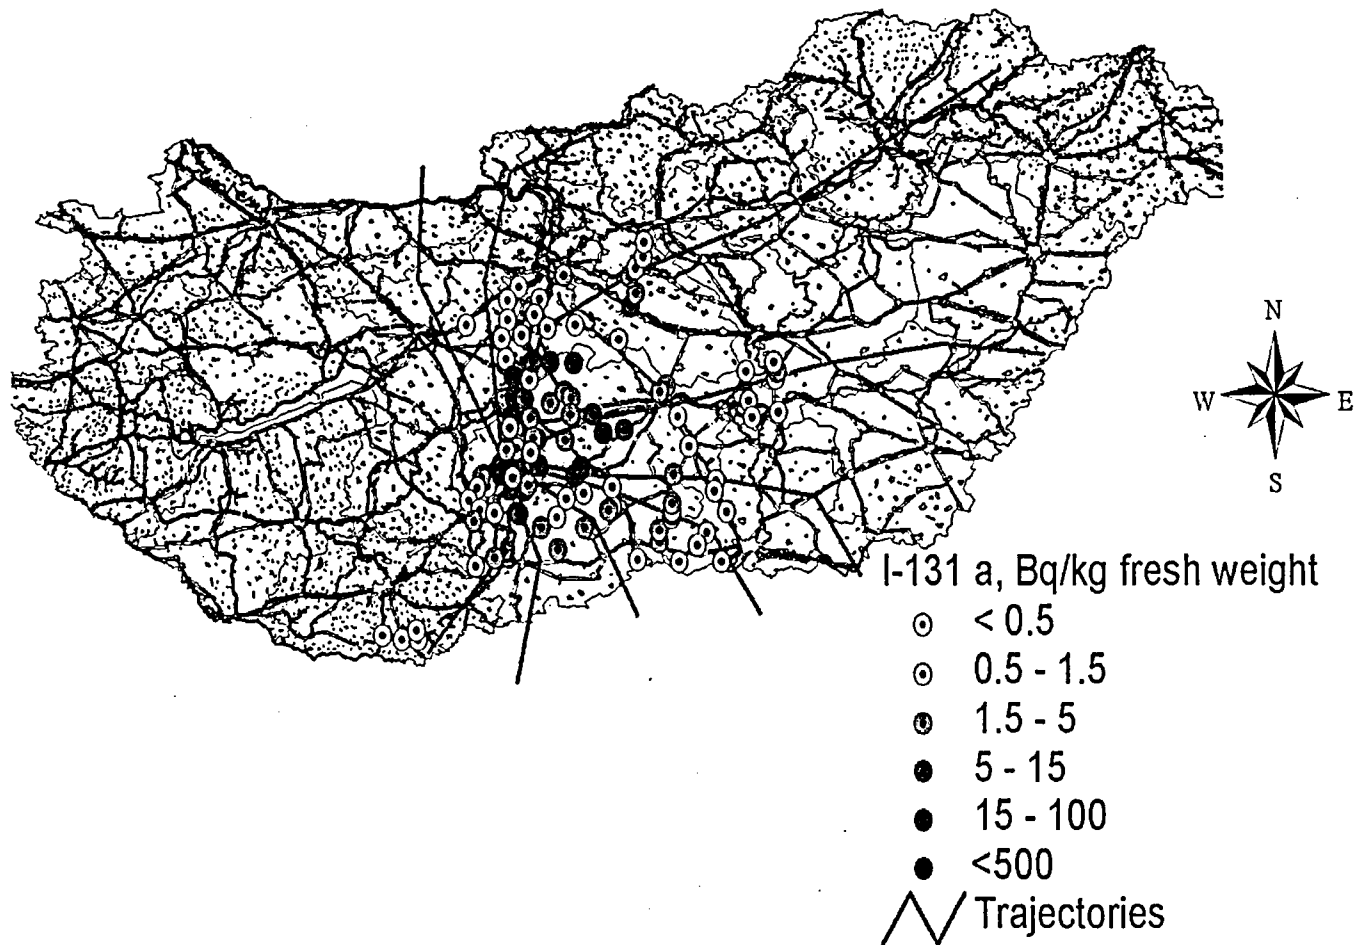
Specific activity of I-131 in plants

Field measurements in the plant and in the surrounding area yield as typical values of I¹³¹ surface contamination between a few Bq/m² and a few hundred Bq/m². The highest level detected in the close vicinity of the plant was less than one thousandth of the average contamination in Hungary following the Chernobyl accident. No activity due to the event has been found in milk samples.
