On the cleaning system incident at the Paks NPP

Dr. Lajos Vöröss

**Hungarian Atomic Energy
Authority**

— Presentation from
mid-2003

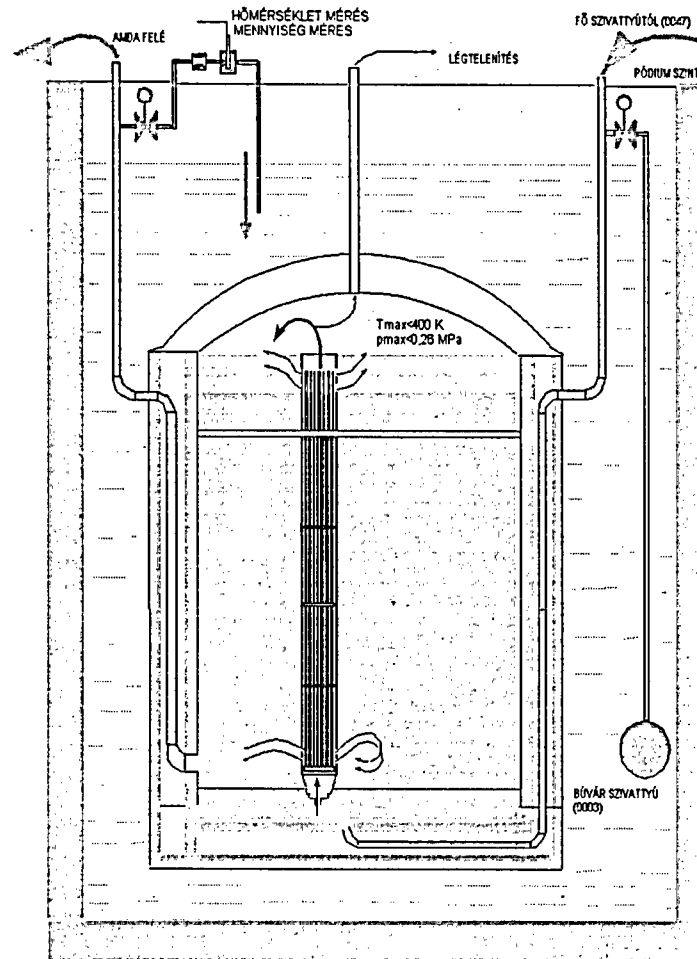
Layout of the B operating mode

- ⌘ Immediate cause: insufficient cooling
- ⌘ Plans have not secured sufficient cooling for every possible case
- ⌘ Safety analysis has not covered in-vessel flow-patterns for B-mode cooling
- ⌘ Plans for system-parameter control have not guaranteed recognition of insufficient cooling
