On the cleaning system incident at the Paks NPP

**Presented
by
Dr. József Rónaky
Hungarian Atomic Energy
Authority**

*Presentation from
mid-2003*

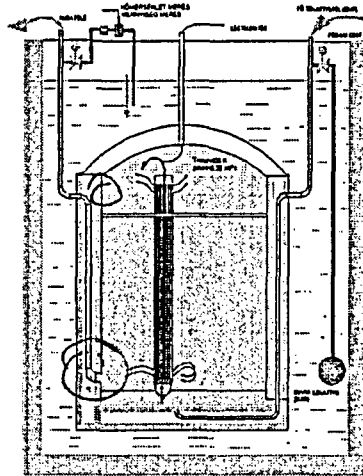
Layout of the B operating mode

- Immediate cause: insufficient cooling
- Plans have not secured sufficient cooling for every possible case
- Safety analysis has not covered in-vessel flow-patterns for B-mode cooling
- Plans for system-parameter control have not guaranteed recognition of insufficient cooling

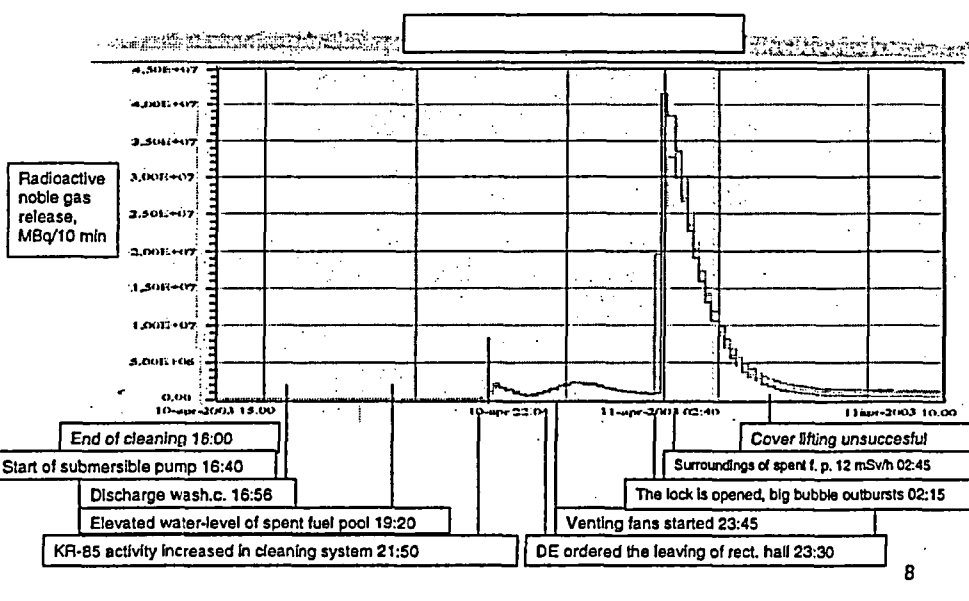
Events during the incident

- 10.04. 22:00 - increase of Kr-85 dose rate detected
- 11.04. 02:15 - Lid lock opened, bubble outburst
- 11.04. 04:20 - unsuccessful attempt to open the vessel-lid (rope rupture), vessel semi-open
- Elevated release of noble gases and iodine through the NPP stack
- Elevated, but <500 nSv/h dose rate at one of the 9 near-station monitors for a short period (background value: ~ 100 nSv/h)
- No other off-site effect detected
- Classified to INES level 2
- Extensive field exploration and monitoring initiated

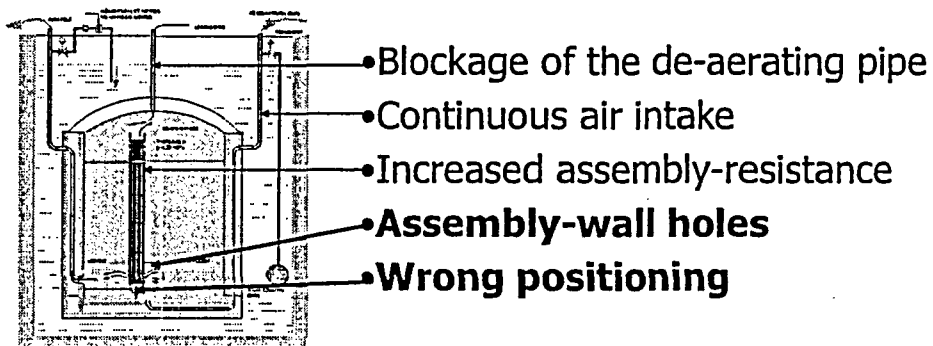
B operating mode: waiting for offloading

- Post-cleaning cooling insufficient for coolant by-pass
- Evolution of a steam-cushion
- Gap release due to assembly dry-out
- Thermal shock or steam explosion after lid opening crushes the assemblies

Possible direct causes

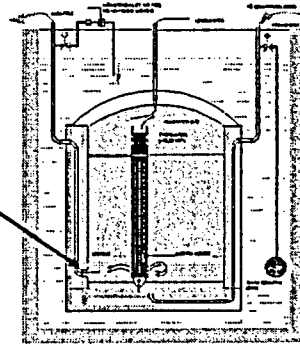
Outlet at the bottom of the tank

Root-cause
