**Review of Responses to  
NRC Bulletin 2003-02-Leakage  
from Reactor Pressure Vessel  
Lower Head Penetrations and  
Reactor Coolant Pressure  
Boundary Integrity**

**U.S. Nuclear Regulatory Commission  
Office of Nuclear Reactor Regulation  
Washington, DC 20555-0001**

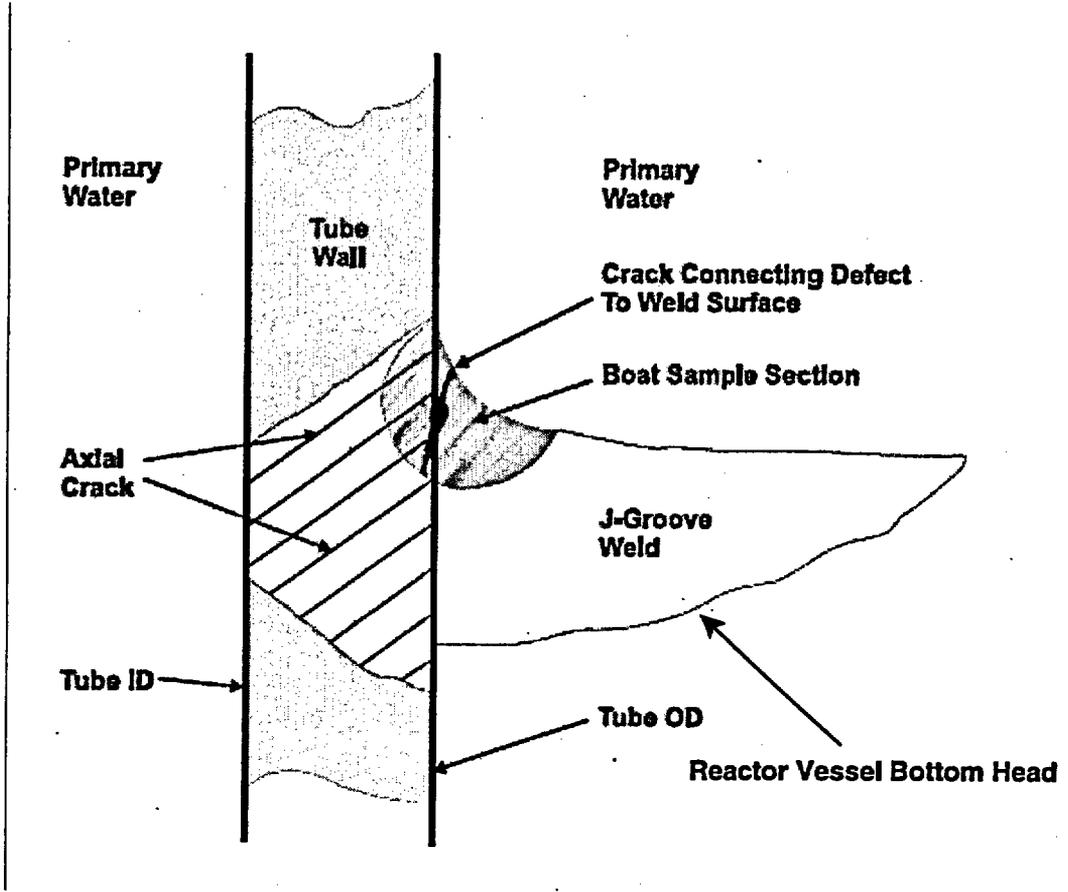
**Figure 3-1 Composite Drawing Showing Axial Crack, Weld Flaw, and Weld Crack**

To facilitate metallurgical analysis of the actual cracks, boat samples were removed from Penetrations 1 and 46 employing an Electric Discharge Machining (EDM) cutting technique. In the case of the BMI nozzles inside the reactor pressure vessel, the boat sample excavations could not be repaired. The desire for the largest possible boat sample was balanced against conservative structural limitations. The boat sample from Penetration 46 was designed to capture as much tube material as possible in an attempt to harvest a portion of a crack not connected to the ID of the nozzle. The margins for error associated with positioning the EDM equipment through 70 feet of water resulted in a shallow cut in Penetration 46. The resulting undersized sample was either inadvertently discarded or completely consumed in the margins of the EDM cutting tool. The boat sample from Penetration 1 captured material and defects from the J-groove weld and J-groove/tube interface, as designed. A composite drawing showing the axial crack, weld flaw and weld crack is shown in Figure 3-1.

The boat sample from Penetration 1 contained a portion of the large through-wall axial crack in the tube, three "discontinuities" which were confirmed to be lack of fusion resulting from slag inclusions, and one crack at the helium bubble location which connects the surface of the J-groove weld to the largest area of lack of fusion. The crack in the weld that connects the surface of the J-groove weld to the largest area of lack of fusion was determined from the inspections to be singular and unique. A 0.2-inch long crack spanned an 0.080-inch ligament separating the lack of fusion void from the surface of the J-groove weld in the ground fillet transition at the tube/J-groove weld interface. The length of the crack spanned and was limited to the width of the lack of fusion void. The section of the boat sample containing this crack was broken in the laboratory to expose the crack face for examination. Tenacious deposits obscured the crack face, and gradually more aggressive attempts to remove the deposits also attacked and distressed the metal surface. The crack exhibited some intergranular characteristics. To some reviewers, the nature of the oxide deposits suggested hot cracking. Fatigue could also be a factor in the development of this crack. However, the precise mechanism responsible for initiating and propagating this crack could not be determined.

Earlier ultrasonic testing (UT) results identified an axial crack in Penetration 1 which penetrated the inside diameter of the nozzle and extended from just above to just below the J-groove weld. The boat sample from Penetration 1 successfully captured a part of the upper portion of this crack in the region of the tube/J-groove weld interface. The intergranular nature of this crack

exhibited classic primary water stress corrosion cracking (PWSCC) characteristics. The extent of the crack was examined by progressively grinding away thin layers of the section of the boat sample. The orientation of the ground surface was such that more weld material and less tube material was exposed at each successive grind. The initial exposed surface consisting of nearly all tube material contained a crack that extended into the weld material and then stopped. As successive layers were ground away, exposing more weld and less tube, the extent of the crack became smaller and smaller. The final ground surface, which consisted almost entirely of weld material, revealed no crack at all in the weld and a small vestige of crack in the remaining small bit of tube.

The axial crack in the tube appeared to grow from the EDM surface out to the tube/J-groove interface since it branched and connected two of the three voids, at least at this location in the boat sample. This fact might suggest inside surface initiated PWSCC. However, neither of the two cracks in Penetration 46, the other leaking BMI penetration, connected to the inside surface of the tube. A supplemental eddy current examination of the inside surface was performed, specifically to confirm the UT results that the flaws did not penetrate the inside surface. Eddy current examination established that the cracks did not connect to the inside surface. Based on this fact the licensee concluded that the PWSCC axial crack in the tube was OD initiated. The crack most likely originated on the outside surface of the tube in the highly stressed region of the flooded weld defects.

The boat sample also contained numerous small cracks around the periphery of the tube containing lack of fusion (LOF) voids to a depth of 1 or 2 grains. Although hot cracking in the weld material is a possibility, this intergranular cracking also appeared in the nozzle, where hot cracking is not possible. Therefore, the licensee concluded that this cracking is PWSCC resulting from flooding of the LOF voids.

In summary, metallurgical analysis of a sample removed from one of the leaking BMI penetrations confirmed the presence of weld defects on the highly stressed interface between the Alloy 600 tube and the connection weld to the pressure vessel. The SMAW process used to construct the J-groove welds is prone to leaving weld defects in service and creating locally high residual stresses. The sample revealed one small crack that connected the LOF void to the surface of the weld and primary water. Once the LOF void became flooded with primary water, all of the requisite conditions to support stress corrosion cracking existed at the nozzle outside surface at a location of predicted high residual stress.
