Subject: Supplemental Information Regarding the 2005 Steam Generator Tube
Inspections (TAC No. MD0528)

RESPONSE TO REQUEST FOR ADDITIONAL INFORMATION
DAVIS-BESSE NUCLEAR POWER STATION
14th CYCLE MID-CYCLE OUTAGE (14 MCO) STEAM GENERATOR INSPECTION
(TAC NO. MD0528)

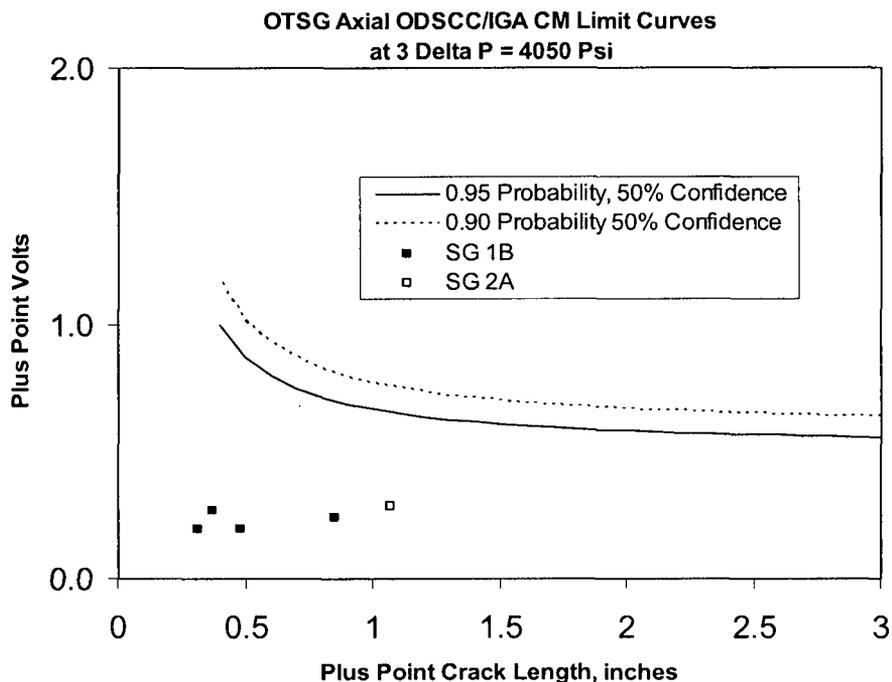
SG	Row	Tube	Ind	Volts	TSP	Inch	Probe	Depth %	Ax Len
2A	95	69	SAI	0.29	UTS	-21.63	520PP	60	1.07
1B	24	95	SAI	0.24	15S	-1.67	520PP	43	0.85
1B	25	98	SAI	0.2	15S	-2.11	520PP	40	0.31
1B	29	104	SAI	0.2	15S	-1.7	520PP	27	0.48
1B	70	60	SAI	0.27	15S	18.41	520PP	50	0.37

These indications were plotted and compared to the pre-established performance criteria for this damage mechanism which related the plus point voltage value and crack length to the structural limit of three times normal operating differential pressure. All the identified indications were below the Condition Monitoring acceptance curves. This demonstrated that the degraded tube burst pressures were above the three times normal operating differential pressure requirement of 4050 psi with a greater than 0.95 probability at 50% confidence.
