Docket Number 50-346

Subject: Supplemental Information Regarding the 2005 Steam Generator Tube  
Inspections (TAC No. MD0528)

RESPONSE TO REQUEST FOR ADDITIONAL INFORMATION  
DAVIS-BESSE NUCLEAR POWER STATION  
14<sup>th</sup> CYCLE MID-CYCLE OUTAGE (14 MCO) STEAM GENERATOR INSPECTION  
(TAC NO. MD0528)

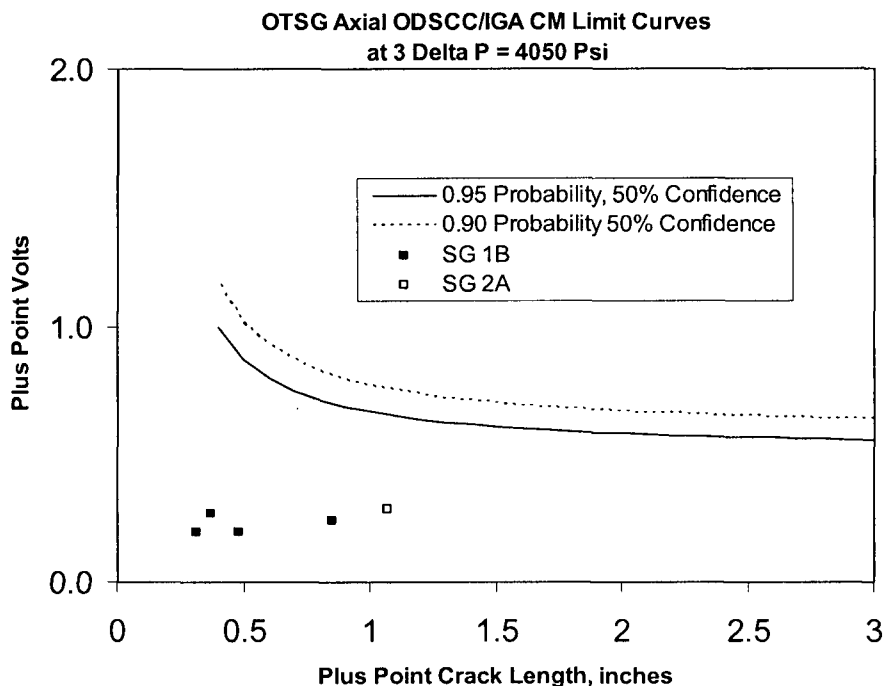
The groove intergranular attack/stress corrosion cracking corrosion indications observed during 14MCO are listed below:

SG	Row	Tube	Ind	Volts	TSP	Inch	Probe	Depth %	Ax Len
2A	95	69	SAI	0.29	UTS	-21.63	520PP	60	1.07
1B	24	95	SAI	0.24	15S	-1.67	520PP	43	0.85
1B	25	98	SAI	0.2	15S	-2.11	520PP	40	0.31
1B	29	104	SAI	0.2	15S	-1.7	520PP	27	0.48
1B	70	60	SAI	0.27	15S	18.41	520PP	50	0.37

These indications were plotted and compared to the pre-established performance criteria for this damage mechanism which related the plus point voltage value and crack length to the structural limit of three times normal operating differential pressure. All the identified indications were below the Condition Monitoring acceptance curves. This demonstrated that the degraded tube burst pressures were above the three times normal operating differential pressure requirement of 4050 psi with a greater than 0.95 probability at 50% confidence.
