From: "Paul Gunter" <pgunter@nirs.org>
To: <hga@nrc.gov>
Date: 07/26/2006 3:22:27 PM
Subject: Interim staff guidance on AMR of embedded steel containment at Oyster Creek

Memorandum

Subject: Oyster Creek, Drywell Liner
Embedded Region Issues

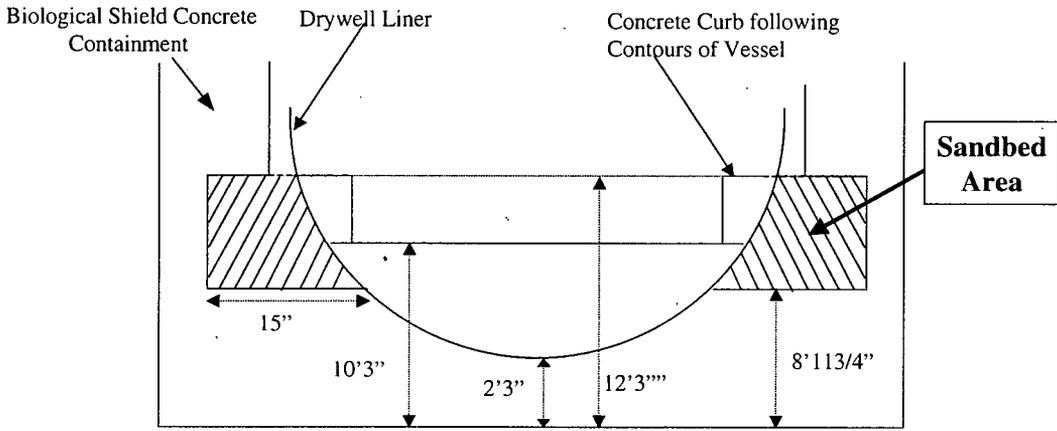
Figure 3

Figures 1 and 2 are sketches of the location of the sandbed area and its dimensions (Fig. 2). In view of the small access hole (20" diameter) and the even smaller sandbed dimensions (15" wide) and the resulting very confined work area one needs to wonder just how effective the repairs of the concrete floor and subsequent coating and sealing of the crevice might have been. Similarly, considering the extension of the sandbed area of 5 to 7 feet either side of the access hole, and its narrowness, one needs to ask just how thorough visual inspection can really be.

Schematic Drawing of Lower Spherical Section of Drywell Liner
(not to size)

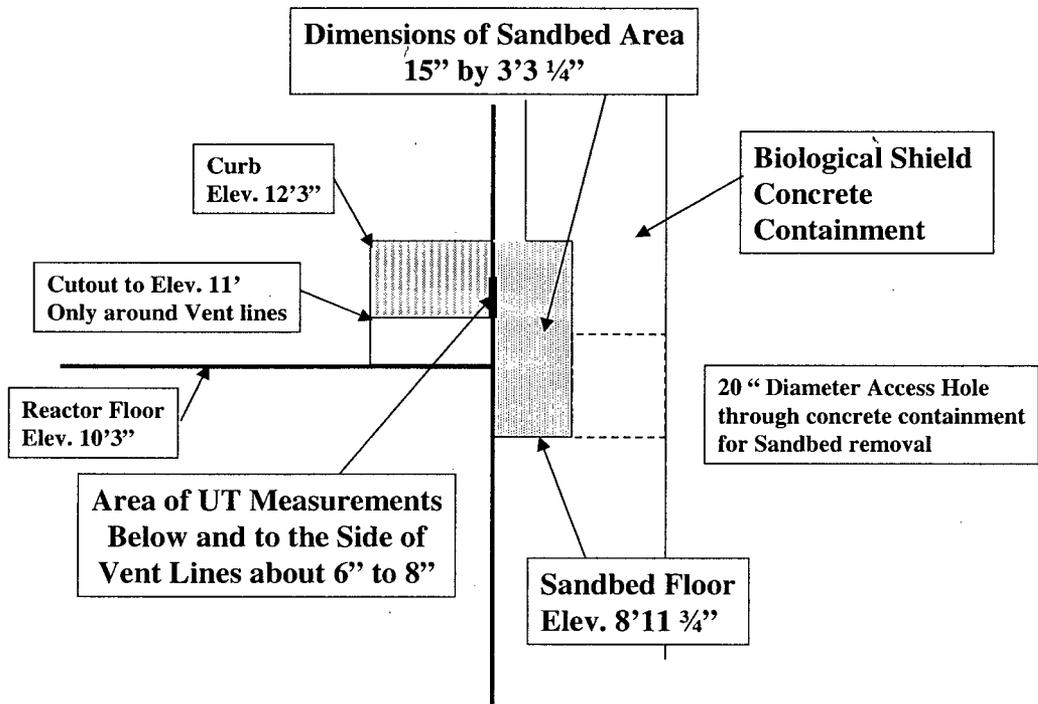
Figure 4

Schematic Cross Section through Sandbed Area

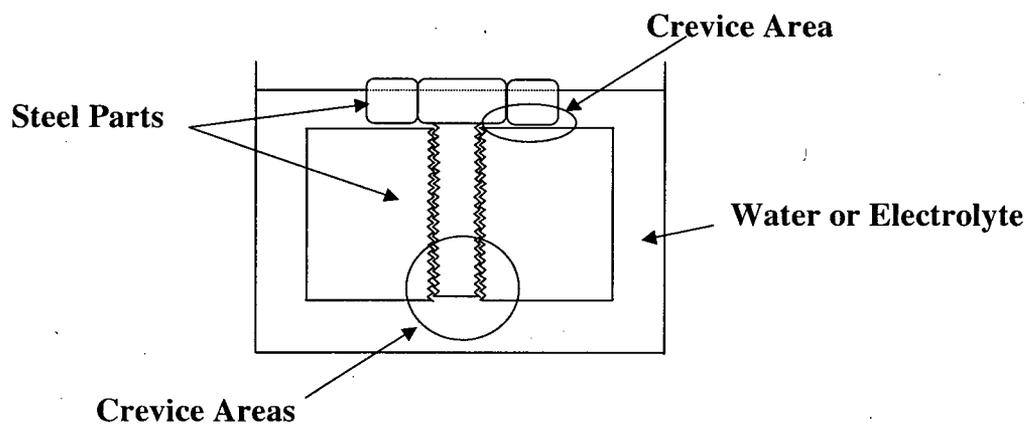
Figure A I-1

However, physical observations are quite in tune with the above explanation. Crevice corrosion, as for instance in bolt threads, under washers, etc. is commonly observed. Ground rods corrode a few inches below the surface of earth or mud in which they are embedded. Applied to the sandbed it is indeed observed that corrosion does not occur on top of the sandbed where aeration is greatest, but in fact in an area below that surface. The question then arises as to why the corrosion rate should not be greatest at the very

Formation of Crevice underneath Screw-head

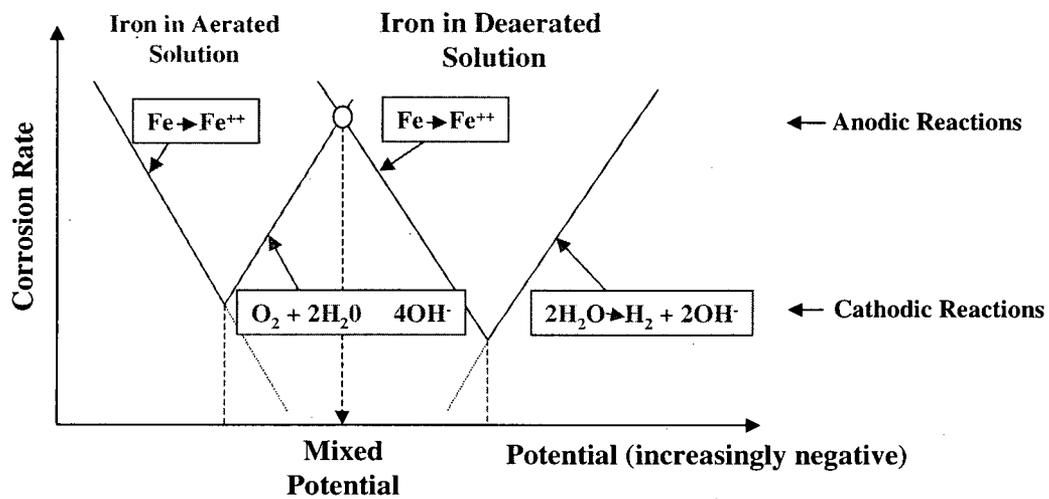
Figure AI-2

Such situations can be theoretically discussed by means of polarization diagrams presented in the form of an Evans diagram as in Fig. A I-2. The diagram describes separately the polarization behaviors of the two parts of the iron piece as if they were disconnected and then defines a mixed potential as well as the resulting anodic and cathodic corrosion rates at the mixed potential.

In reality, however, the two pieces of metal are in electrical contact and are furthermore wetted by the same solution (i.e. in electrolytic contact as well). Under these conditions the metal must assume one potential and one potential only, namely the mixed potential. As can be seen from Fig. A I-2 this is only possible if the cathodic reaction rate of the aerated side increases which then forces the anodic reaction of the deaerated side to increase as well. To a certain extent this result may be counter intuitive in that now the area that is starved in oxygen is corroding while the oxygen rich side is, as is often said as well, cathodically protected by the corroding side.

**Evans Diagram for Coupling of Iron in Aerated Solution
With Iron in Deaerated Solution**
