Palo Verde Nuclear
Generating Station

**Subject: Palo Verde Nuclear Generating Station (PVNGS)
Unit 3
Docket No. STN 50-530
License No. NPF 74
Licensee Event Report 2006-006-00**

4. TITLE
Voluntary LER for Failure of Emergency Diesel Generator to Attain Required Voltage Due to Relay Contactor

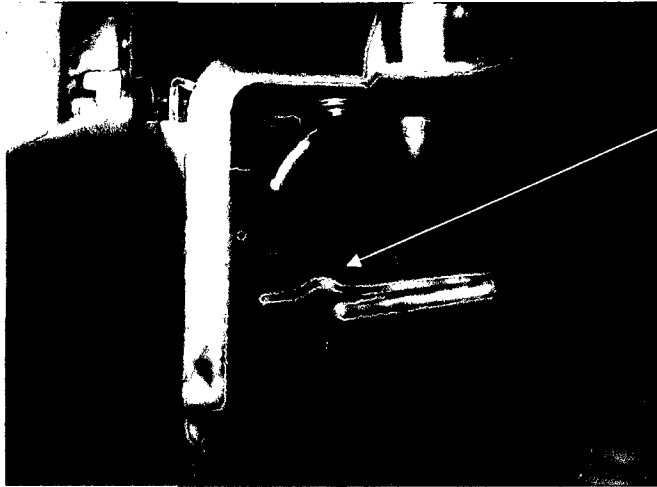
Inspection of the six K1 contactors installed in all the Palo Verde EDGs found four that were bent (picture 2) per the generic data sheets, one that had been bent but then was straightened at some later time (picture 1) and one that had never been bent (picture 3). Corrective maintenance was performed to straighten the DC Coil Switch actuator arms that were found bent.

Picture 1
Field straightened

All EDG K1 contactor DC Coil Switch contacts were cleaned and all actuator arms were straightened, as necessary, to provide additional pressure on the normally open contact mating surfaces. All contactors were bench and/or functionally tested.

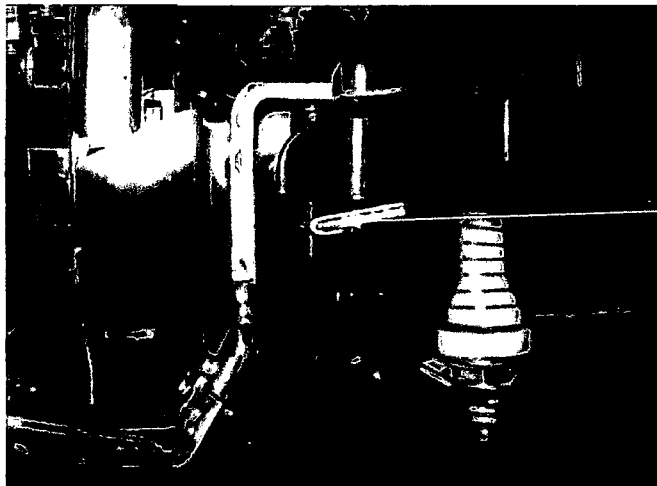
The metal actuator arm for the alternating current (AC) auxiliary contacts mounted on the contactor armature on the opposite side of the K1 contactor was found to be straight, however, the metal actuator arm for the DC Coil Switch was found to be bent down. (See the last page of the LER for pictures). A decision was reached by engineering and maintenance to make an adjustment and straighten the metal actuator arm for the DC Coil Switch contact module. This adjustment allowed for more positive pressure on the normally open (but held closed when latched) DC Coil Switch contact surfaces (the amount of depression travel for the switch actuator was increased). The contactor was then cycled manually several times. The DC Coil Switch contacts were measured and found to be closing/opening as expected. Functional testing with the adjusted K1 re-installed in cabinet 3JDGAB02 was successfully performed five

Picture 2
Bent from manufacturer
