SUBJECT: Entergy Nuclear Operations, Inc.
Pilgrim Nuclear Power Station
Docket No. 50-293
License No. DPR-35

License Renewal Application, Amendment 1

LETTER NUMBER: 2.06.040

Pilgrim Nuclear Power Station Drywell Shell Information

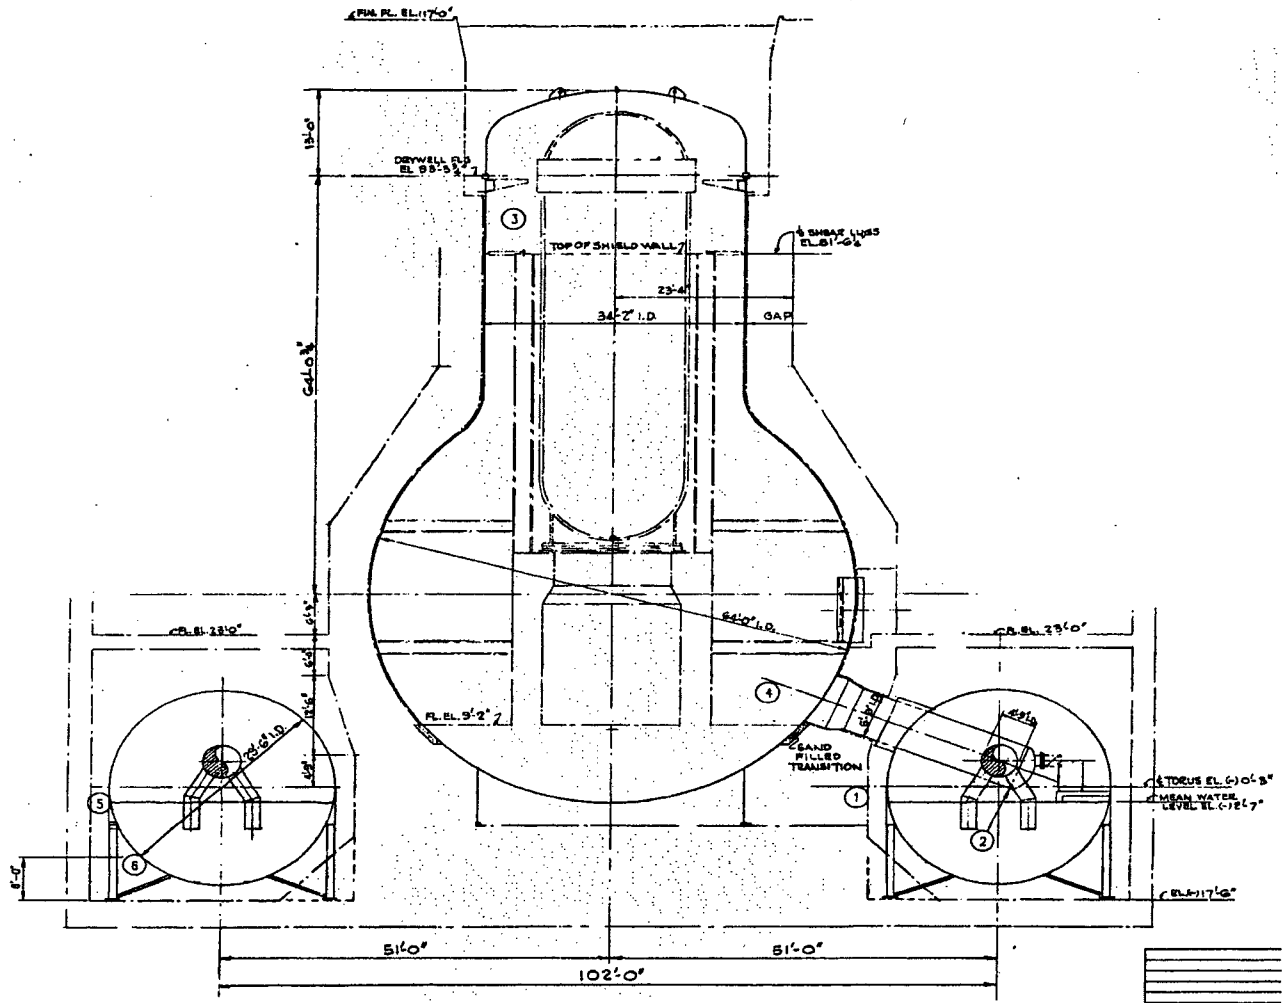
Taken from ISIWEAUG1

- (X) DENOTES I.E. INSPECTION POINT NUMBER.
- (1) ANNULUS AIR GAP DRAIN LINES.
- (2) VENT HEADER LOW POINTS (8 PLACES).
- (3) UPPER DRYWELL (EL. 72'-0" & 83'-0") SHELL THICKNESS.
- (4) LOWER DRYWELL (EL. 9'-0") SHELL THICKNESS.
- (5) TORUS SHELL THICKNESS AT MEAN WATER LINE
EL. (-) 2'-7" (FROM O.D.).
- (6) TORUS SHELL THICKNESS AT EL. (-) 11'-6" (FROM O.D.).
