SUBJECT: Docket 71-6078, Model Nos. 927A1 and 927C1 Packages, Approval for
Shipment of Mishandled Fuel Assembly Contents - Supplement

Enclosure 2. Fuel Assembly Inspection Report – Identification Number P2S404

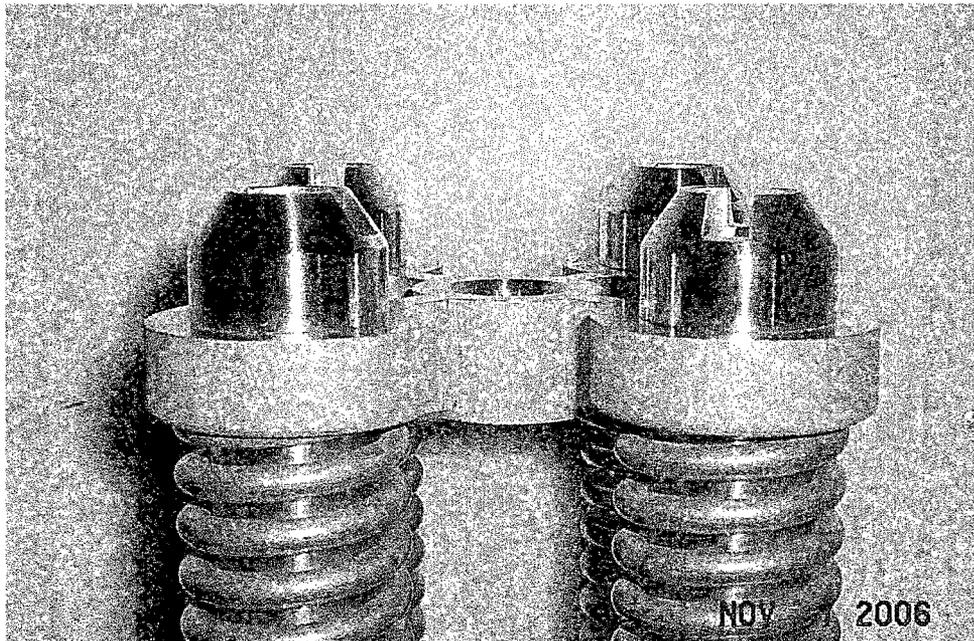
Figure 1 – Upper end fitting assembly - hold down plate and springs

The center post flange to flow plate welds were intact. All corner posts were seated against the hold plate. Guide tubes #2 and #3 appeared to be bowed to the center of the assembly near the LEF. This would be expected since the upward deformation of the LEF plate would pull the corner guide tubes towards the center. The UEF was securely attached and showed no movement when force was applied manually.

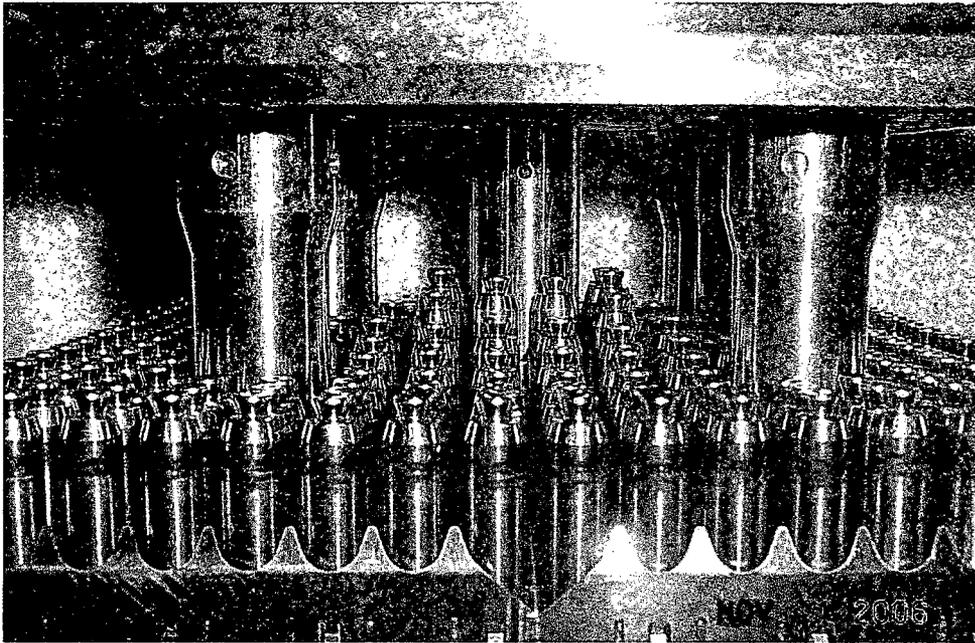
Figure 3 – Upper end fitting assembly – flow plate, guide tubes, instrument housing, fuel rods, top grid

Lower end fitting (LEF) plate was deformed upward around center instrument tube. At upper end fitting (UEF), fuel rods around center instrument tube are raised up to a maximum of about 0.5 inch. At guide tube #4, one locking disc weld was broken as a result of the LEF being pulled up and away. Disc could be pushed in slightly but bolt showed no movement. All other locking disc welds were intact and bolts were immobile. The LEF was securely attached and showed no movement when force was applied manually. The raised rods could not be pushed down by hand.

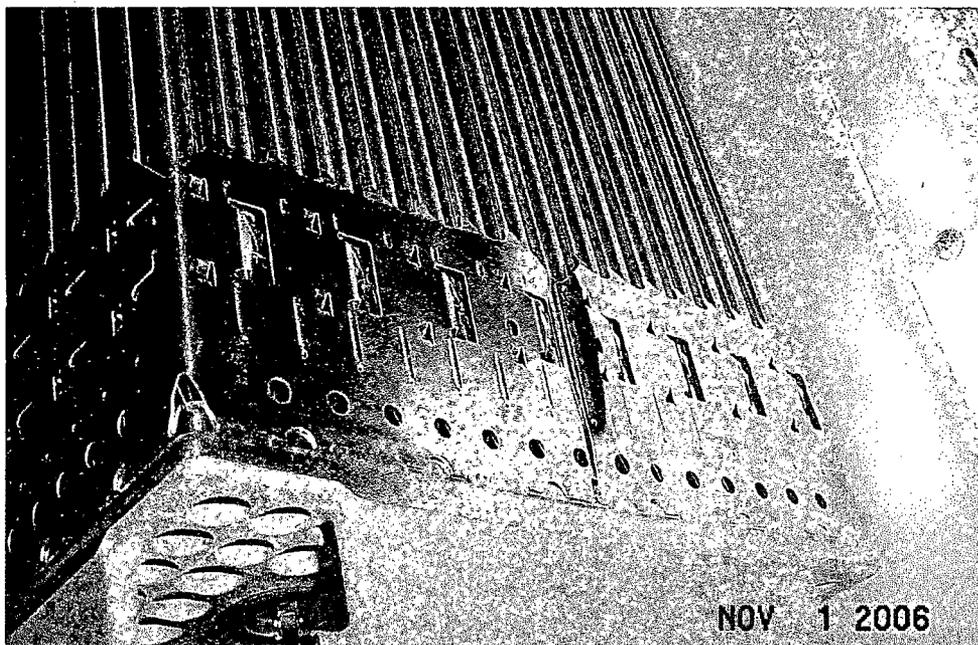
Figure 4– Lower end fitting assembly – guardian grid, low end fitting (Side view A)

The LEF to Guardian Grid welds are all intact. The Guardian grid outer straps have been buckled outward in the center on the 90, 180, and 270 degree faces (0° face was down and not inspected). The grid buckling occurred at Rod 9 (from left to right) on the 90° face, Rod 9 on the 180° face, and Rod 8 on the 270° face. The maximum magnitude of the outer strap bowing was about 0.25 inch. The rods mentioned above showed slight movement when perpendicular pressure was applied. All other rods were tightly held and showed no movement. All peripheral rods were touching the LEF and the Guardian grid springs were engaged in the fuel rod detents.
