RE: Possible Medical Event

William Beaumont Hospital  
3601 West Thirteen Mile Road  
Royal Oak, Michigan 48073  
NRC License No. 21-01333-01

**Notice of Medical Misadministration**

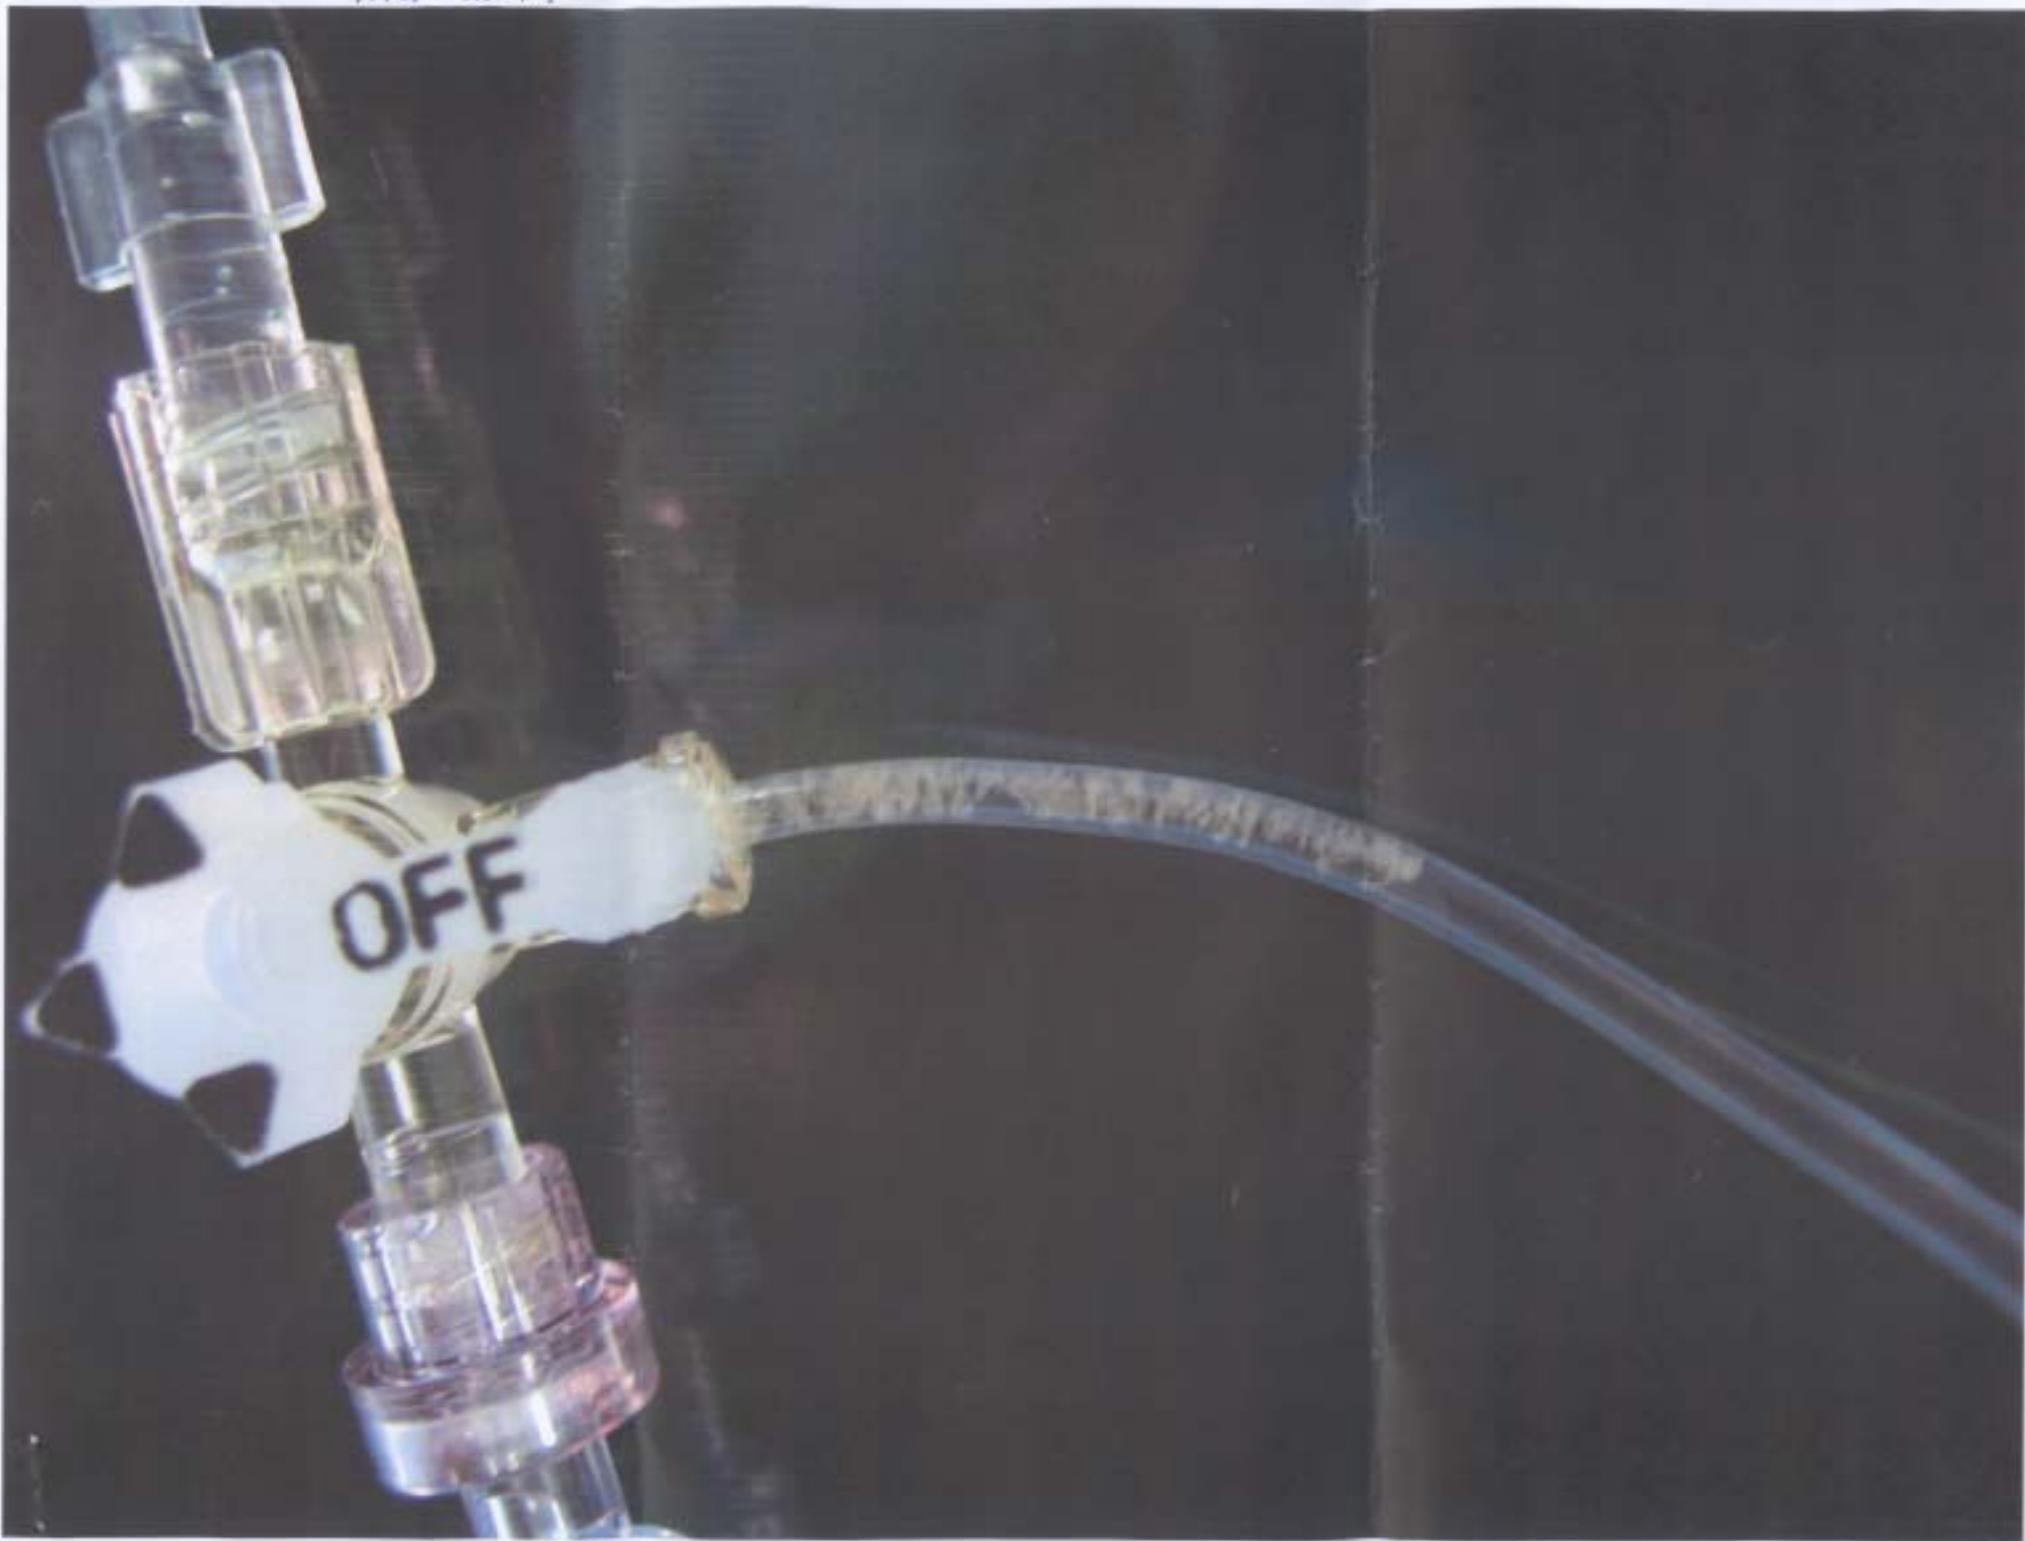
IMG-2219

Attached is the report of a possible medical event and two printed photographs. IMG-2279 shows the clumping of the Y-90 SIRSheres from the patient's delivery set that was photographed 48 hours after the treatment. Both the medical physicist and Dr. Savin agreed that the clumping was very similar; however, the clumping was distributed throughout the line and not confined to the area of the stopcock as shown in the photo.

The contents of the delivery set including the "V" vial, delivery set, tubing, and intra-hepatic catheter were examined using appropriate shielding on November 8, 2006. While the specific gravity of the microsphere resin (1.6) will cause it to separate out, the clumped microspheres were also clearly visible in the "C" line. Both the authorized physician and medical physicist confirmed that the appearance was similar to what was observed at the time they were administering the dose.

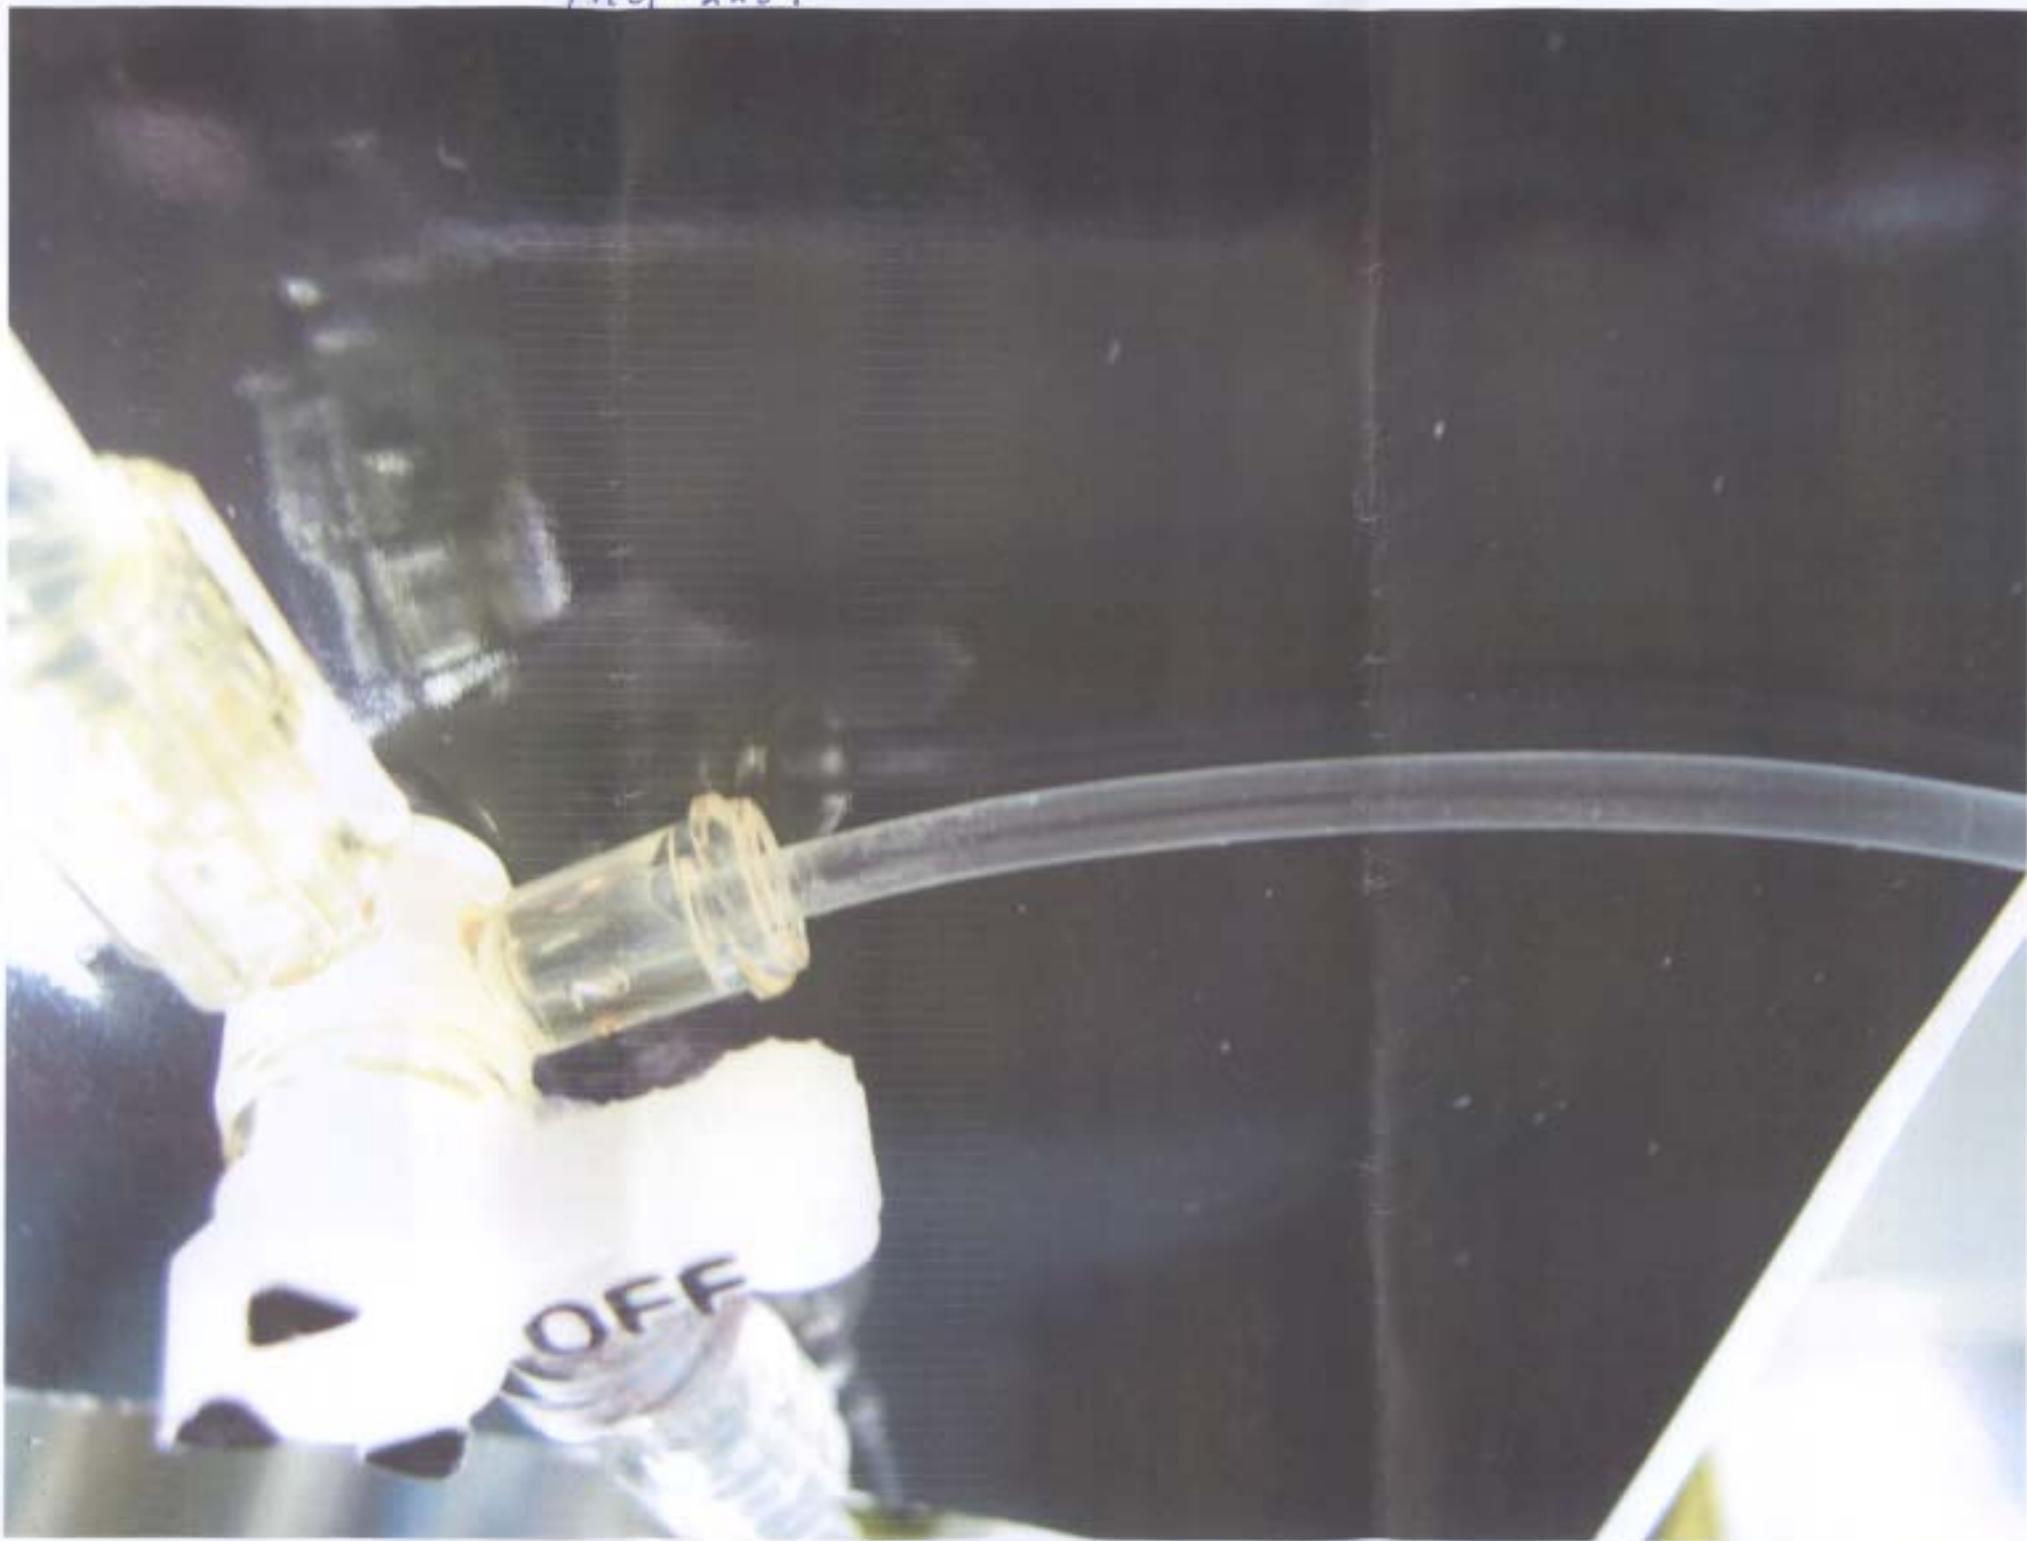
1MG-2289

IMG-2289 shows our experimental set up. After we prepared the dose for the patient done on Nov. 8, the same amount of dose was prepared in a spare "V" vial with sterile water from what was left of the Y-90 SIRSpheeres in the original shipping vial. A spare delivery set was set up behind appropriate shielding, primed with sterile water and a similar amount of Y-90 microspheres infused by the medical physicist in a simulated injection. This photo was taken 24 hours after the experiment.

The authorized user, medical physicist and RSO were concerned that a bad batch of Y-90 SIRSpheres from the manufacturer might cause clumping for the therapy patient scheduled on November 8, 2006. When questioned about this the previous evening, the Sirtex medical director assured us that it was very unlikely that clumping would occur since we were receiving a different lot number. The Y-90 dose was received at 9:00 a.m. on November 8, 2006. As a precaution, we ran the following experiment before we administered the Y-90 treatment on November 8, 2006. After the prescribed dose was prepared and assayed, the same amount of dose was prepared in a spare "V" vial with sterile water from what was left of the Y-90 SIRSpheres in the original shipping vial. A spare delivery set was set up behind appropriate shielding, primed with sterile water

and a similar amount of Y-90 microspheres infused by the medical physicist in a simulated injection, while the RSO and radiopharmacist observed the appearance of the microspheres in the plastic tubing. The injection was stopped and the microspheres were observed for several minutes. No clumping occurred and the authorized physician proceeded with the patient's therapy administration.
