RE: Possible Medical Event

**Notice of Medical Misadministration**

Licensee: William Beaumont Hospital, 3601 West Thirteen Mile Road, Royal Oak, MI  
Date/Time of Discovery: November 7, 2006 at 1:45 p.m.  
Referring and Attending Physician: Michael Savin, M.D.  
Authorized User: Michael Savin, M.D.

Date of Report: November 13, 2006

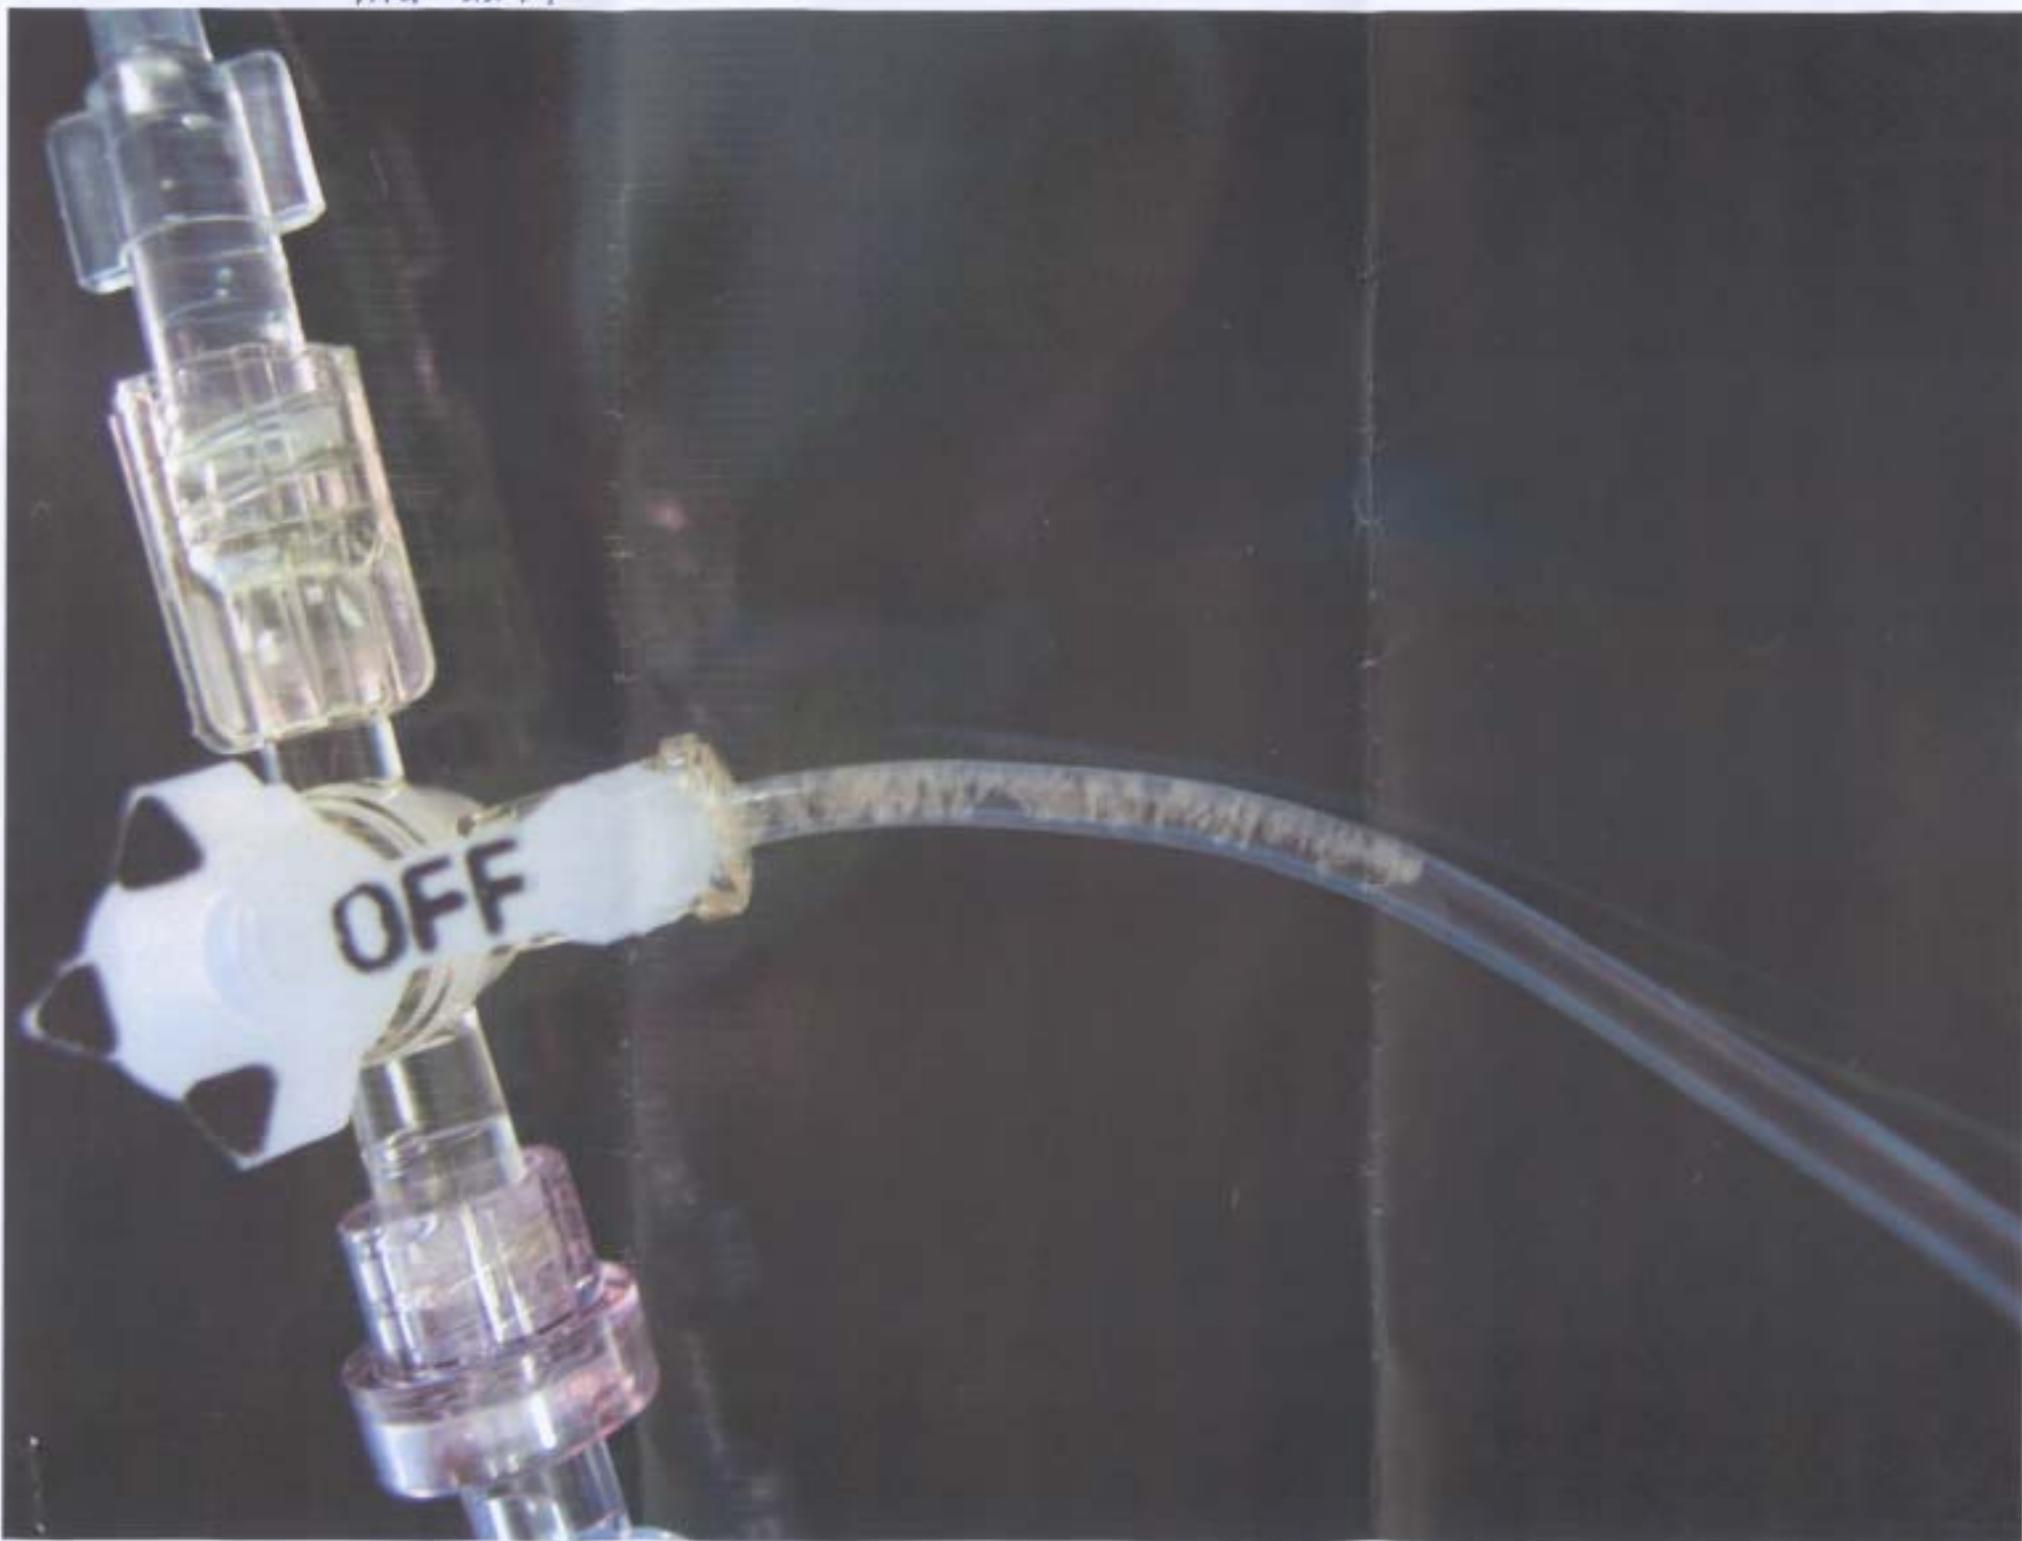
IMG-2219

Attached is the report of a possible medical event and two printed photographs. IMG-2279 shows the clumping of the Y-90 SIRSheres from the patient's delivery set that was photographed 48 hours after the treatment. Both the medical physicist and Dr. Savin agreed that the clumping was very similar; however, the clumping was distributed throughout the line and not confined to the area of the stopcock as shown in the photo.

conformance with the manufacturer's instructions. The final cause to be ruled out for the clumping was whether this was a flawed batch of Y-90 SIRSpheres from the manufacturer (lot no. 110986-008).

The contents of the delivery set including the "V" vial, delivery set, tubing, and intra-hepatic catheter were examined using appropriate shielding on November 8, 2006. While the specific gravity of the microsphere resin (1.6) will cause it to separate out, the clumped microspheres were also clearly visible in the "C" line. Both the authorized physician and medical physicist confirmed that the appearance was similar to what was observed at the time they were administering the dose.

Once adequate decay in storage has occurred, the Y-90 delivery set and shipping vial used in this medical event will be returned to the manufacturer to determine the possible cause of the clumping. Once we receive the results of the Sirtex analysis, additional corrective actions will be taken as recommended by the manufacturer.

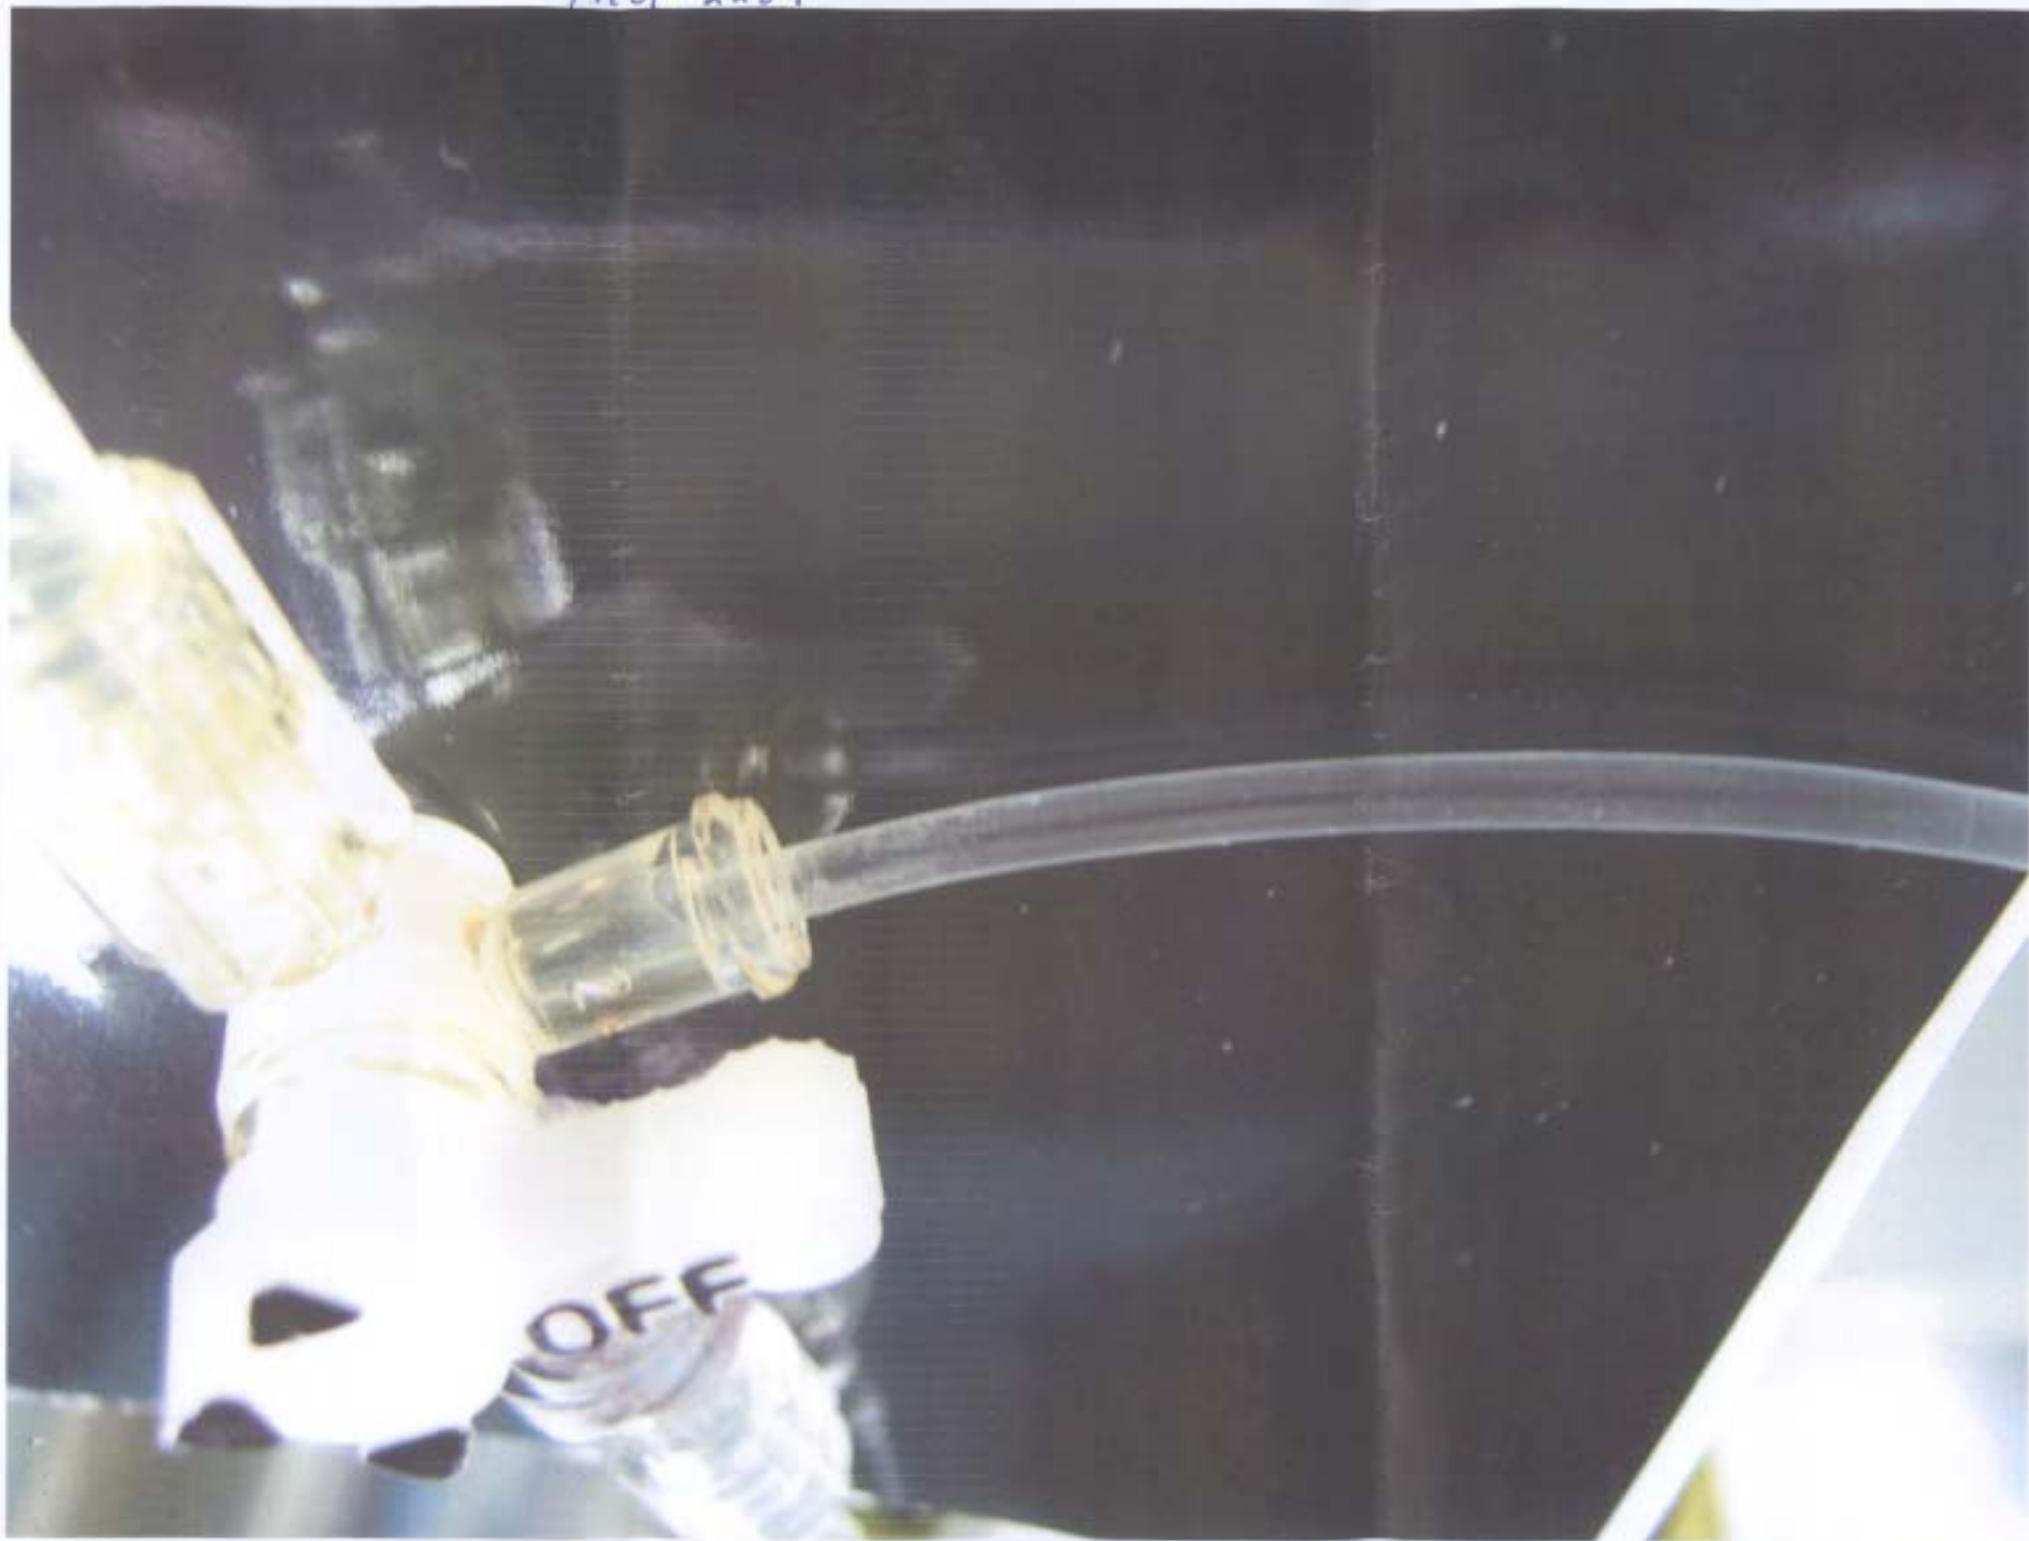
1MG-2289

IMG-2289 shows our experimental set up. After we prepared the dose for the patient done on Nov. 8, the same amount of dose was prepared in a spare "V" vial with sterile water from what was left of the Y-90 SIRSpheeres in the original shipping vial. A spare delivery set was set up behind appropriate shielding, primed with sterile water and a similar amount of Y-90 microspheres infused by the medical physicist in a simulated injection. This photo was taken 24 hours after the experiment.

and a similar amount of Y-90 microspheres infused by the medical physicist in a simulated injection, while the RSO and radiopharmacist observed the appearance of the microspheres in the plastic tubing. The injection was stopped and the microspheres were observed for several minutes. No clumping occurred and the authorized physician proceeded with the patient's therapy administration.
