Braidwood Station, Unit 1  
Facility Operating License No. NPF-72  
NRC Docket No. 50-456

Subject: Relaxation Request for First Revised Order (EA-03-009) Establishing Interim Inspection Requirements for Reactor Pressure Vessel Heads at Pressurized Water Reactors

Relaxation Request From NRC Order EA-03-009  
Section IV, Paragraph C(5)(b)(i)

Braidwood Station Unit 1

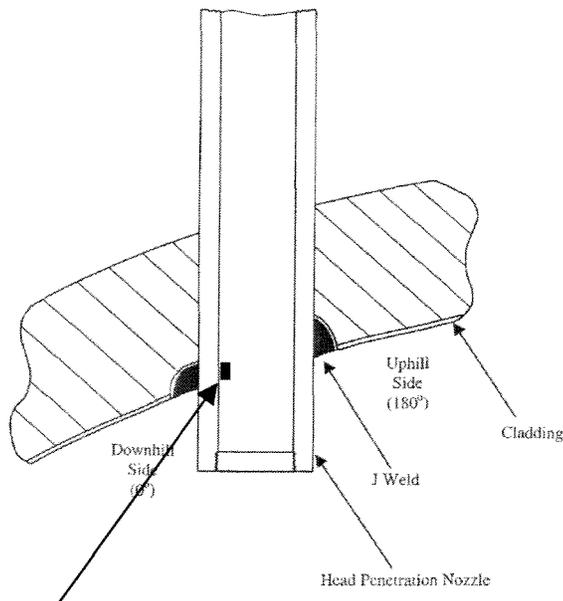
**Figure 1A**  
Relative location of ID surface anomaly on penetration 74.

For one penetration (number 74), a limited amount (less than 6%) of volumetric examination coverage was restricted due to a surface anomaly on the ID of the tube. The anomaly caused probe lift off which prohibited complete eddy current and ultrasonic data acquisition.

The surface anomaly was examined by a remote visual examination. Upon visual examination, the base metal appeared to be scratched and gouged (reference electronic photographs contained in Attachment 3). Based on the remote visual examination, the physical size of the disruption was estimated at 0.25-inch in circumferential extent and 0.6-inch in axial height and located at the downhill location of the J-Groove weld.

It is believed the anomaly is the result of contact between an incore thermocouple probe (bullet nose) retaining clip that slipped out of place and came in contact with the nozzle thereby gouging the inside surface during RPV head lift during the first refueling outage for Braidwood Unit 1. As depicted in Figure 1A above, the lowest axial height location is near the 0° downhill start of the J-Groove weld.

In addition to the limited examination coverage of the ten penetrations above, total coverage required by the Order could not be achieved for penetration number 74 due to a surface anomaly on the ID surface which caused probe liftoff. EGC is proposing to perform a bare metal visual examination, consistent with the Order

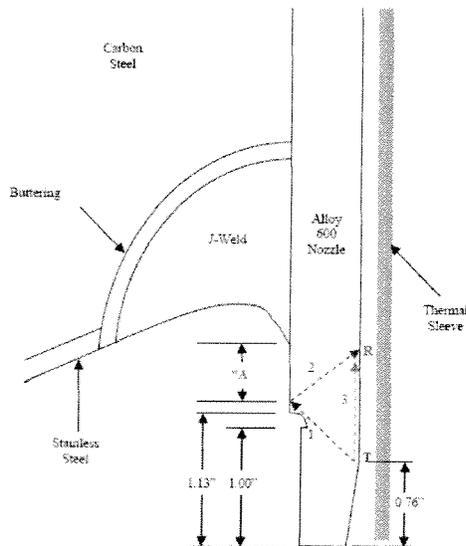
Figure 1B

The distance from the top of the thread relief to the bottom of the fillet of the J-groove weld, identified as "A" in Figure 1B, varies based on location of the penetration in the RPV head. These distances are generally longer for penetrations at "inboard" locations and become progressively shorter for penetrations located further away from the center of the RPV head. At the ten subject penetration nozzles (i.e., numbers 42, 49, 54, 63, 65, 66, 71, 72, 77, and 78) the configuration is such that the distance from the lowest point at the toe of the J-groove weld to the bottom of the scanned region is less than the 1-inch lower boundary limit specified in section IV.C.(5)(b)(i) of the Order.

Illustration of Axially Oriented TOFD Examination Coverage on Braidwood Station Unit 1 Penetration Geometry (Including General Dimensions) at 0 Degrees

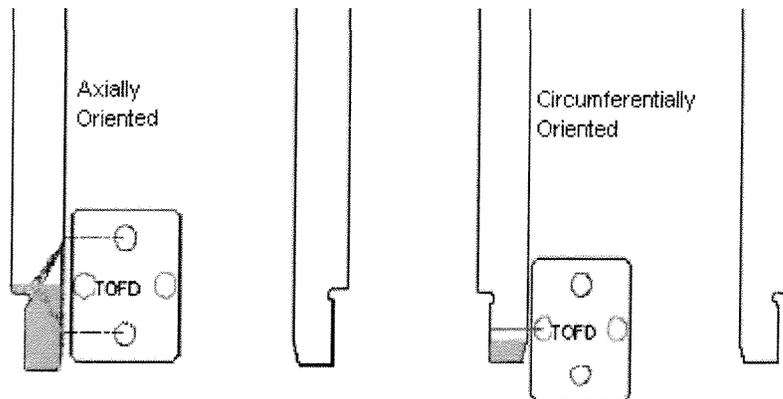
Figure 6  
Open Housing Probe Coverage Limitations

Housing Probe's circumferentially oriented transducers, the TOFD beam is not interrupted by the OD thread relief. The dimensions listed in Table 1 reflect the circumferential TOFD transducer coverage limitation of 0.76 inches due to the chamfered region. This is why the Open Housing Probe coverage is consistently greater than the Trinity Probe coverage. Figure 6 shows both the axial and circumferential Open Housing Probe TOFD coverage limitations. The shaded areas indicate the portions of the tube that cannot be inspected.

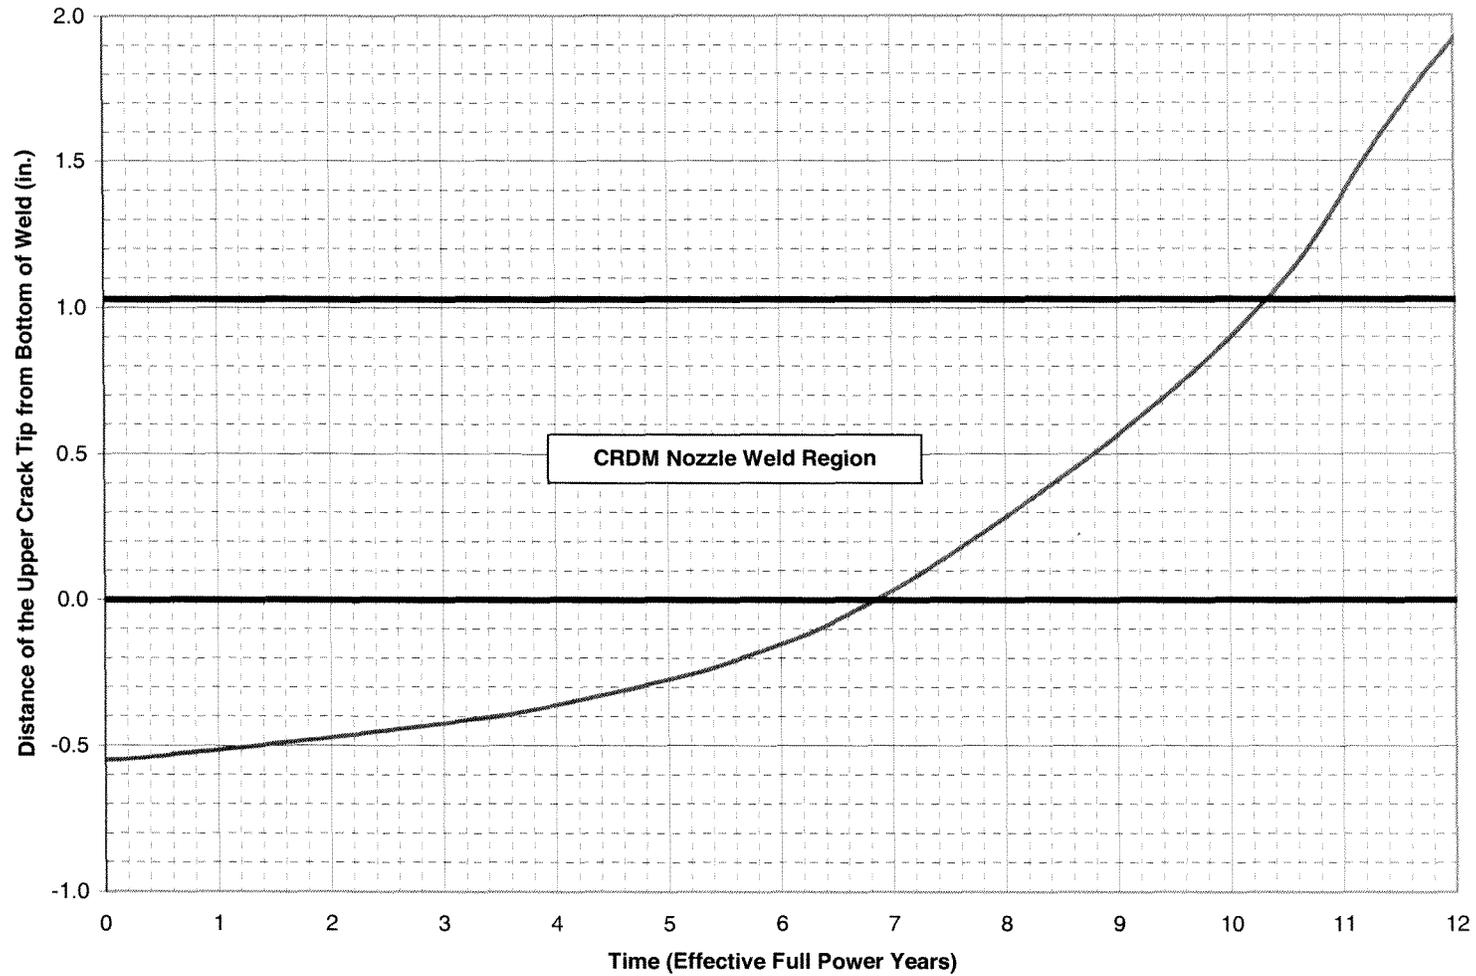
Figure 7  
Through -Wall Longitudinal Flaw in the 25.4 Degree CRDM Row Downhill Side - Crack Growth Prediction  
(Applies to Penetrations 42, 49, and 54)

Based on A1R12 examination results (see Table 1), the worst-case minimum distance below the J-groove weld to the top of the zone that could not be inspected was determined to be 0.76 inches on the downhill side of the penetration nozzle number 49. To account for the inspection tolerance of the inspection equipment (0.04 inches), an axial through-wall flaw was conservatively postulated to be located at 0.70 inches below the J-groove weld in the crack propagation calculation for the downhill side of the penetration nozzle. Using the applicable crack growth rate for the penetration (Figure 7), it would take greater than 6.8 EFPY for the postulated flaw to propagate from that location to the bottom of the J-groove weld, which would occur after the next scheduled inspection.

For the subject penetrations that EGC is seeking relaxation, Figures 7 through 10 (WCAP-16394-P, Figures 6-12, 6-13, 6-14, and 6-15) provide results of the calculation. The calculation demonstrates that the minimum time for a flaw to propagate from that location to the bottom of the J-groove weld would be greater than four operating cycles. The results of the flaw propagation calculation indicate that, even if a flaw were to occur in the region of the penetration nozzle not being inspected, there would be adequate opportunity for detection prior to the crack reaching the reactor coolant system pressure boundary. The results demonstrate that the extent of the proposed inspection coverage would provide reasonable assurance of the structural integrity of the Braidwood Unit 1 RPV head penetration nozzles and the J-groove welds.

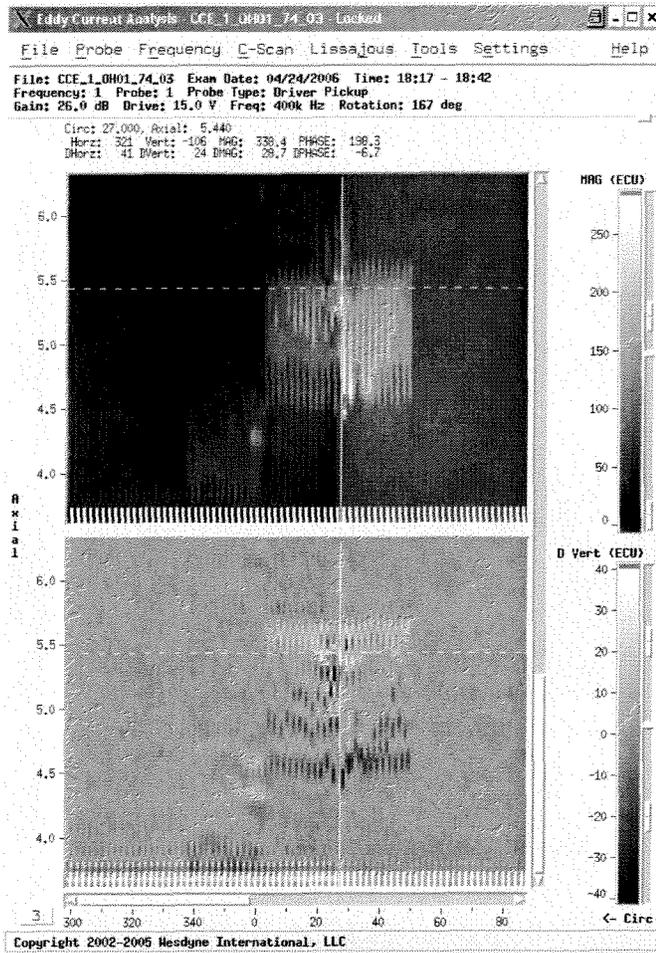
**Figure 1**  
**400 KHz Liftoff Evaluation**

For the indication associated with Penetration number 74, the 400 KHz peak-to-peak magnitude was 424.3 eddy current units (ECU's). Two thirds of this value is 282.9 ECU's, shown in Figure 1. The 100 KHz peak-to-peak magnitude was 257.6 ECU's. Two thirds of this value is 171.8 ECU's, shown in Figure 2.

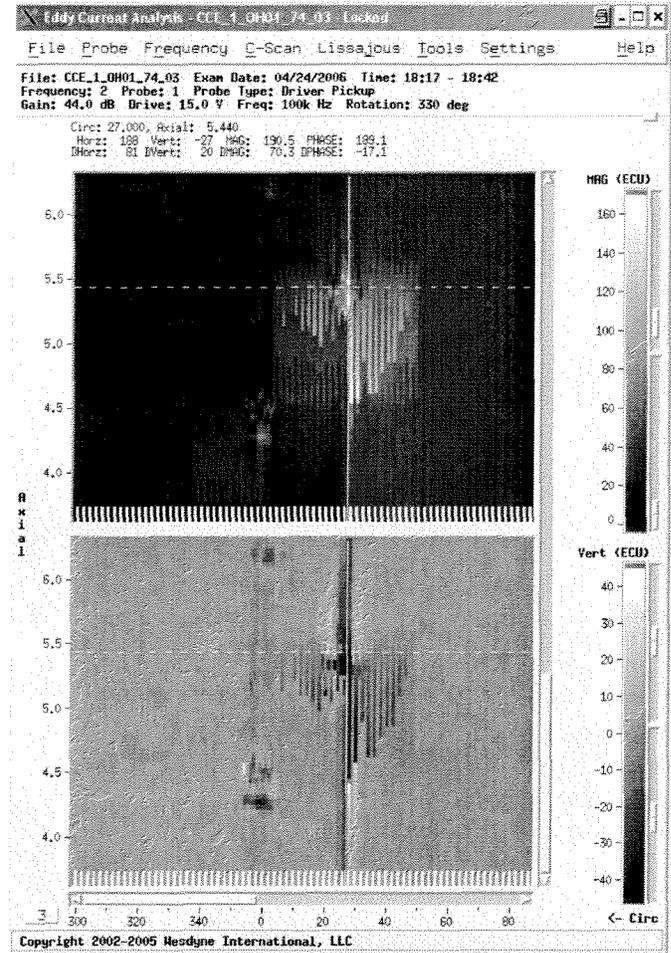
**Figure 2**  
**100 KHz Liftoff Evaluation**

There are only two magenta signals in these views. The upper signal is due to the strong ET response, and is discussed in the next section.

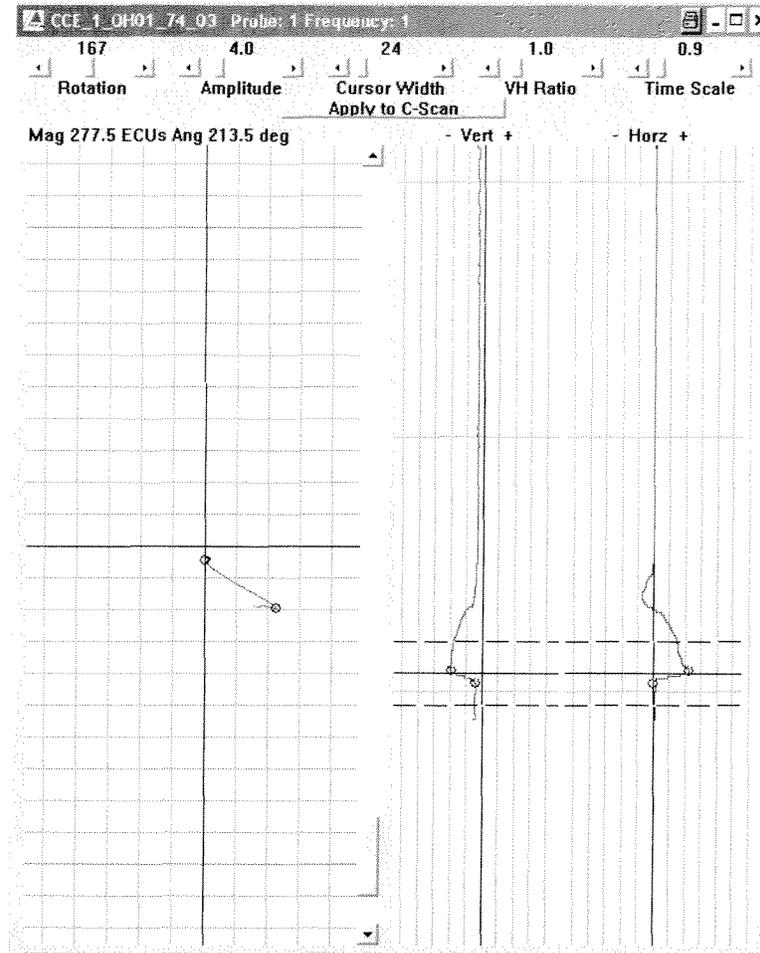
**Figure 3**  
**Lower Magenta Signal**

The lower signal is a localized liftoff signal due to the probe kicking as it transits the area of disturbance (see Figure 3). Since it is a single excursion that appears on only a single stroke, it does not meet the criteria of Section 5 of WDI-ET-004 and thus is not a flaw-like response.

Since no magenta appears in the general area, the ET data acquired here is valid and normal data analysis can be performed.

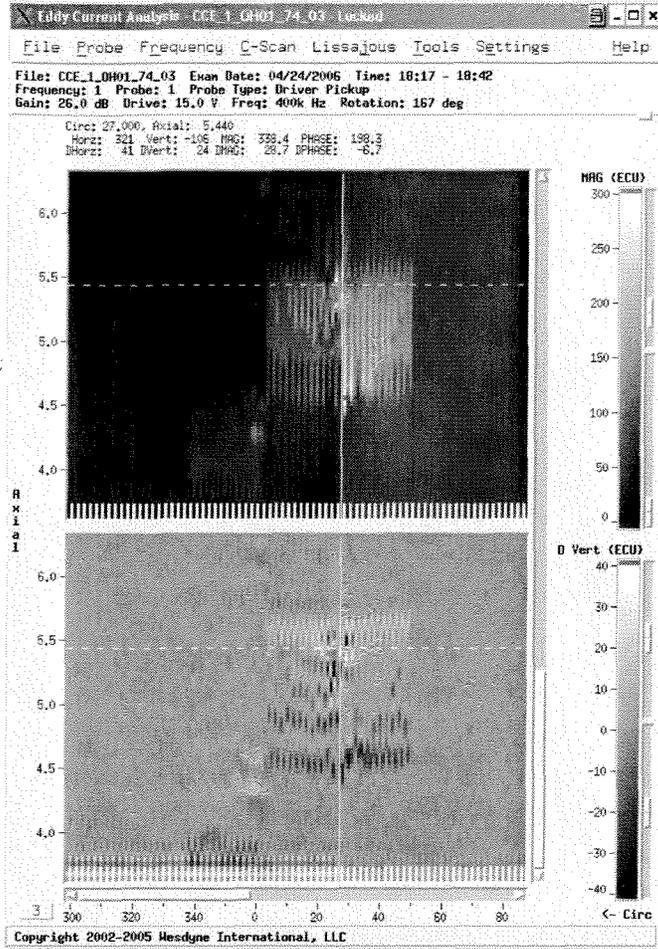
**Figure 4**  
Strong Signal Location, ET Results

Figure 4 above shows the location of the strong response in the ET data. Figure 5 above shows the UT data for Channel 2 at the same location. The lateral wave is distorted, but there is no break. Therefore it can be concluded that there are no ID related indications at that location.

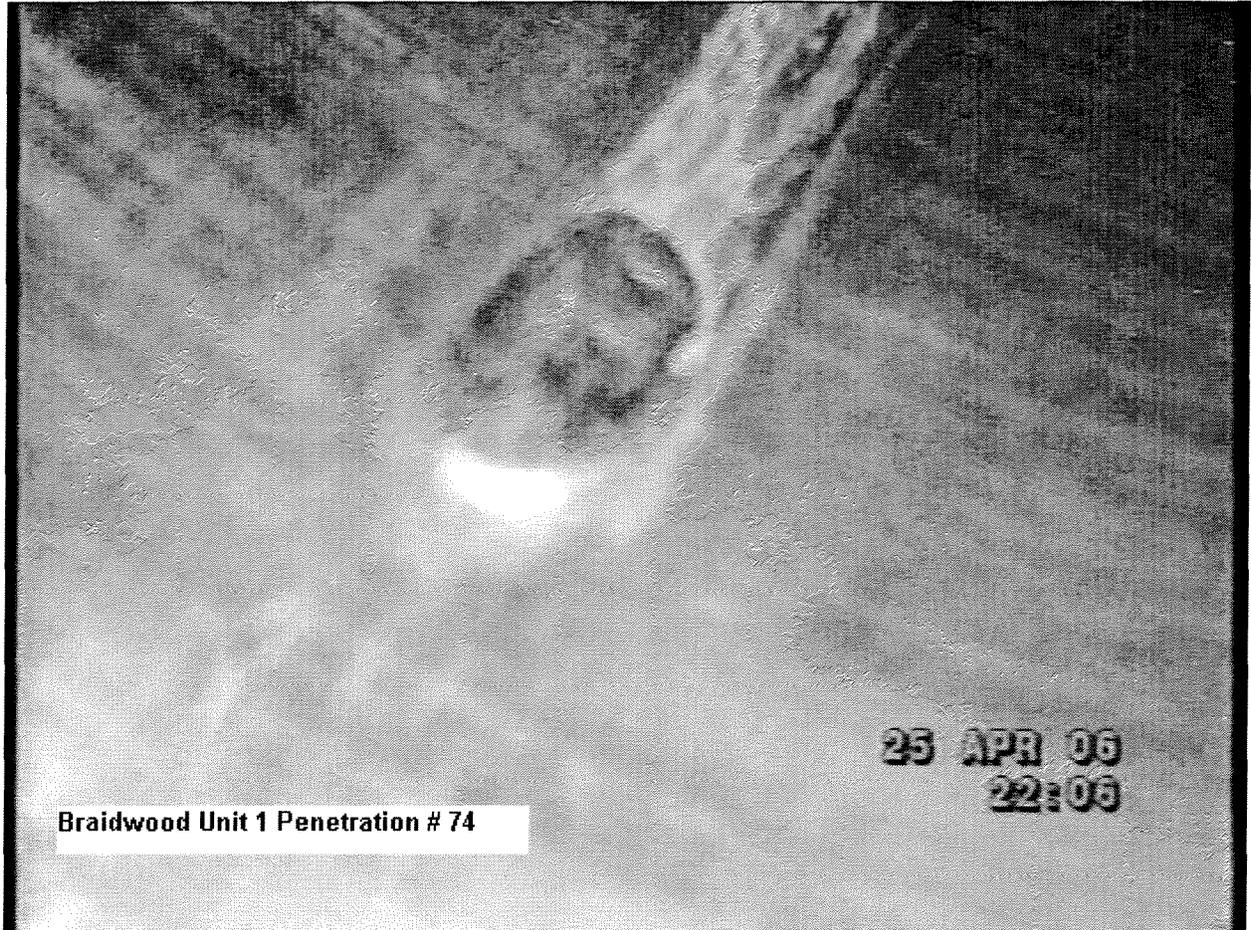
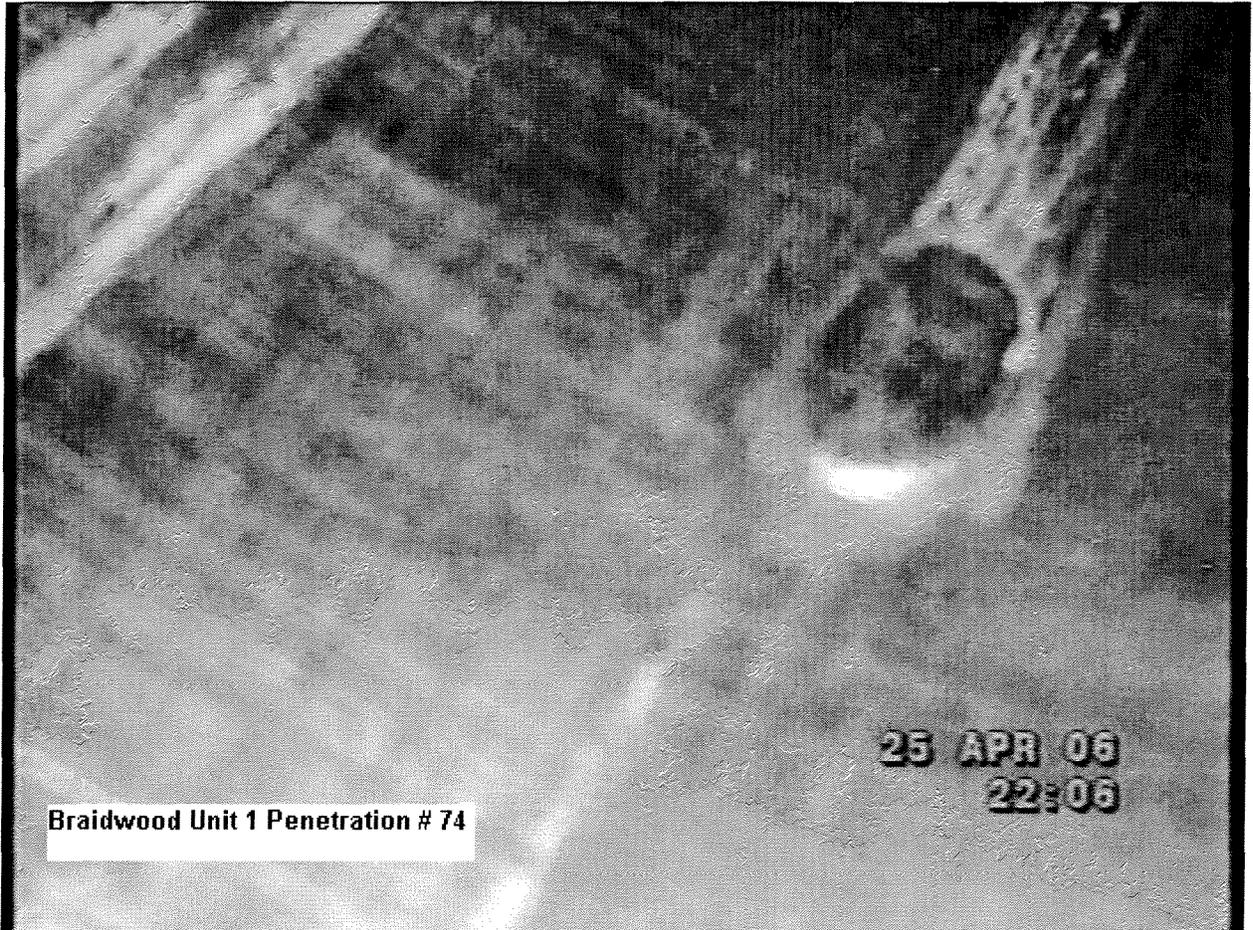
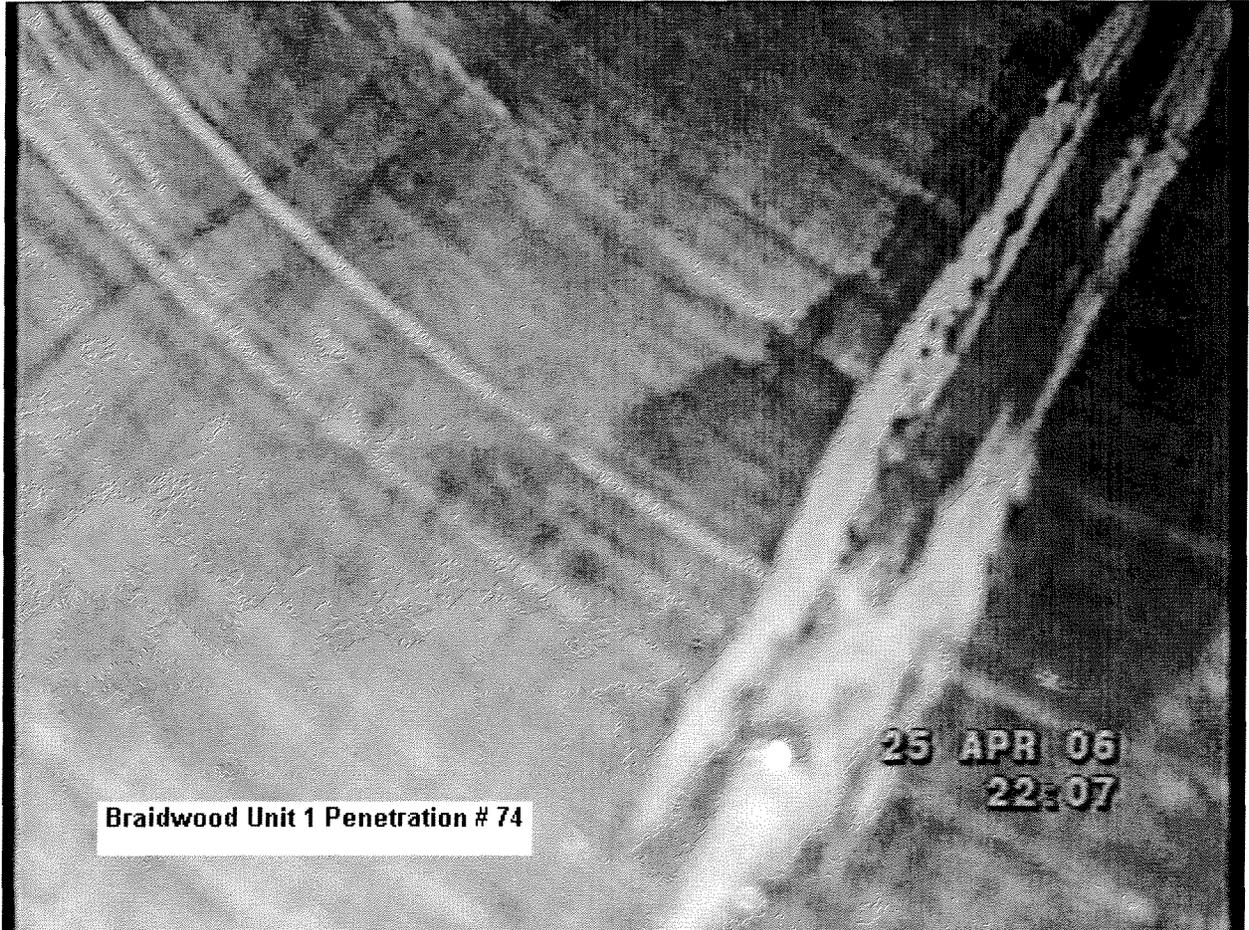
Attachment 3  
Braidwood Unit 1 Penetration Number 74 Remote Visual Images

A supplemental visual examination using a borescope video recording was performed on the areas of concern. The area of the surface anomaly that caused the limited examination coverage was estimated at 0.25-inch in circumferential extent and 0.6-inch in axial height.

Based on the UT and Eddy Current data collected, there was enough coverage to assure that there were no crack-like indications, under the anomaly, connected to the ID surface of penetration 74 (Attachment 3). Primary water stress corrosion cracking (PWSCC) possibly originating at the ID of the RPV penetration tube and progressing to the OD of the tube is not a concern, since full ID coverage directly under the anomaly was obtained. Available leak path results showed no suspect areas in the J-groove weld above the location of the anomaly.
