**Subject: Docket No. 50-362
Additional Information Supporting Third Ten-Year Inservice Inspection
(ISI) Interval Relief Request ISI-3-21 Request for Alternative to ASME
Code Rules for the Embedded Flaw Repair Process for Control
Element Drive Mechanism (CEDM) # 56
San Onofre Nuclear Generating Station Unit 3**

**SAN ONOFRE Unit 3
Control Element Drive Mechanism (CEDM) #56
November 2006 Ultrasonic Exam Re-evaluation**

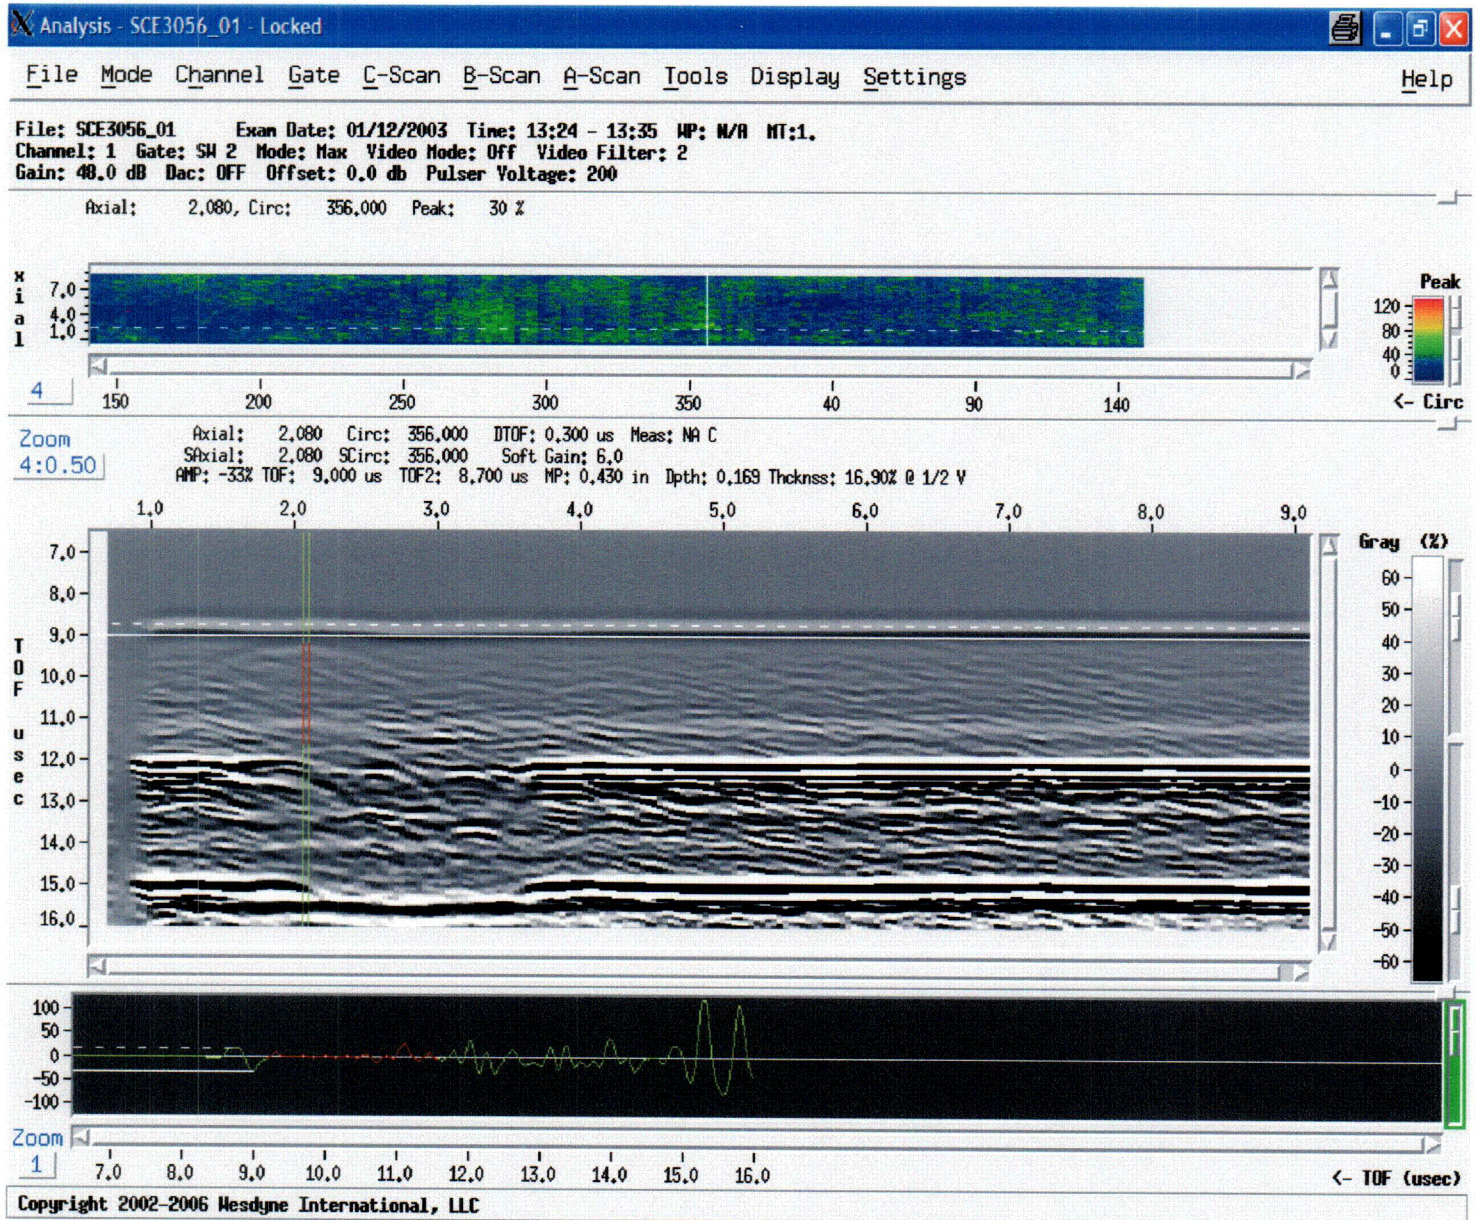
Figure 1A

Data from the 2003 inspection were re-evaluated in November 2006. Evaluation of the same indication has determined that the indication had a remaining wall of 0.169". This evaluation considered both the B and "B" prime scan (Figures 1A and 1B) for evaluation.

Comparing Figures 1A from the Cycle-12 inspection and Figure 4A from the Cycle-14 inspection shows that the depth of this indication in CEDM 56 has remained essentially the same from 2003 thru 2006. It is SCE's conclusion that this indication shows no growth from discovery in 2003.

Indication (Anomaly) #1
B Scan Channel 1

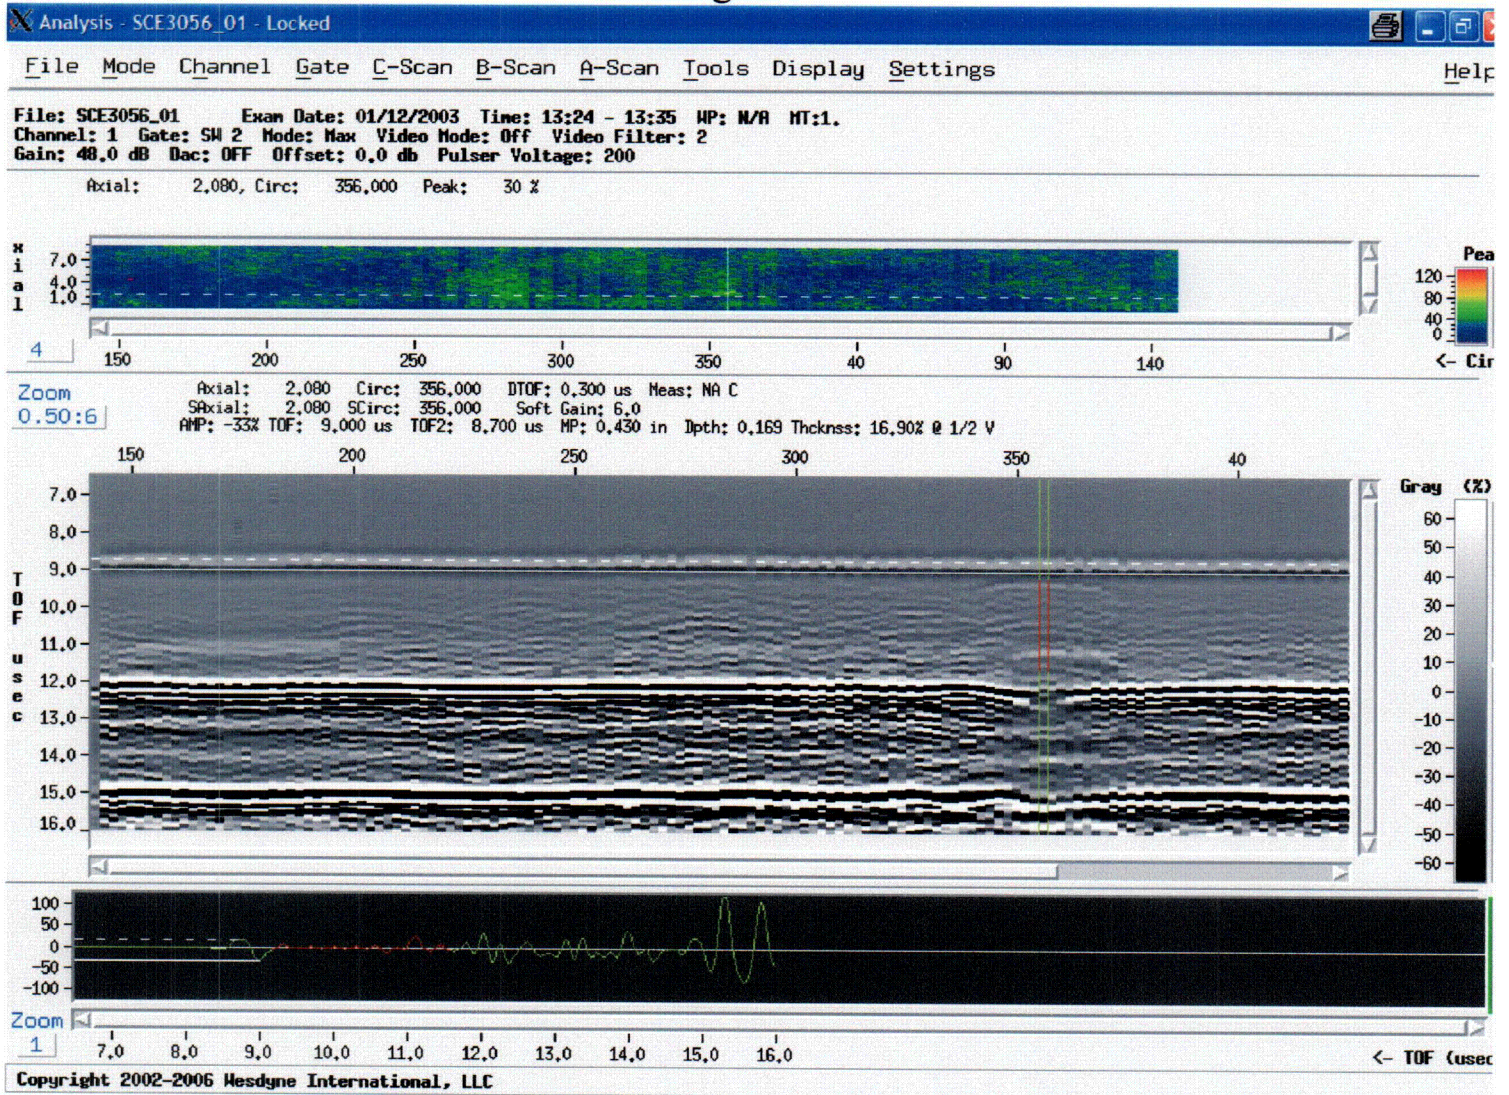
Figure 1B

Indication (Anomaly) #1
 "B" Prime Scan Channel 1

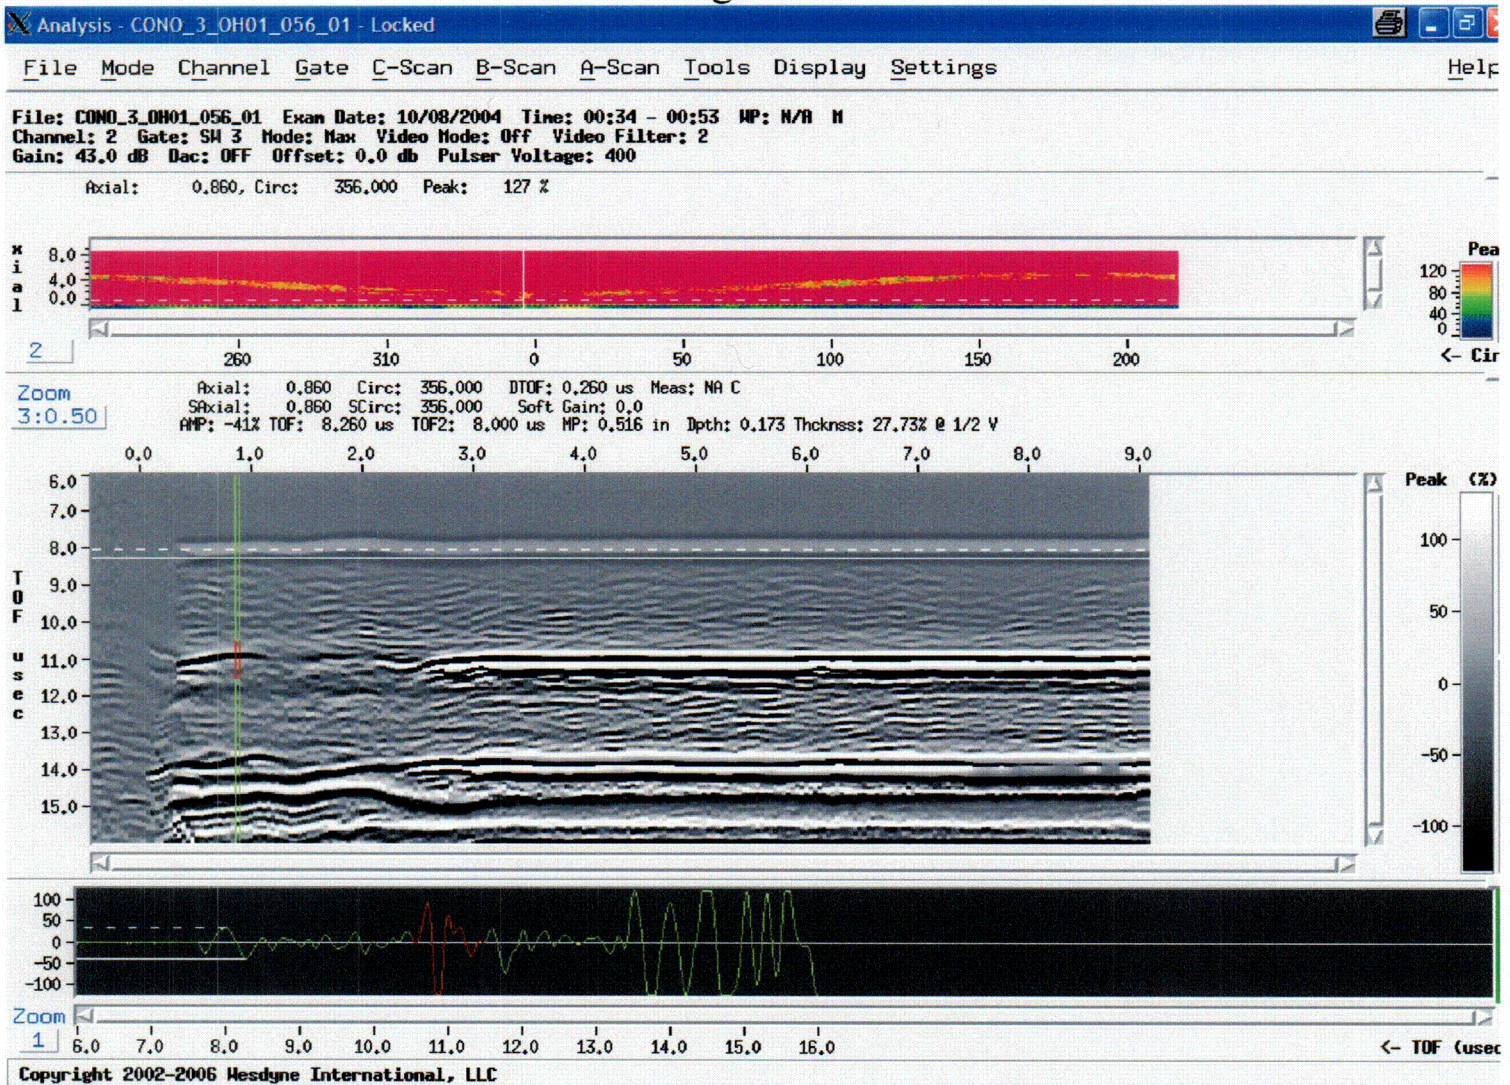
Figure 2A

Sizing results of this indication in November 2006 were similar to the 2004 inspection record. The indication through wall depth was 0.491" with a remaining ligament of 0.170". (See Figures 2A and 2B).

Indication (Anomaly) #1
 B Scan Channel 2

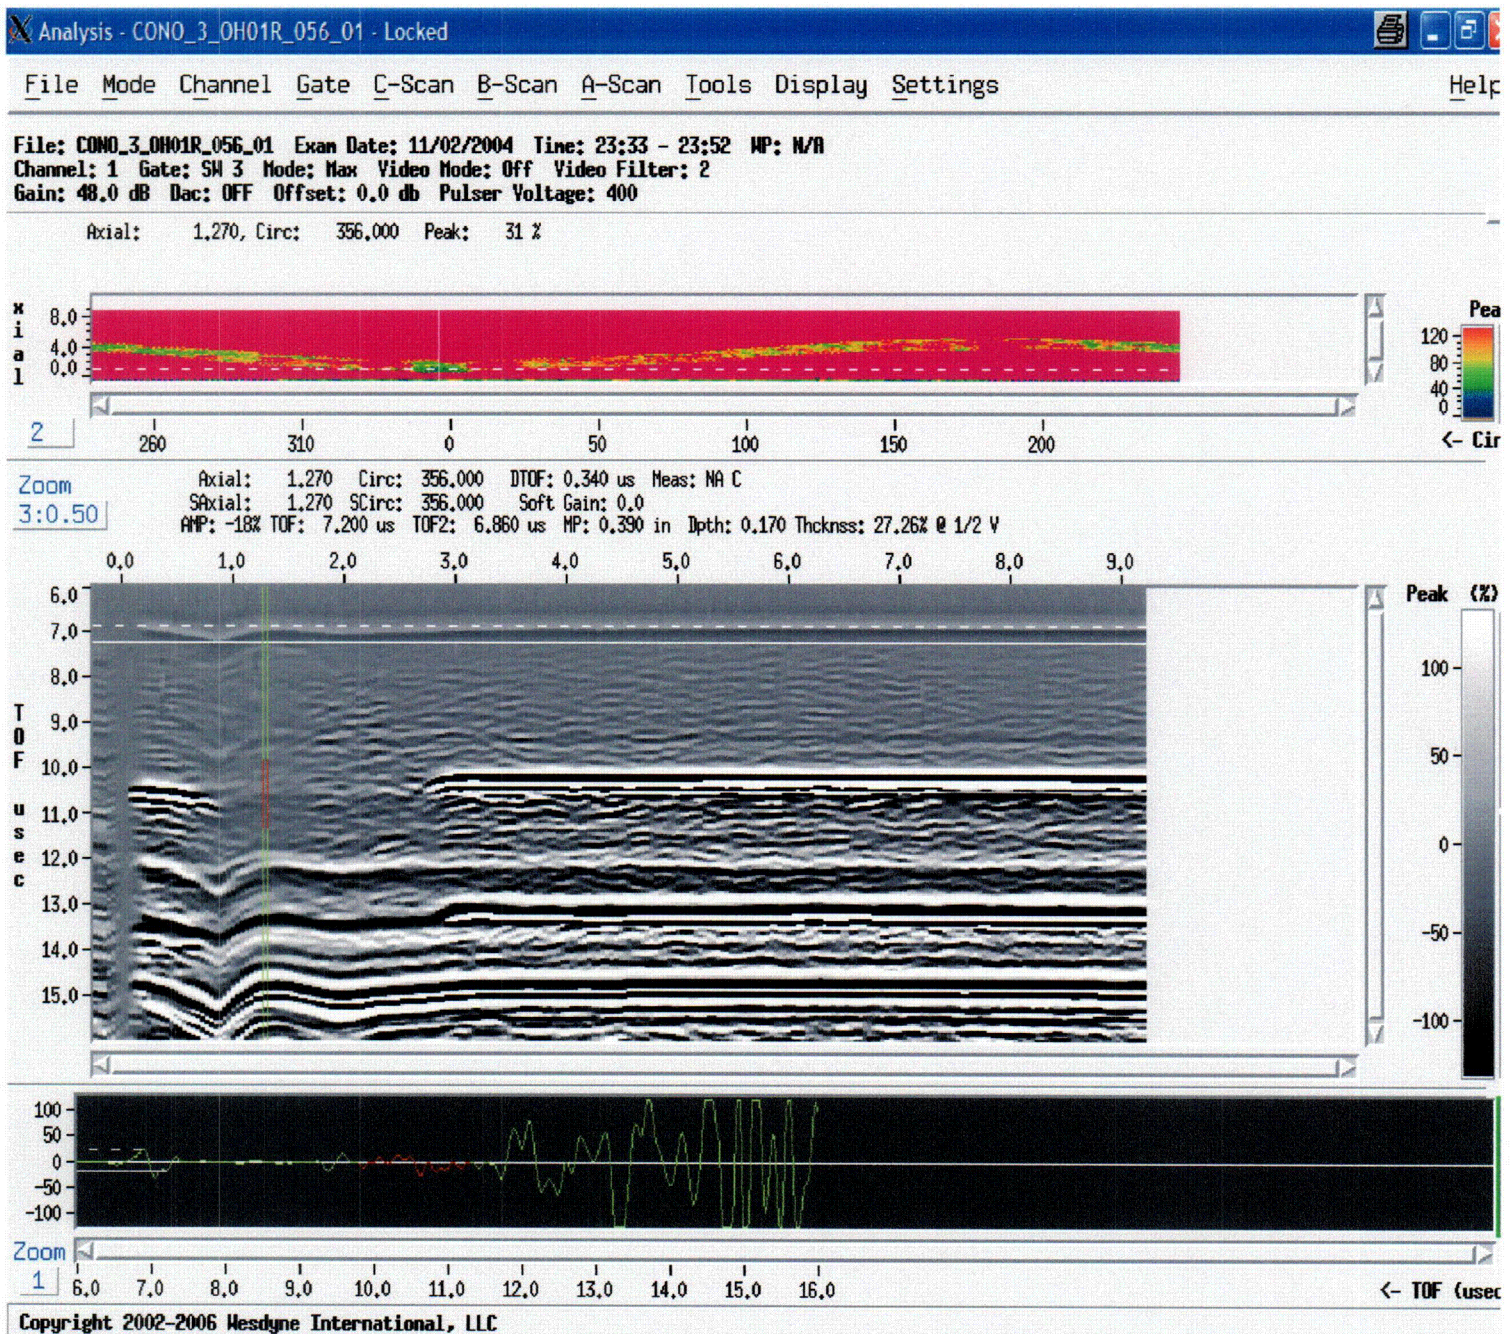
Figure 2B

Indication (Anomaly) #1
 B Scan Channel 1

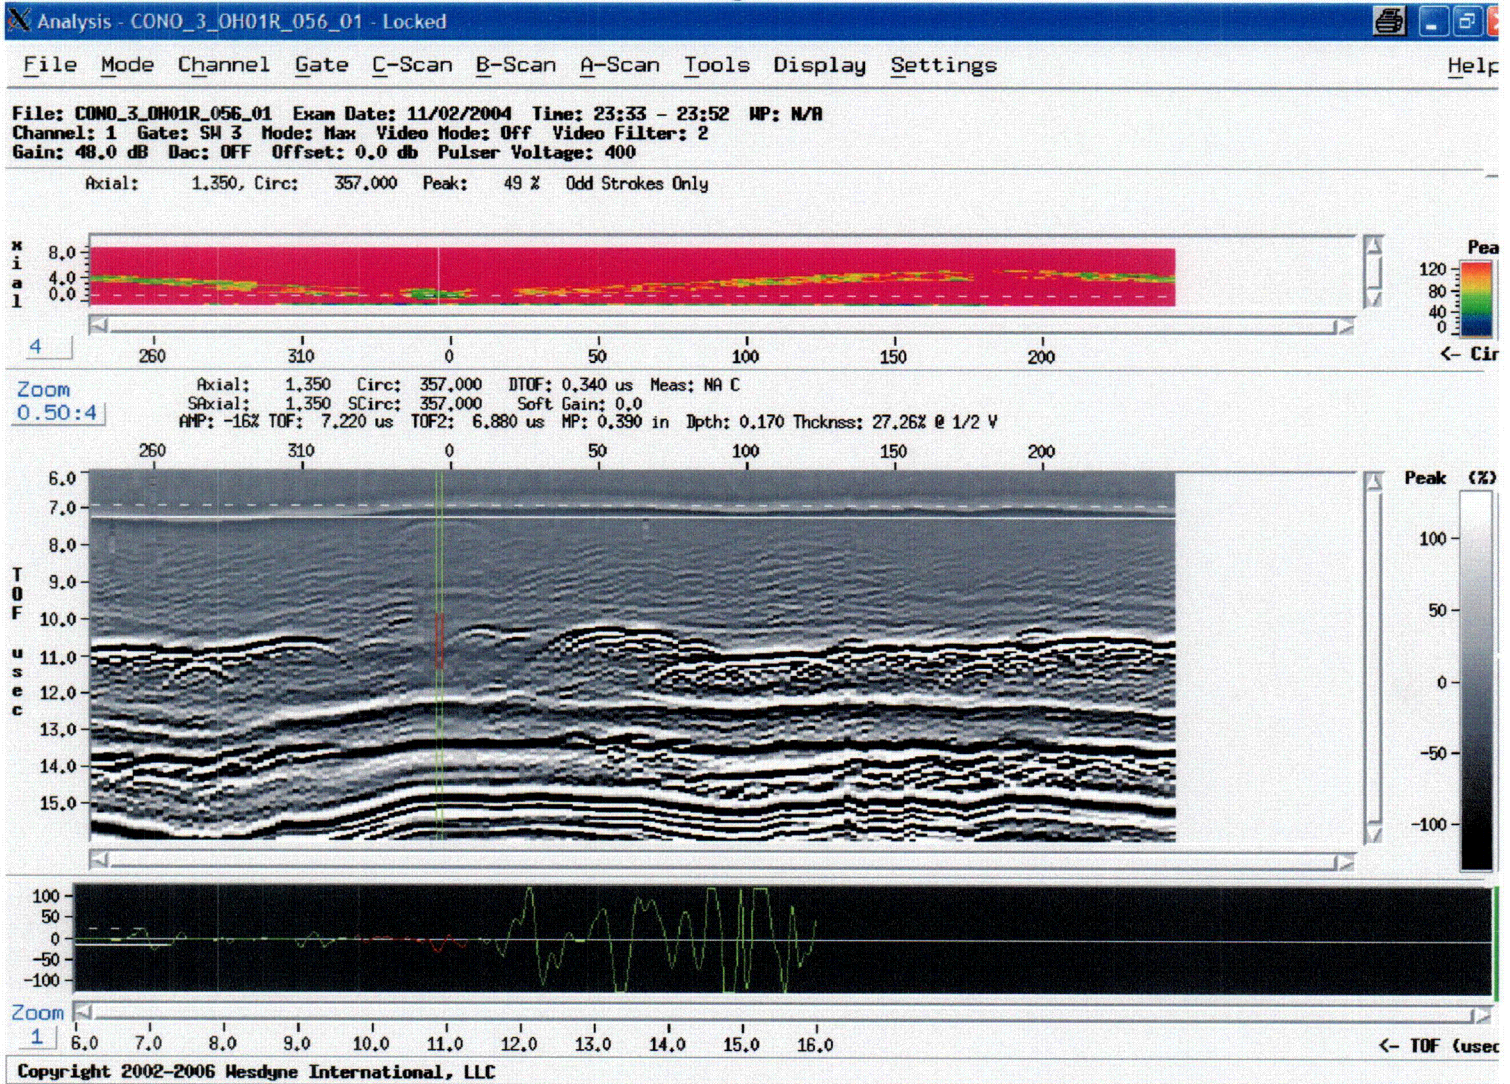
Figure 3

The November 2006 analysis of post repair inspection data found no change from the pre repair inspection data. (See Figure 3)

Post Repair Examination
 "B" Prime Channel 1

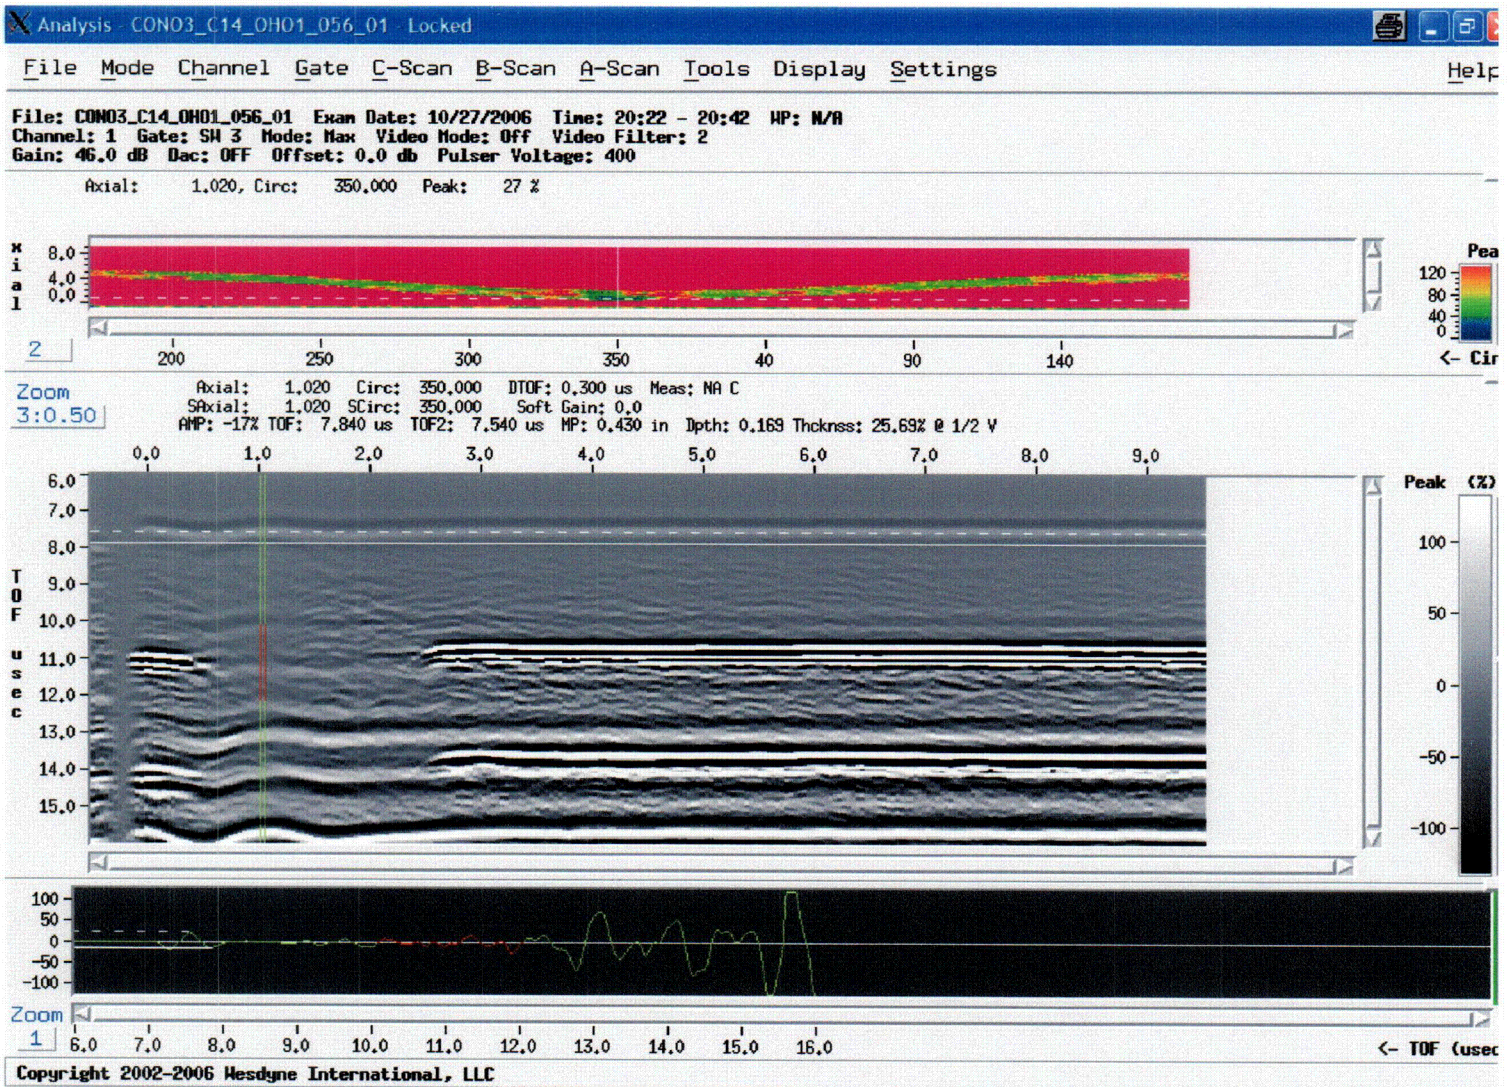
Figure 4A

The November 2006 re-evaluation concluded that the Indication has a through wall depth of 0.492" and a remaining ligament of 0.169". (See Figures 4A and 4B).

Indication (Anomaly) #1
B Scan Channel 1

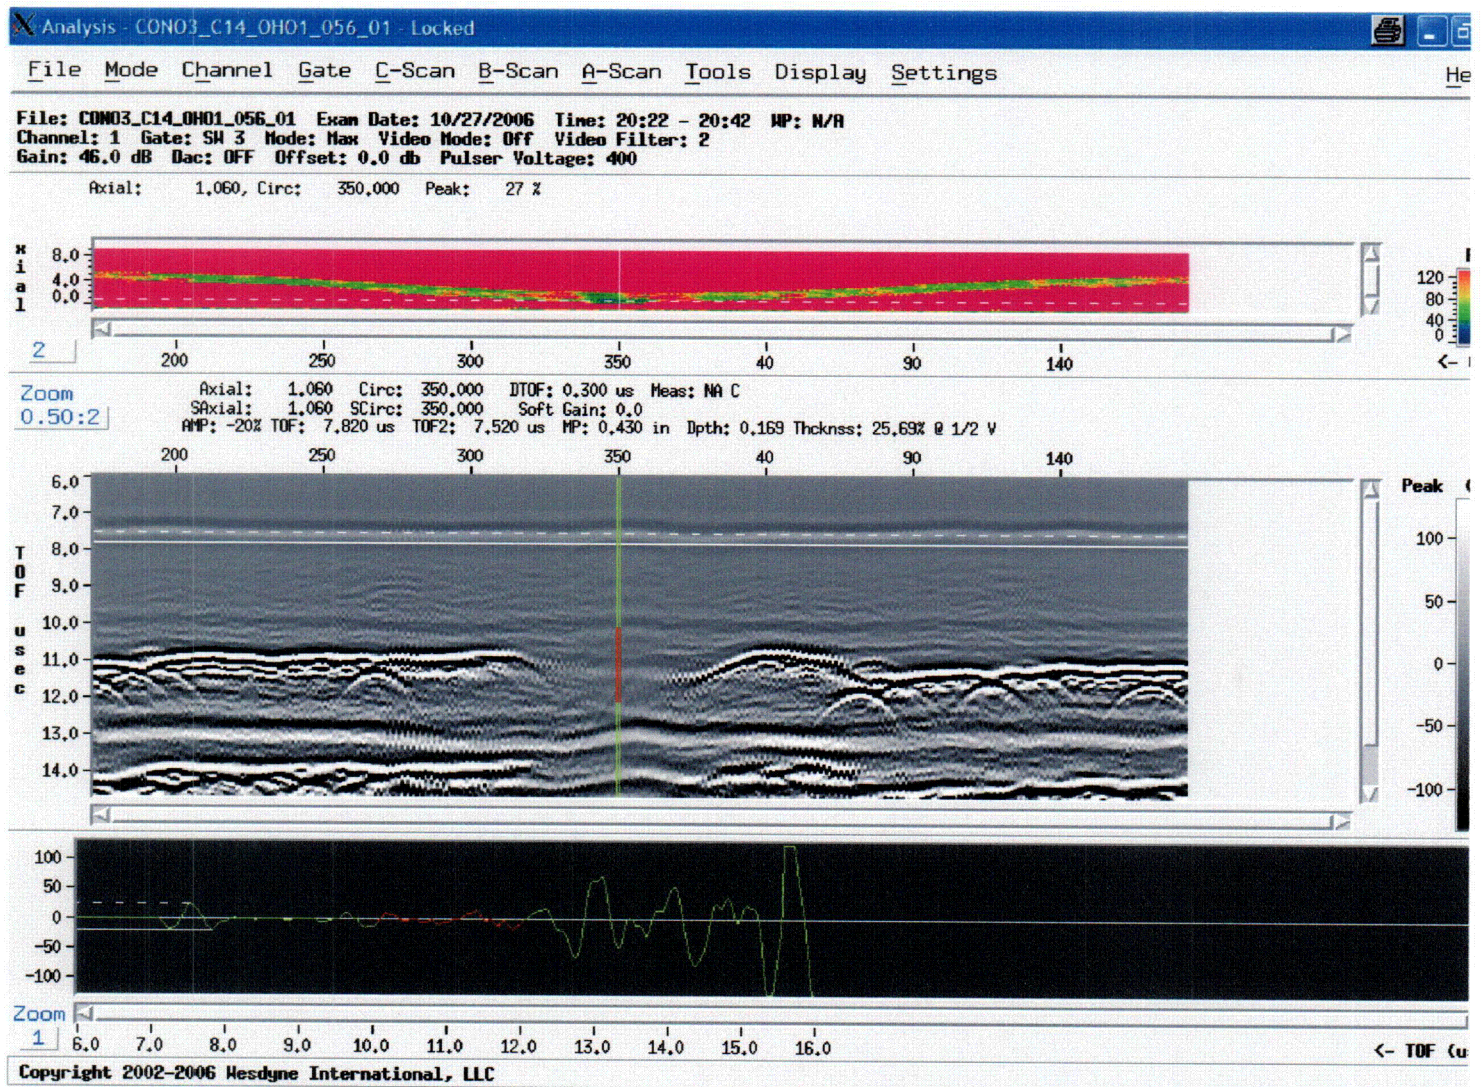
Figure 4B

Indication (Anomaly) #1
 "B" Prime Scan Channel 1
