Subject: **Docket No. 50-362**  
**Licensee Event Report No. 2006-004**  
**San Onofre Nuclear Generating Station, Unit 3**

**4. TITLE**  
Inoperable breaker causes train "A" charging pump to be inoperable for longer than allowed by Technical Specifications

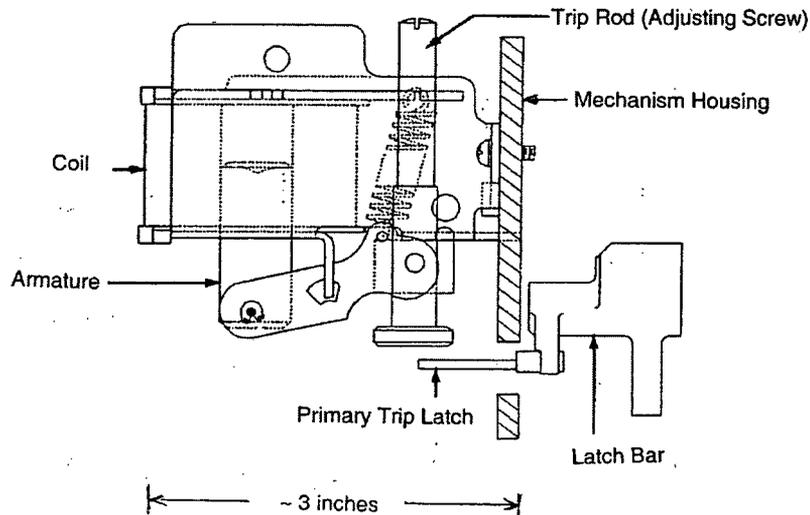
**Shunt Trip Device for ABB K600S Breaker**

SCE determined the “A” train charging pump failed to start because the supply breaker failed to close on demand from the control room due to a failed STD in the breaker. The STD opens the breaker under conditions such as demand from the control room or automatic signals not associated with an electrical fault. The STD is similar to a spring return solenoid, which when energized momentarily with 125 Vdc, produces a magnetic force that pulls up on the armature. This movement causes the trip rod to actuate the primary trip latch to open the breaker. When the voltage is removed, the STD trip rod should return to its normal position by spring tension. If the STD trip rod does not return to the normal position, the primary trip latch will also remain actuated and prevent the breaker from closing. (See attached figure.)

SCE performed bench testing of the failed breaker and found the STD trip rod to be sticking intermittently in the energized position. SCE concluded the sticking STD had prevented the breaker from closing as described above. Because the STD only actuates when opening the breaker, this failure most likely occurred when the breaker was last opened. SCE is continuing to investigate the cause of the sticking STD.

SCE replaced the STD in breaker 3B0413 and returned the "A" train charging pump to service on October 3, 2006. The defective STD was returned to the manufacturer for failure analysis.
