Oyster Creek 1R21 Outage

Communication Package Related to Drywell Shell Inspections October 23, 2006

1R21 Drywell Inspections

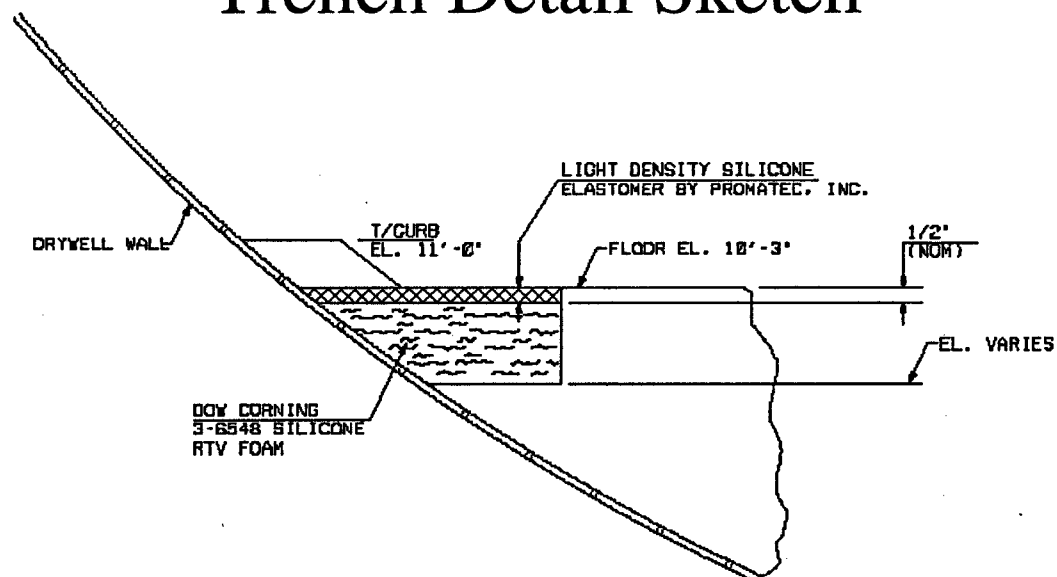
Trench Detail Sketch

CROSS-SECTION AREA
OF TRENCHES IN BAYS 5 & 17

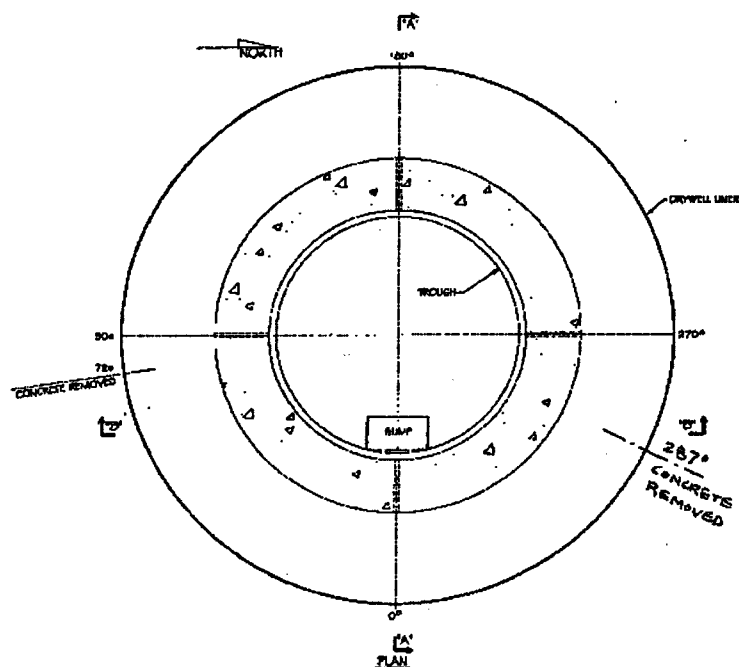
Top View – Drywell Floor Sketch

- Surface of drywell shell visible from trenches in Bays 5 and 17 exhibited a surface layer of iron oxide
- Approximately 5" of water found in bottom of trench in Bay # 5, and trench in Bay 17 had only dampness
- Connection between under-vessel area trough and floor drain sump potentially allowing water leakage
- Trough located in the under-vessel area is not lined, potentially allowing water passage into the concrete slab

- Visual Examination (VT-1) of floor drain sump liner to look for evidence of a leak path
- Tracer test aimed at determining whether under-vessel trough is in communication with trench in Bay 5
- Development of contingency repair to trough to address likely water source into trench
- Complete non destructive examination and analysis of Drywell shell in trench areas
- Perform evaluation of the impact of water that may exist beneath concrete surface on drywell shell
- Development of contingency repair to caulk intersection of Drywell Shell and concrete slab curb
