Oyster Creek 1R21 Outage

Startup PORC

Update on Drywell Shell Inspections

November 4, 2006

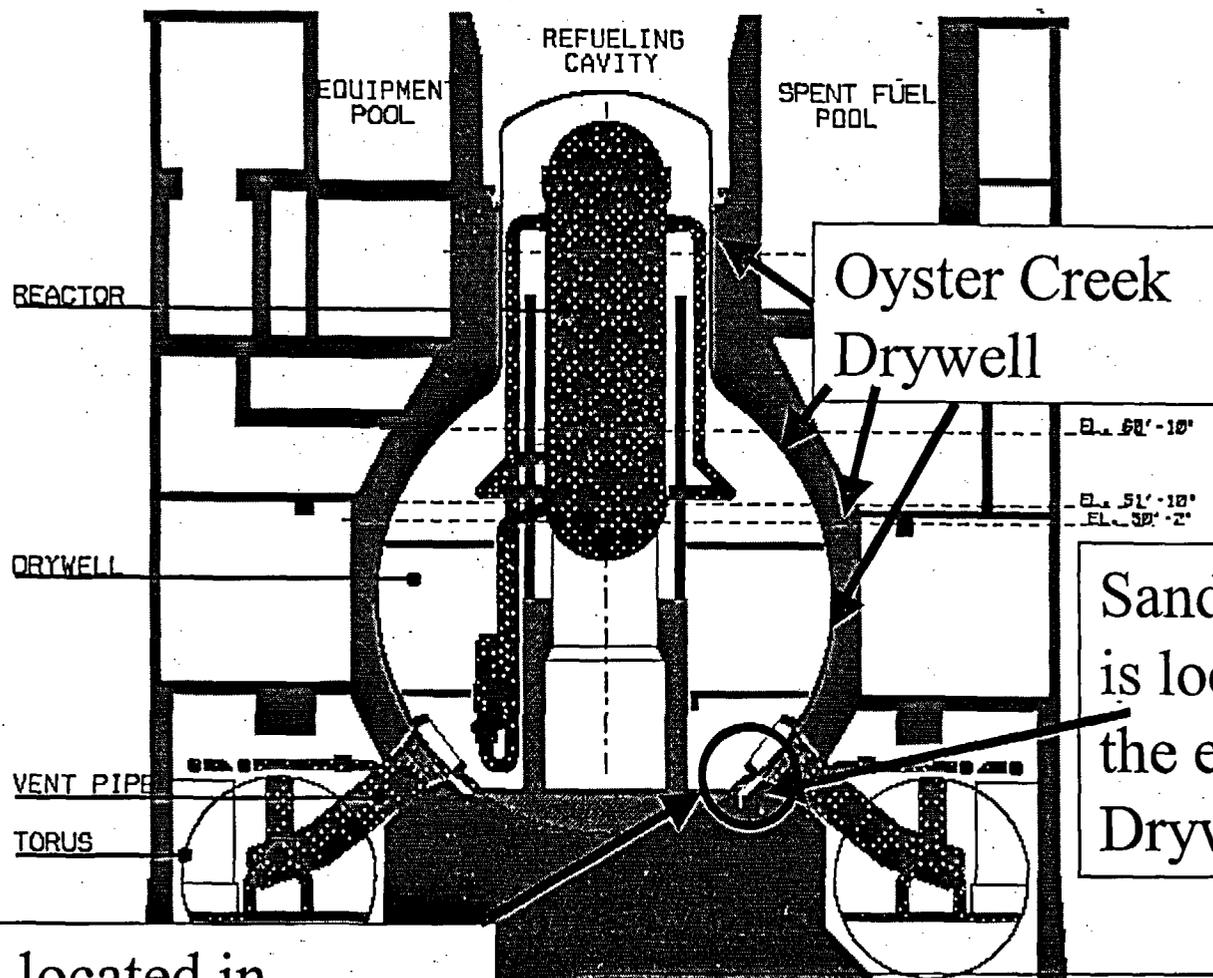
Sandbed region is located on the exterior of Drywell

Trenches located in concrete floor inside the Drywell in two locations

In 1986, the station removed concrete at two locations inside the drywell to create the "trench area" to gain access to the drywell shell adjacent to the sand bed region. The purpose of clearing out the area was to obtain UT thickness measurements.

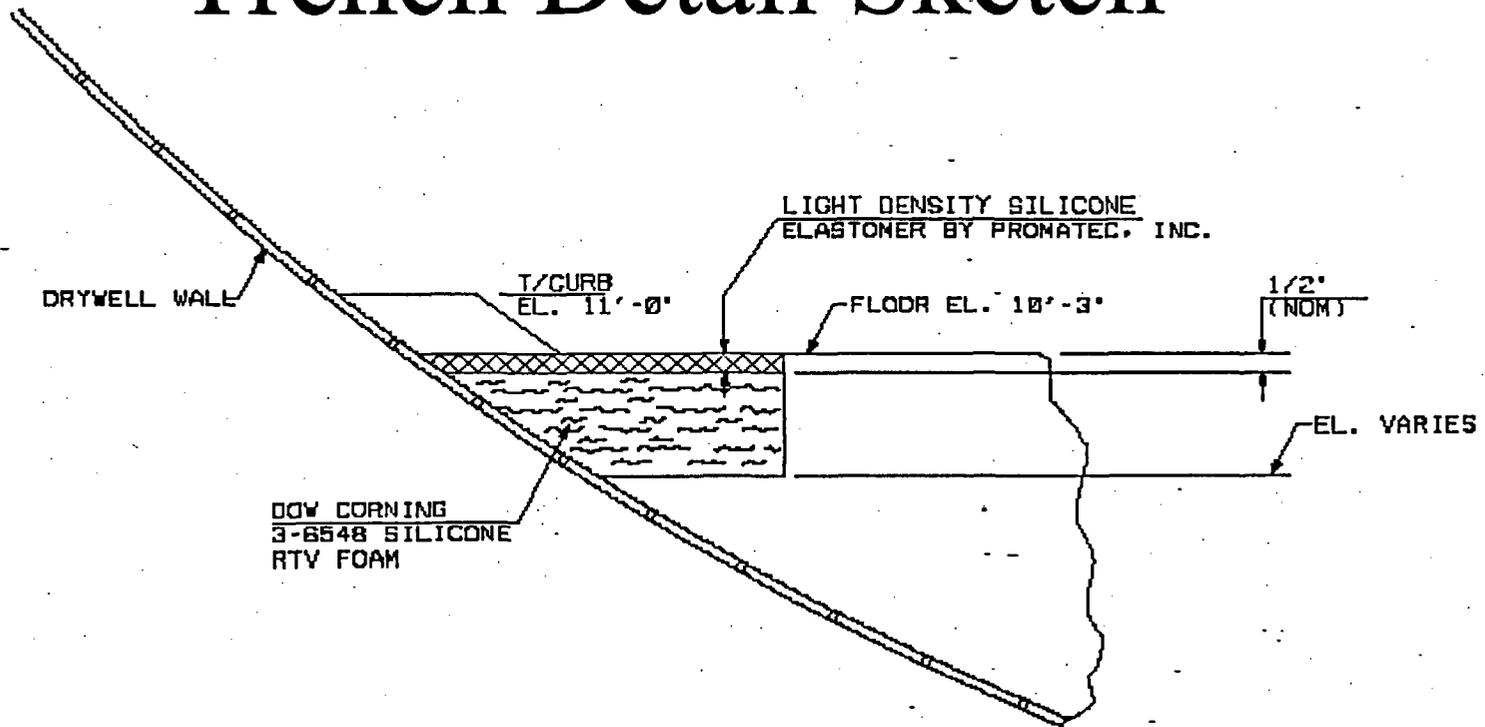
Trench Detail Sketch

CROSS-SECTION AREA
OF TRENCHES IN BAYS 5 & 17
