Update on 1R21 License Renewal Activities

Drywell Shell Inspections and Status of Water Existing in the Internal Sand Bed Trench Area

Date: Sunday, Oct. 22, 2006

From: Tim Rausch, Site Vice President

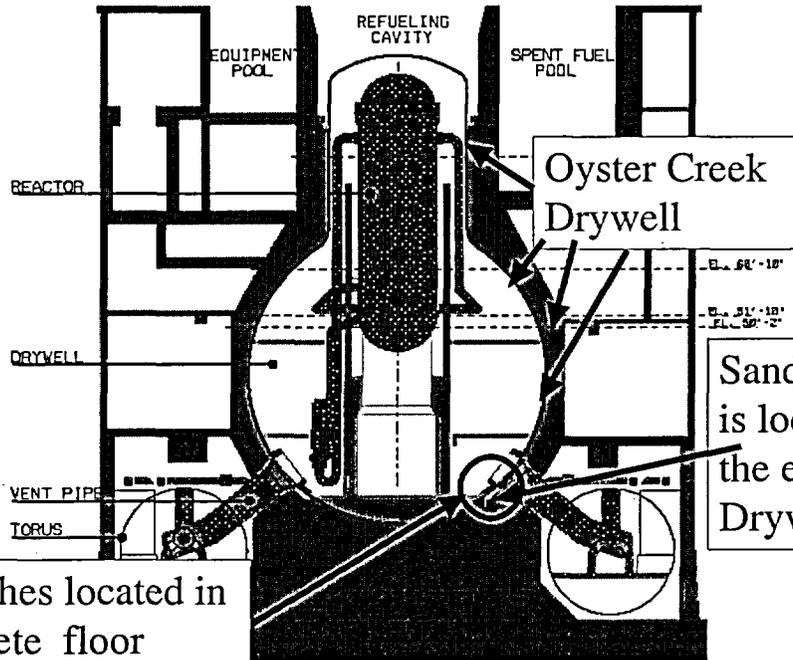
However, during our inspections of the interior and exterior of the drywell, we identified a small amount of standing water in one of two trenches inside the drywell. After the water was removed, some water returned to the location.

Trenches located in concrete floor inside the Drywell in two locations

Sandbed region is located on the exterior of Drywell

In 1986, the station removed concrete at two locations inside the drywell to create the "trench area" to gain access to the drywell shell adjacent to the sand bed region. The purpose of clearing out the area was to obtain UT thickness measurements.
