Oyster Creek 1R21 Outage

Communication Package Related to
Drywell Shell Inspections
October 23, 2006

1R21 Drywell Inspections

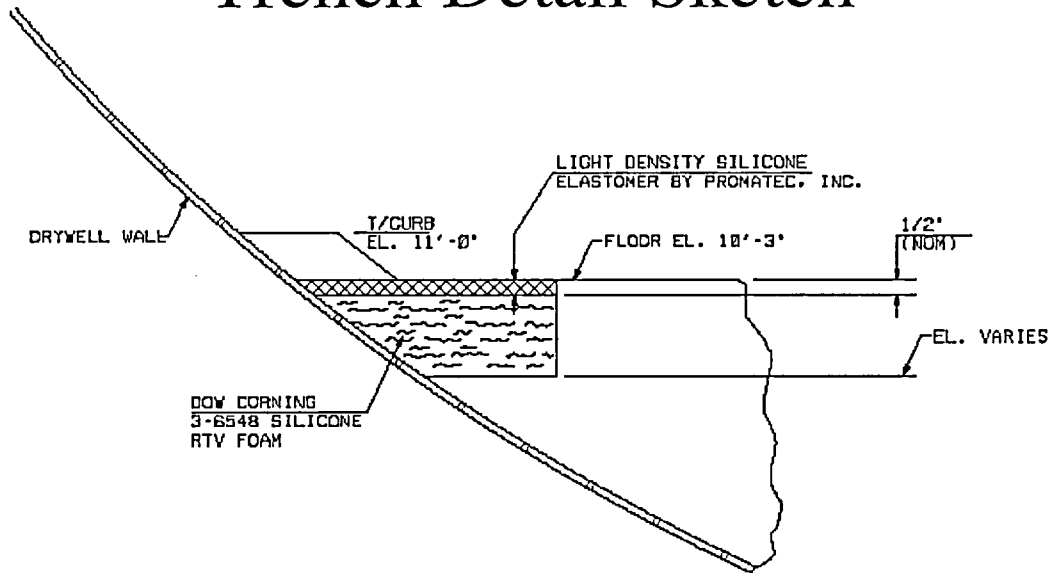
Trench Detail Sketch

CROSS-SECTION AREA
OF TRENCHES IN BAYS 5 & 17

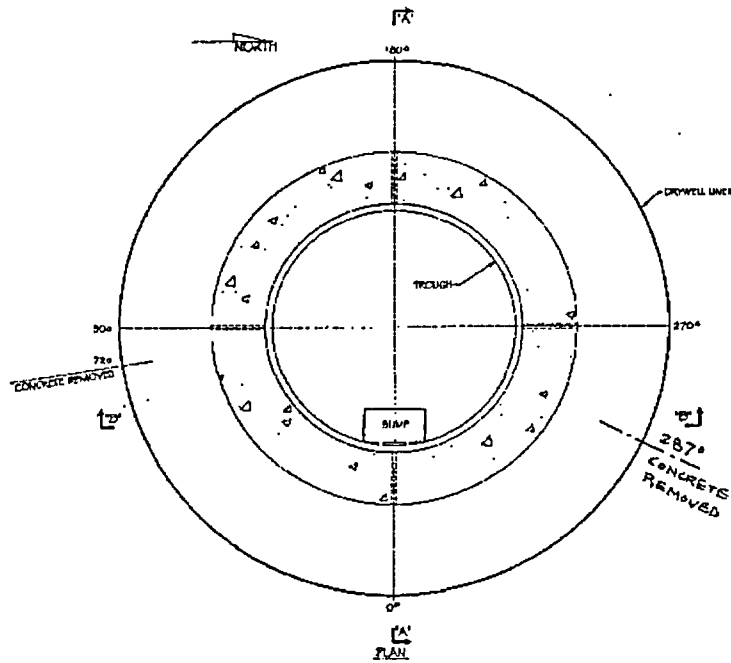
Top View – Drywell Floor Sketch

- Surface of drywell shell visible from trenches in Bays 5 and 17 exhibited a surface layer of iron oxide
- Approximately 5" of water found in bottom of trench in Bay # 5, and trench in Bay 17 had only dampness
- Connection between under-vessel area trough and floor drain sump potentially allowing water leakage
- Trough located in the under-vessel area is not lined, potentially allowing water passage into the concrete slab

- Visual Examination (VT-1) of floor drain sump liner to look for evidence of a leak path
- Tracer test aimed at determining whether under-vessel trough is in communication with trench in Bay 5
- Development of contingency repair to trough to address likely water source into trench
- Complete non destructive examination and analysis of Drywell shell in trench areas
- Perform evaluation of the impact of water that may exist beneath concrete surface on drywell shell
- Development of contingency repair to caulk intersection of Drywell Shell and concrete slab curb
