IR 546049 Assignment 02

Engineering Response

Evaluate the current acceptability of the Oyster Creek drywell shell below elevation 10'-3" considering the standing water found in the Bay #5 inspection trench and the moisture identified in the Bay #17 inspection trenches. This evaluation will demonstrate that adequate margin exists in the drywell shell to support plant start-up through the next plant operating cycle. Additionally, the as-found conditions will be demonstrated to not adversely impact current design or licensing bases requirements. The inspection trenches are located inside the drywell.

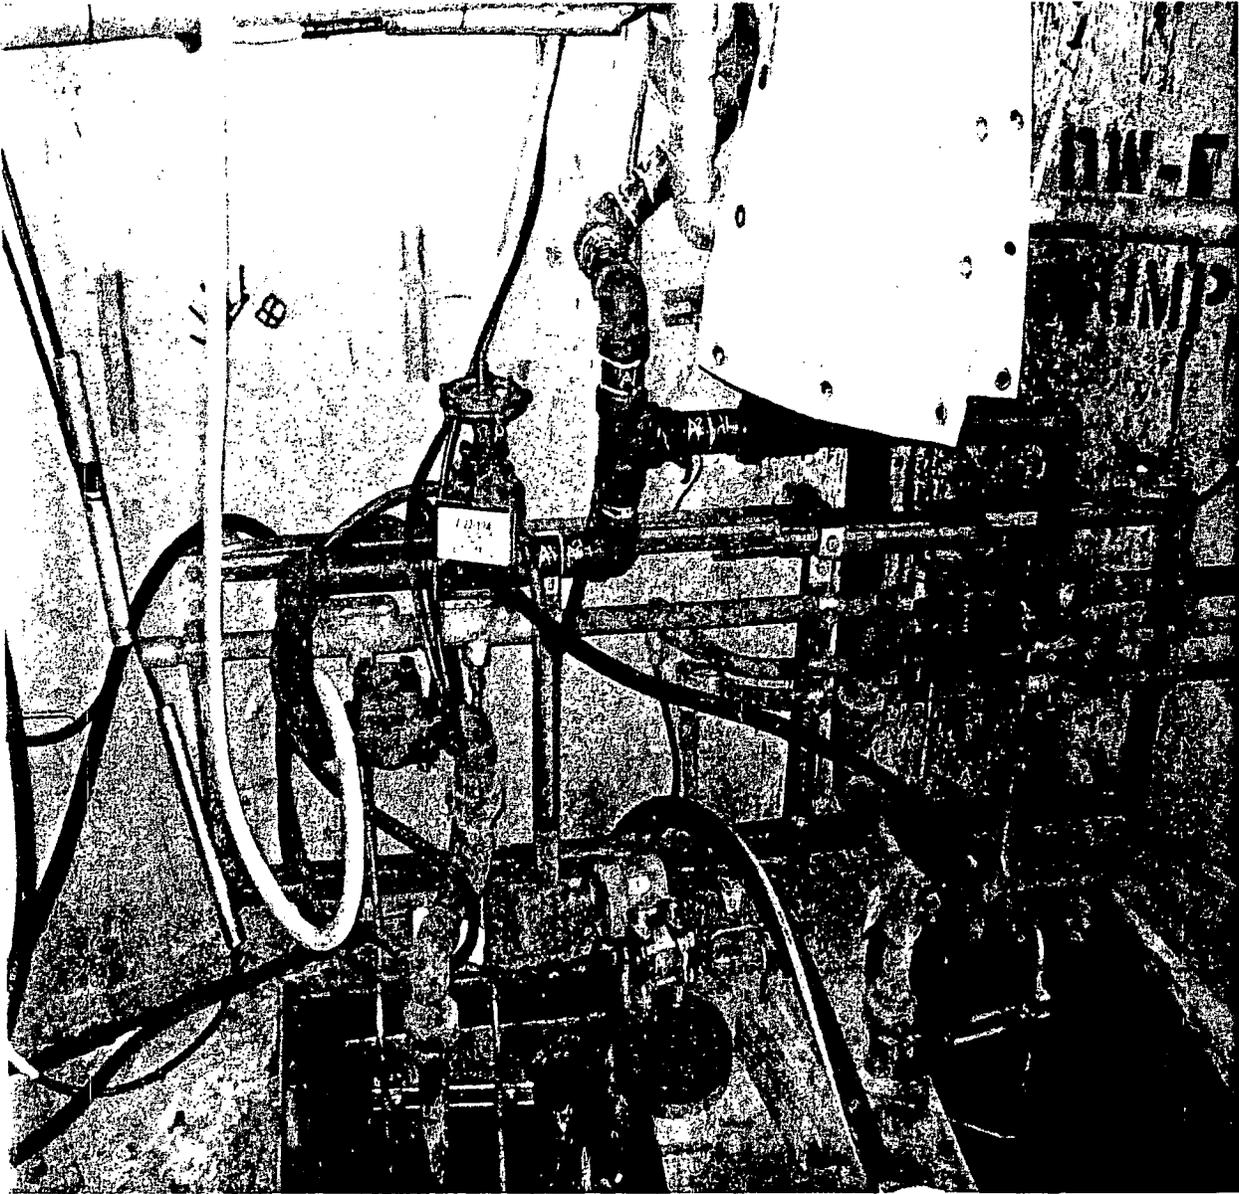
Sheet 11 of 11

A visual inspection was performed on the drywell sump 1-8. the inspection was performed to confirm the stainless steel sump liner remains structurally adequate and leak tight. The inspection looked for pitting, corrosion, cracks, and other defects. The visual inspection confirmed the liner remains structurally adequate and leak tight. The inspection results are included in attachment 7.7.

1-8 Sump appears in good condition.
