Subject: 2006 Annual Site Inspection and Monitoring Compliance Report for UMTRCA Title II Disposal Sites

# 2006 Annual Site Inspection and Monitoring Report for Uranium Mill Tailings Radiation Control Act Title II Disposal Sites

November 2006

Work Performed by S.M. Stoller Corporation under DOE Contract No. DE-AC01-02GJ79491  
for the U.S. Department of Energy Office of Legacy Management, Grand Junction, Colorado

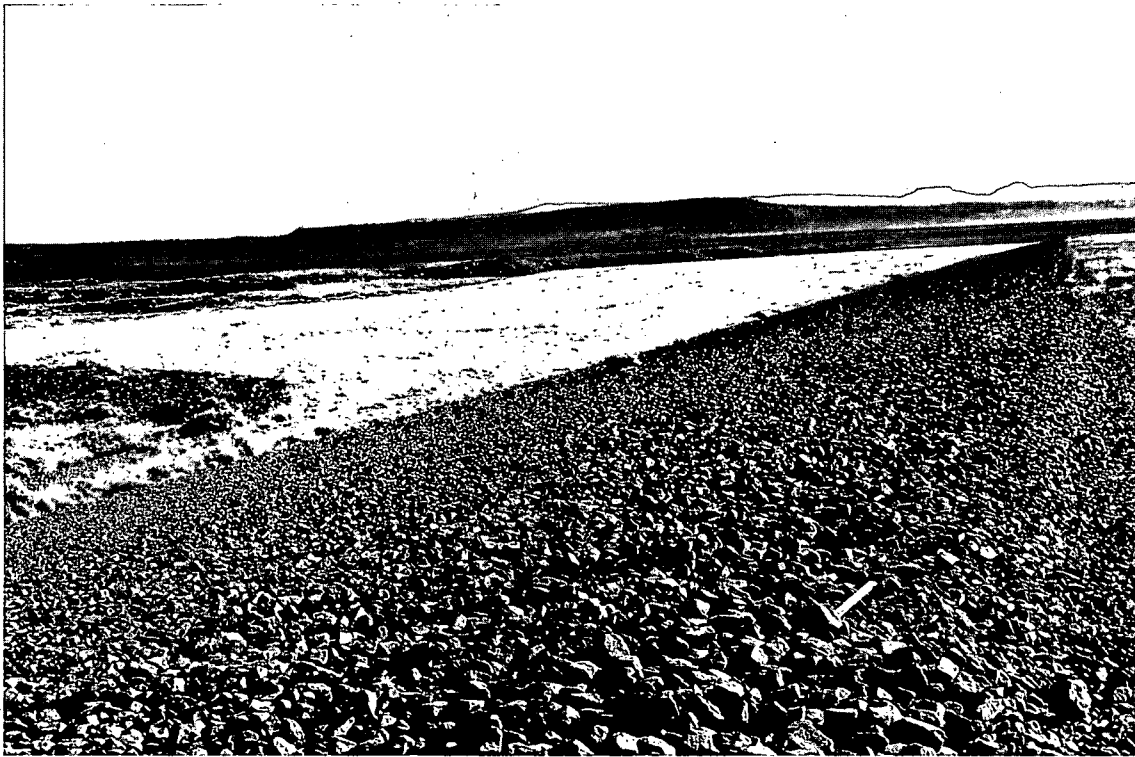
*BLU 8/2006. PL-1. Grass-covered acid tailings disposal cell; northwest side slope of the main tailings disposal cell is in the foreground.*

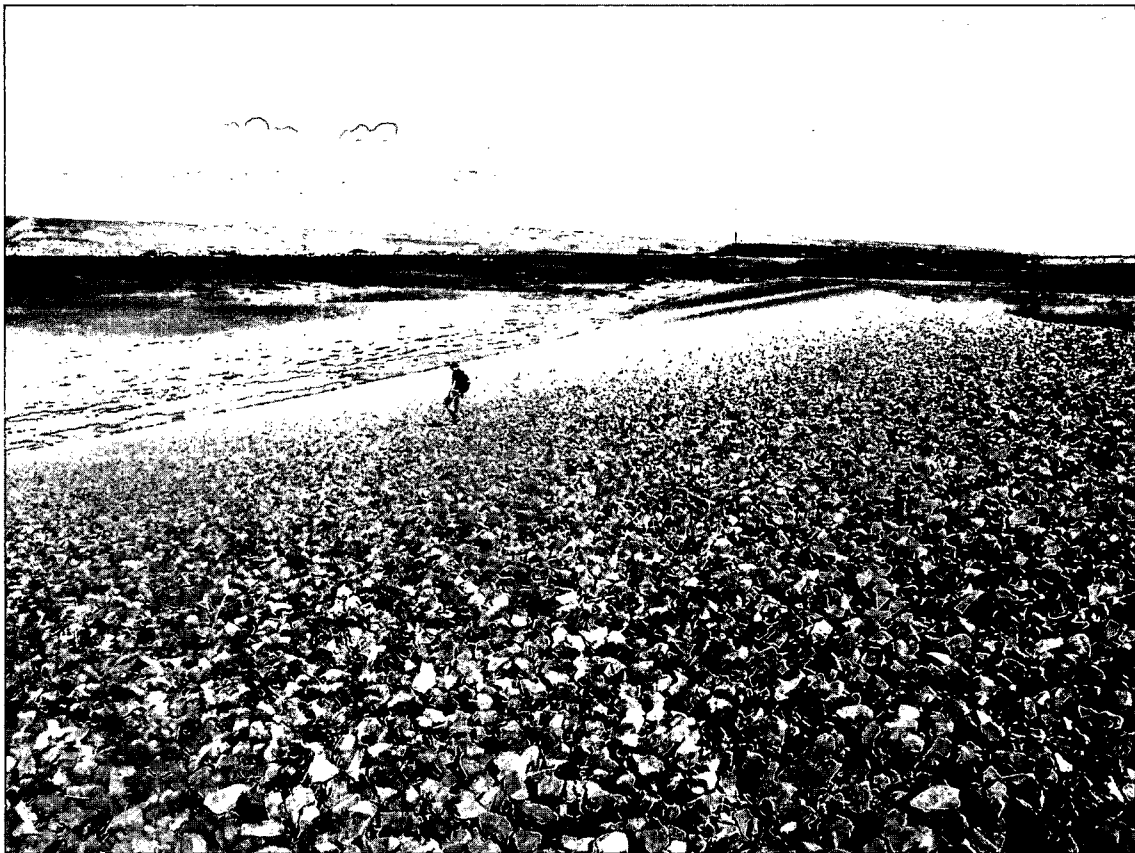
**Main Tailings Disposal Cell, the Acid Tailings Disposal Area, and the South Bench Disposal Area**—These three disposal areas are contiguous and together constitute one large disposal area of approximately 320 acres; all were in excellent condition. The main tailings disposal cell is covered with basalt riprap and slopes northward. The top slope grade decreases from 3 to 4 percent at the south end to less than 0.5 percent at the north end. The top slopes of the acid tailings (PL-1) and the south bench disposal areas are essentially flat and covered by healthy grass. The side slopes of the three disposal areas are protected by basalt riprap (PL-2). The riprap was in excellent condition.

*BLU 8/2006. PL-2 Southwest side slope of the main tailings disposal cell.*

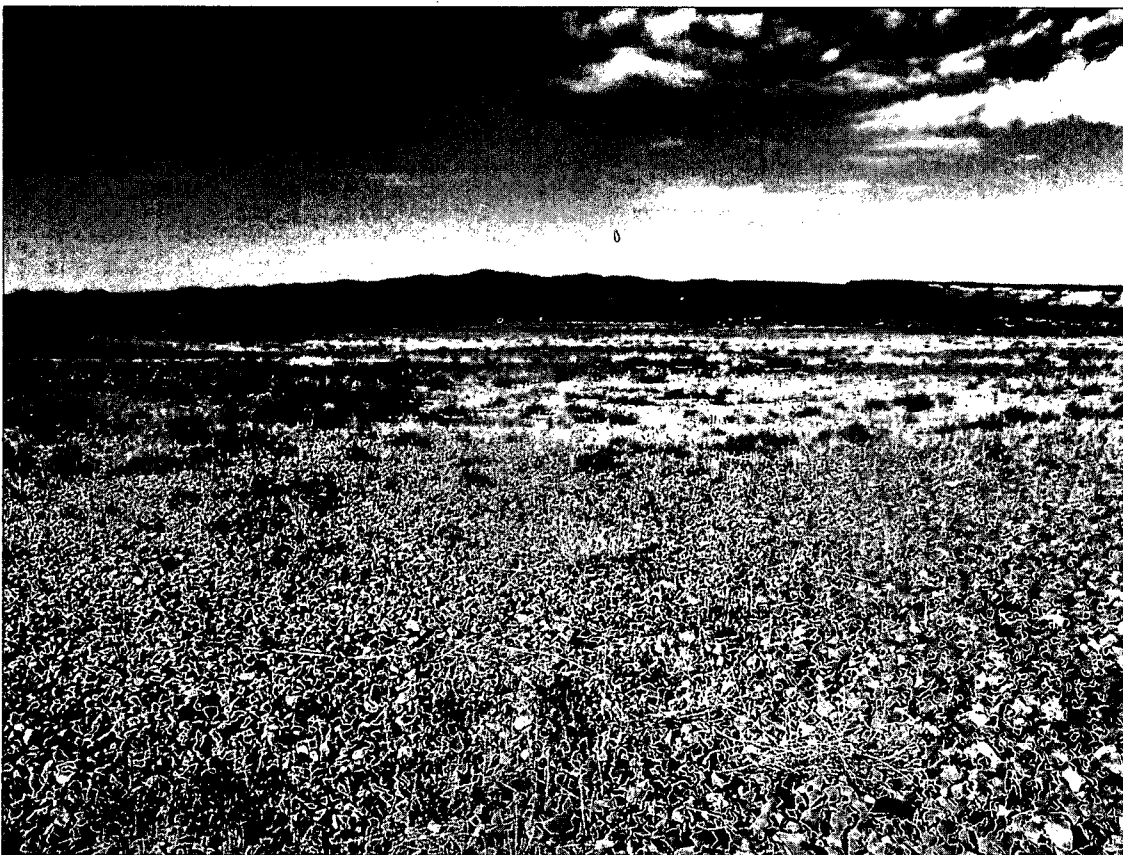
Several small shallow depressions exist on the relatively flat north end of the top slope of the main tailings disposal cell. Although ponded water has been observed in the past, the depressions were dry at the time of the inspection. Slimes from the settling ponds were placed in the northern part of the main tailings disposal cell and areas containing slimes are more likely to settle than areas containing drier waste materials. One depression appeared to be deeper than observed during the 2005 inspection (PL-4). The depressions will continue to be monitored for evidence of significant settling or displacement. Given that evaporation greatly exceeds precipitation in this area, ponding is believed to be infrequent and brief and, therefore, is not a concern.

*BLU 8/2006. PL-4. Dry depression near the north edge of the main tailings disposal cell cover.*

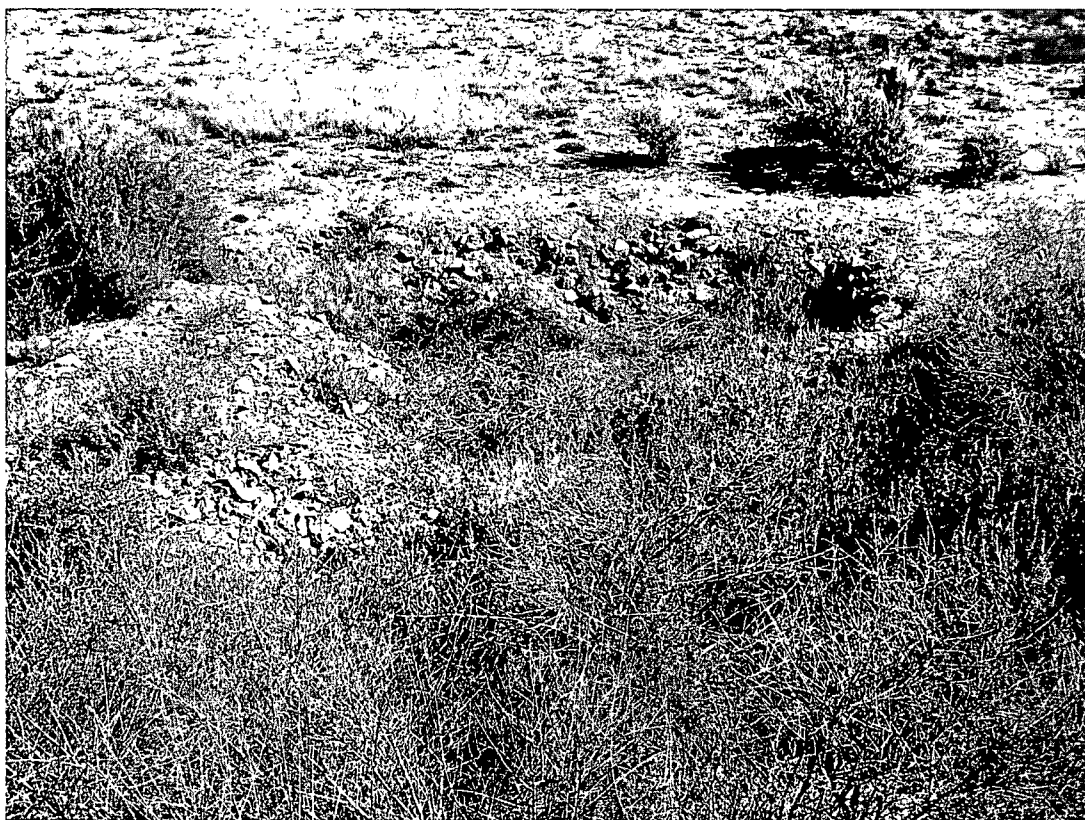
1C The asbestos disposal area is a bowl-like feature or depression just south of the carbonate pile. The north, west, and south side slopes of this depression are covered by limestone riprap; the bottom of the bowl is grass covered. A small depression is located along the south edge of the disposal area, and could represent piping or collapse of uncontaminated fill material incompletely compacted during final grading (PL-6). The depression was first noted during the 1999 annual inspection but has not been a concern because it does not encroach on asbestos-containing materials. However, to mitigate the potential for encroachment into these materials, the depression is scheduled to be filled with crushed basalt rock in 2007. Potential access routes to haul crushed rock to the disposal area were investigated. Other than the depression, the disposal area is in excellent condition.

*BLU 8/2006. PL-6. Depression in the asbestos disposal area.*

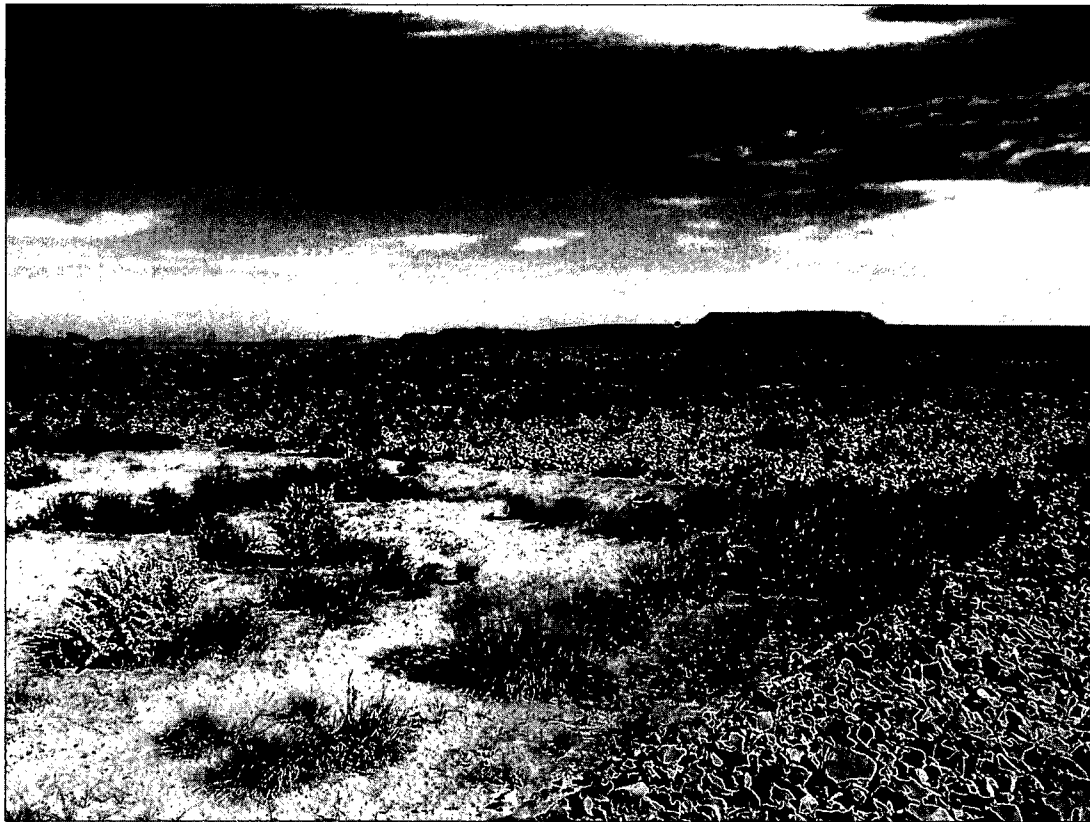
The small riprap-covered PCB disposal area is in excellent condition (PL-7). The two grass-covered landfill areas east of the carbonate tailings disposal cell also are in excellent condition. Two other disposal areas, Disposal Area Number 1 and the Stockpile Area, are south of the carbonate tailings disposal cell. Both are grass-covered and in excellent condition.

*BLU 8/2006. PL-7. Basalt cover of the PCB disposal area.*

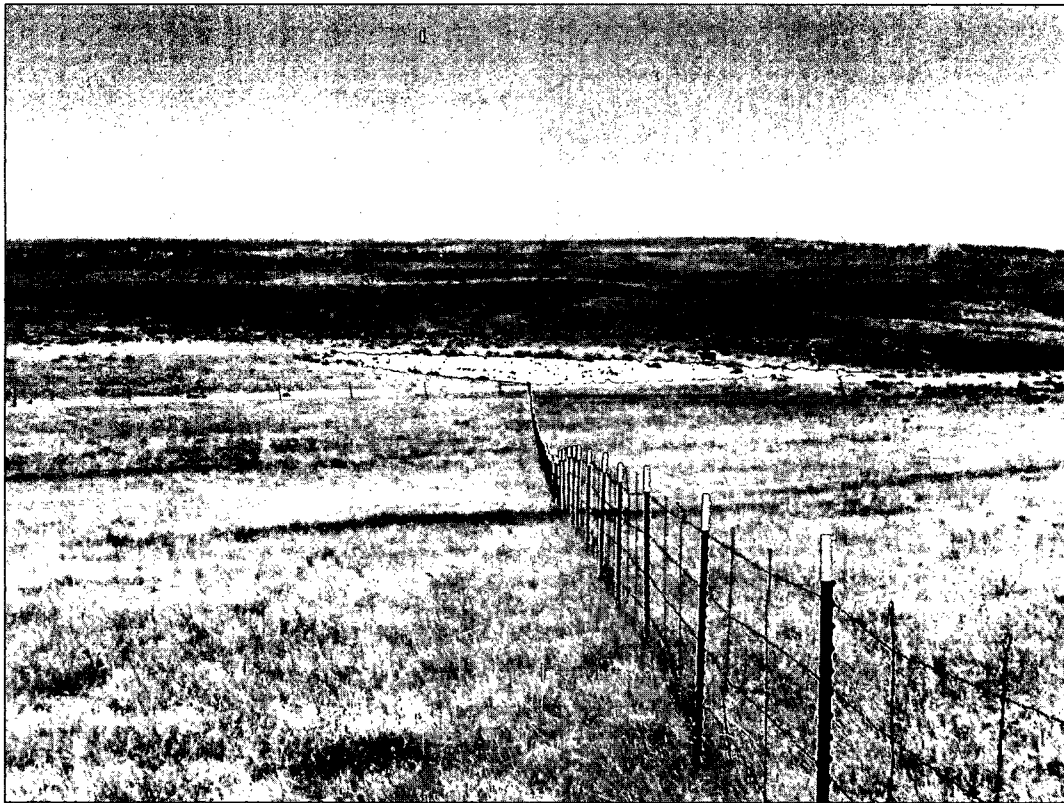
A four-strand barbed wire fence was installed in spring 1999 along the site perimeter boundary to demarcate DOE property and to control grazing on the property. The fence is truncated at the southeast corner to allow livestock access to a pre-existing stock pond. Except for a short portion along the east boundary, where cattle were present, inspectors walked the site perimeter to assess the integrity of the fence. The fence was in excellent condition (PL-1).

*EDG 6/2006. PL-1. Perimeter fence and riprap-armored drainage area near the northwest corner of the site.*

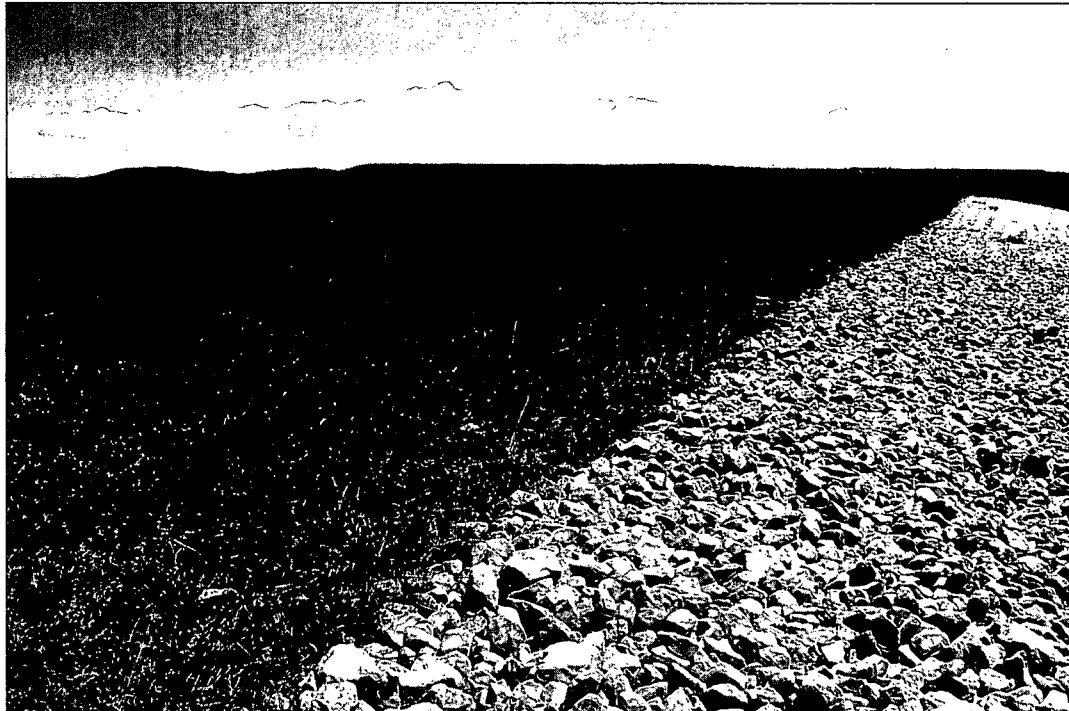
**Top of the Disposal Cell**—The 100-acre top of the disposal cell, completed in 1989, is grass-covered and was in excellent condition (PL-2). DOE manages the grass cover through controlled grazing. The grass is well established and was not over-grazed when inspected. Numerous cattle trails are present on the cell top, but there were no indications of erosion, settlement, or other modifying processes that might affect the integrity of the cell.

*EDG 6/2006. PL-2. Contact between the grass-covered disposal cell top and the riprap-armored tailings embankment.*

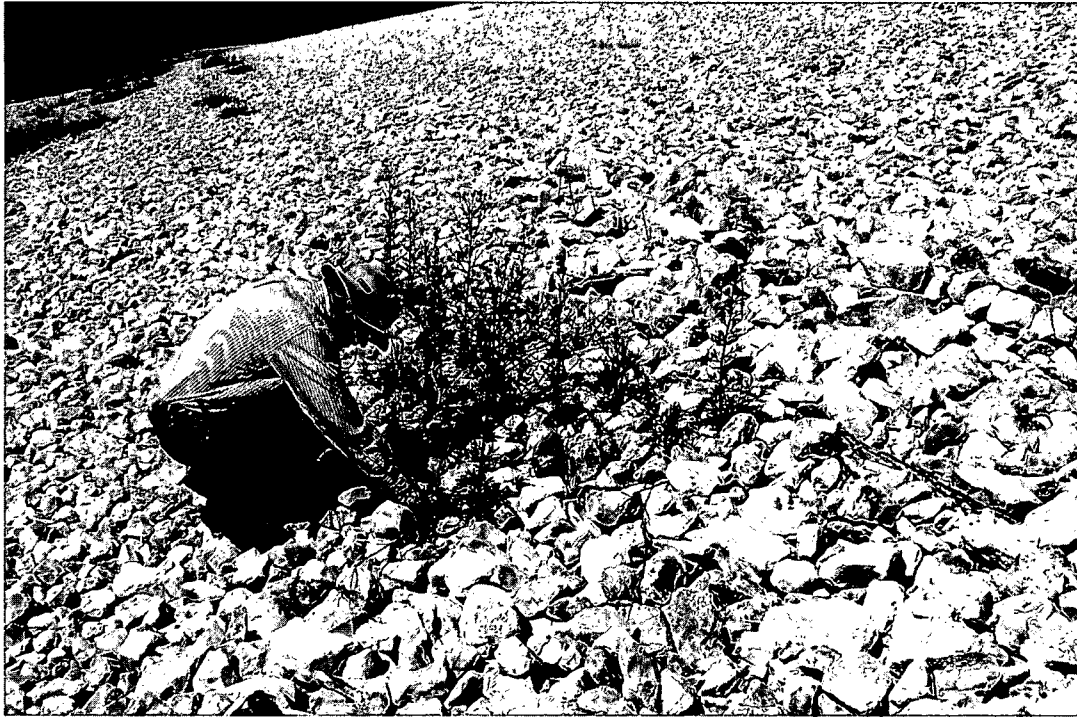
2A DOE has retained the Fall River County weed control agent to spray Canada thistle, a noxious weed persisting on the site, since 1998. The thistle usually has been found growing on and along the edges of the riprap-armored surfaces. Although only one small patch of Canada thistle was found and subsequently sprayed in 2005, numerous patches were present at the time of the 2006 inspection (PL-5). These patches subsequently were sprayed with herbicide by the county.

*EDG 6/2006. PL-5. Patch of Canada thistle on the tailings embankment.*

Noxious weeds were sprayed with herbicide in 2006. No other maintenance or repairs were required.

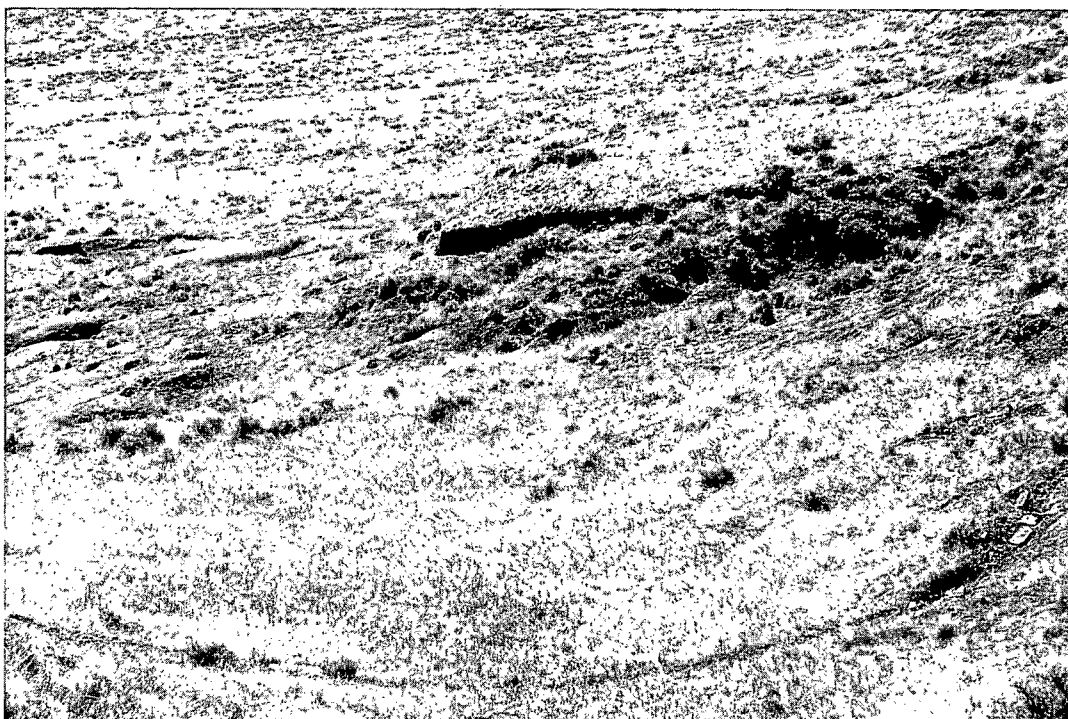
**Region Between the Disposal Cell and the Site Perimeter**—The area between the disposal cell and the site perimeter is grass-covered and in excellent condition. This region also is grazed in a controlled manner, and cattle were present on the site the day of the inspection (PL-6). The grass is well established but minor erosion persists on undisturbed steeper portions of the site east of a natural ridge that separates the east portion of the site from the area containing the cell (PL-7). This erosion does not threaten the integrity of the stabilized tailings.

*EDG 6/2006. PL-7. Minor natural erosion occurring in an undisturbed area in the southeast portion of the site.*

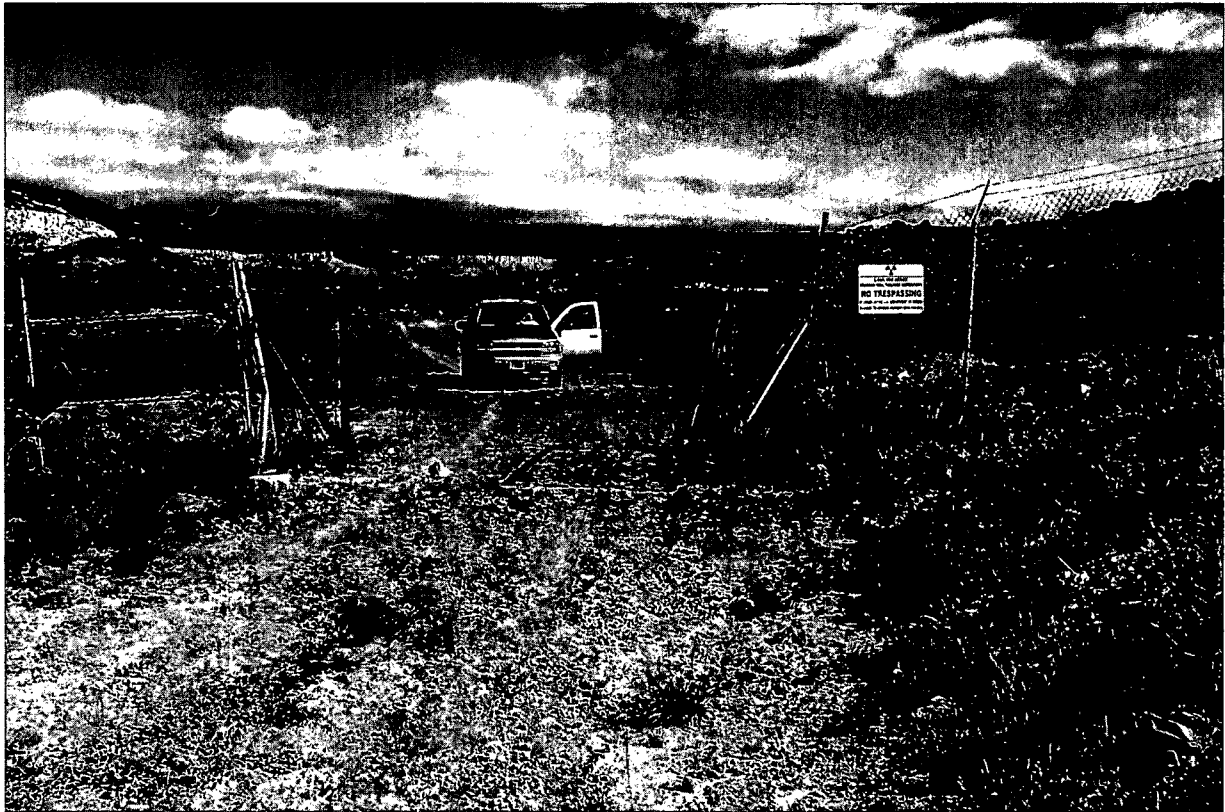
*BAR 8/2006. PL-1. Damaged chain-link fence gate located in the southeast corner of the site.*

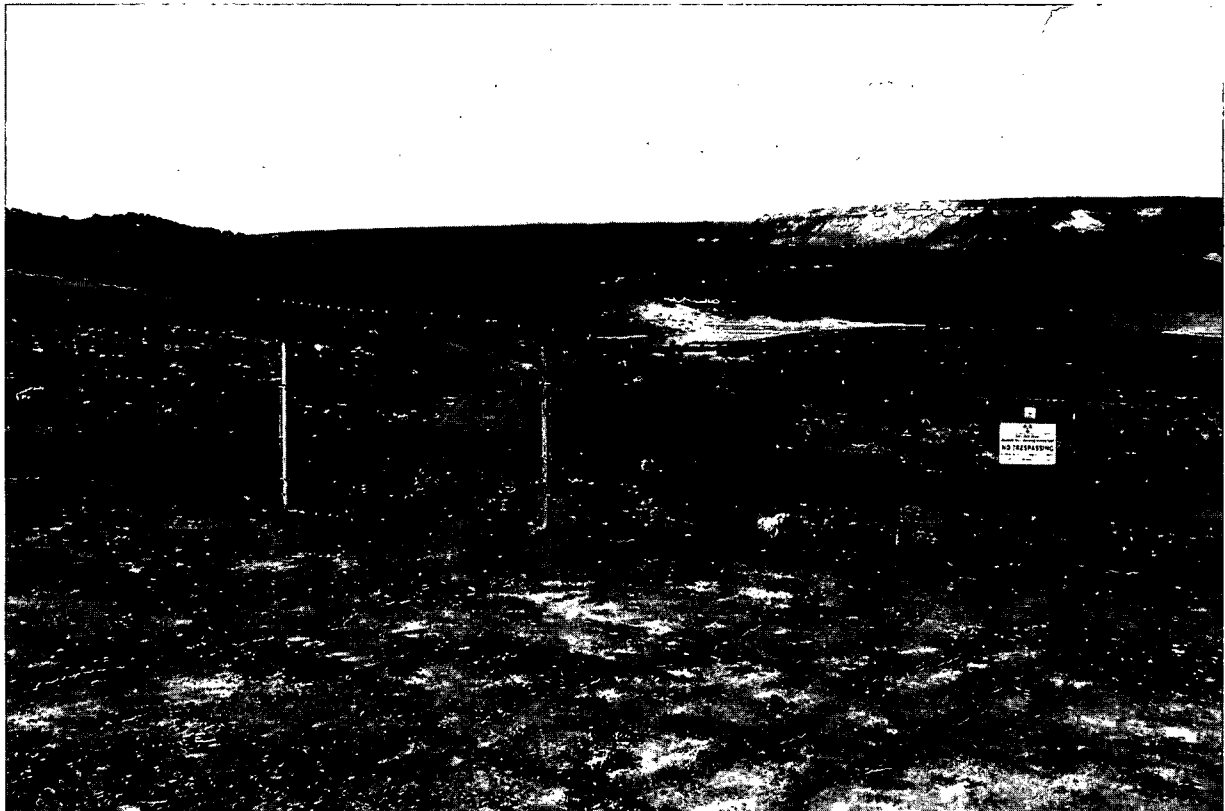
*BAR 8/2006. PL-2. Missing chain-link fence gate located on the east side of the site.*

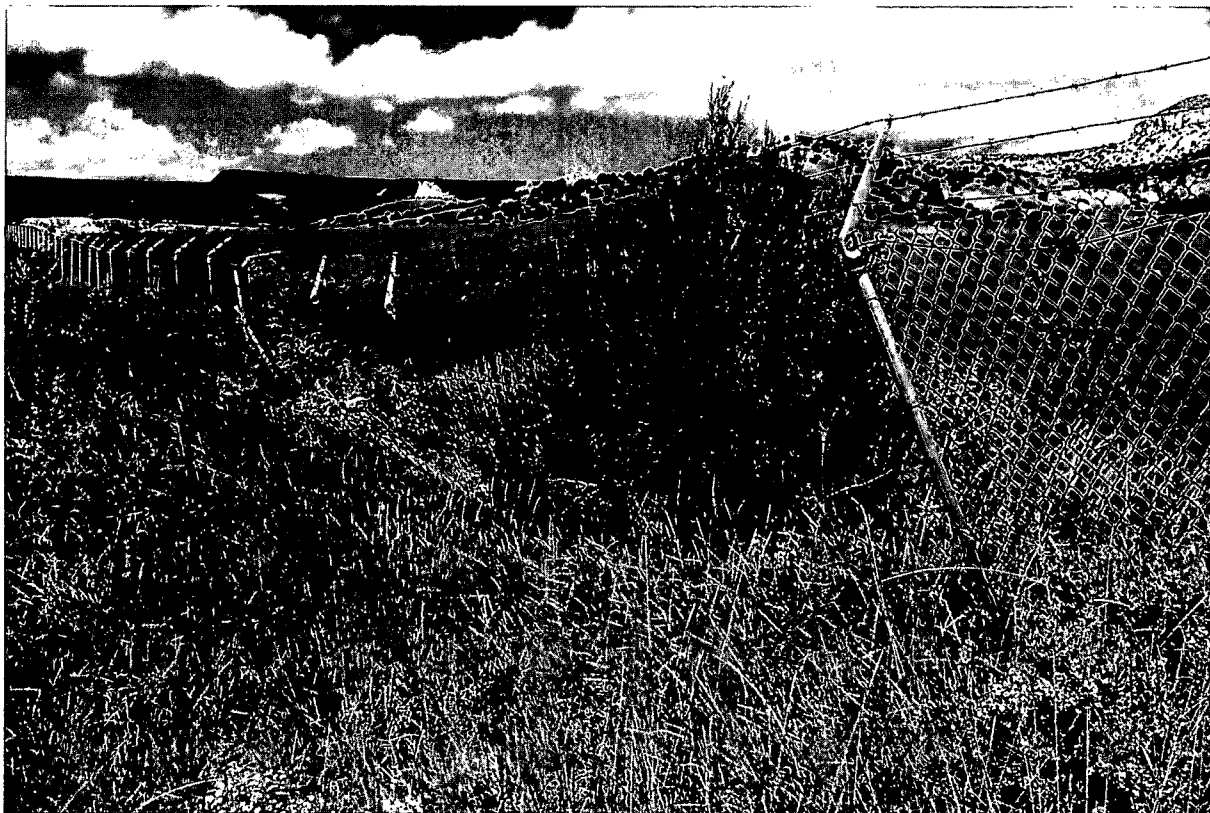
*BAR 8/2006. PL-3. Runoff-damaged section of chain-link fence east of the site access gate.*

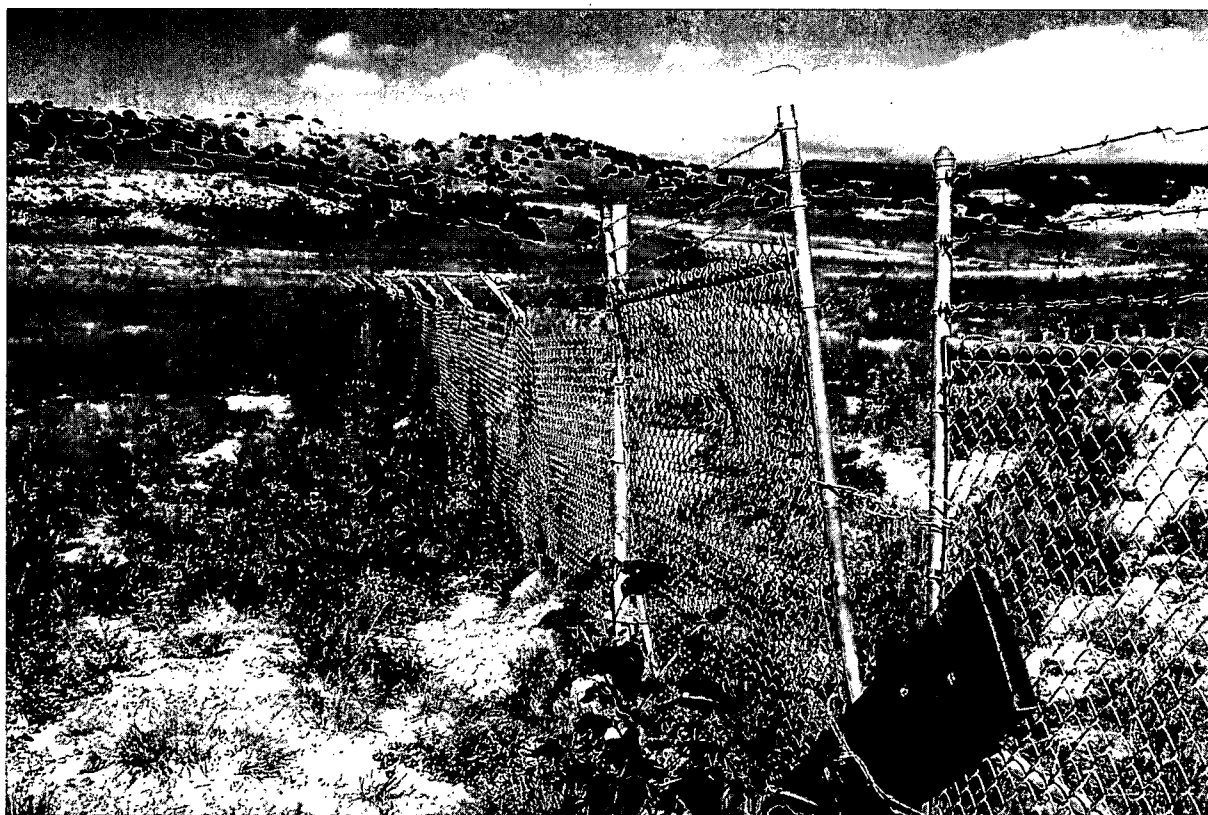
*BAR 8/2006. PL-4. Poor condition of the chain-link fence in the southeast corner of the site.*

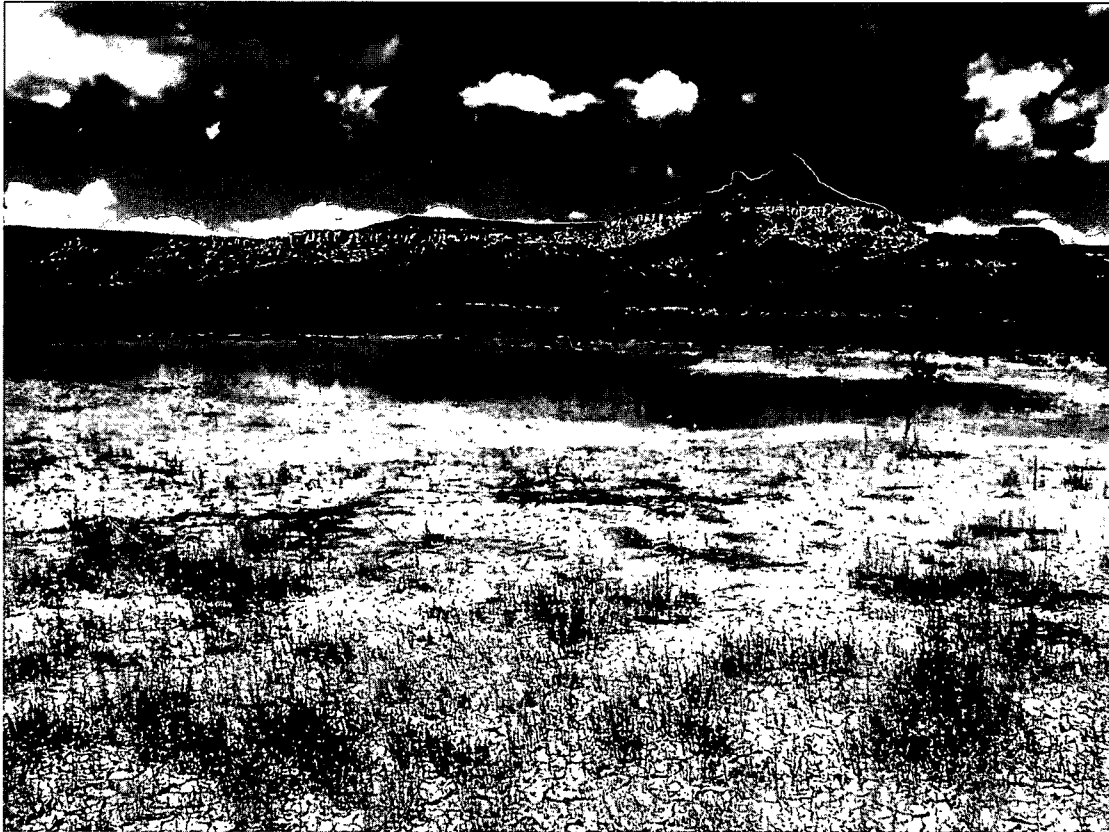
*BAR 8/2006. PL-5. Standing water in a shallow windblown depression on the impoundment cover.*

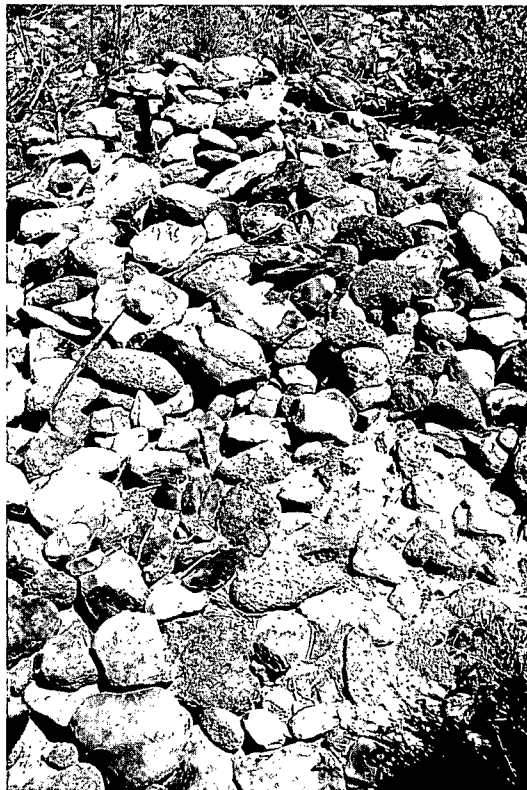
*BAR 8/2006. PL-6. Contaminated drain outlet #2 at the base of the containment dam.*

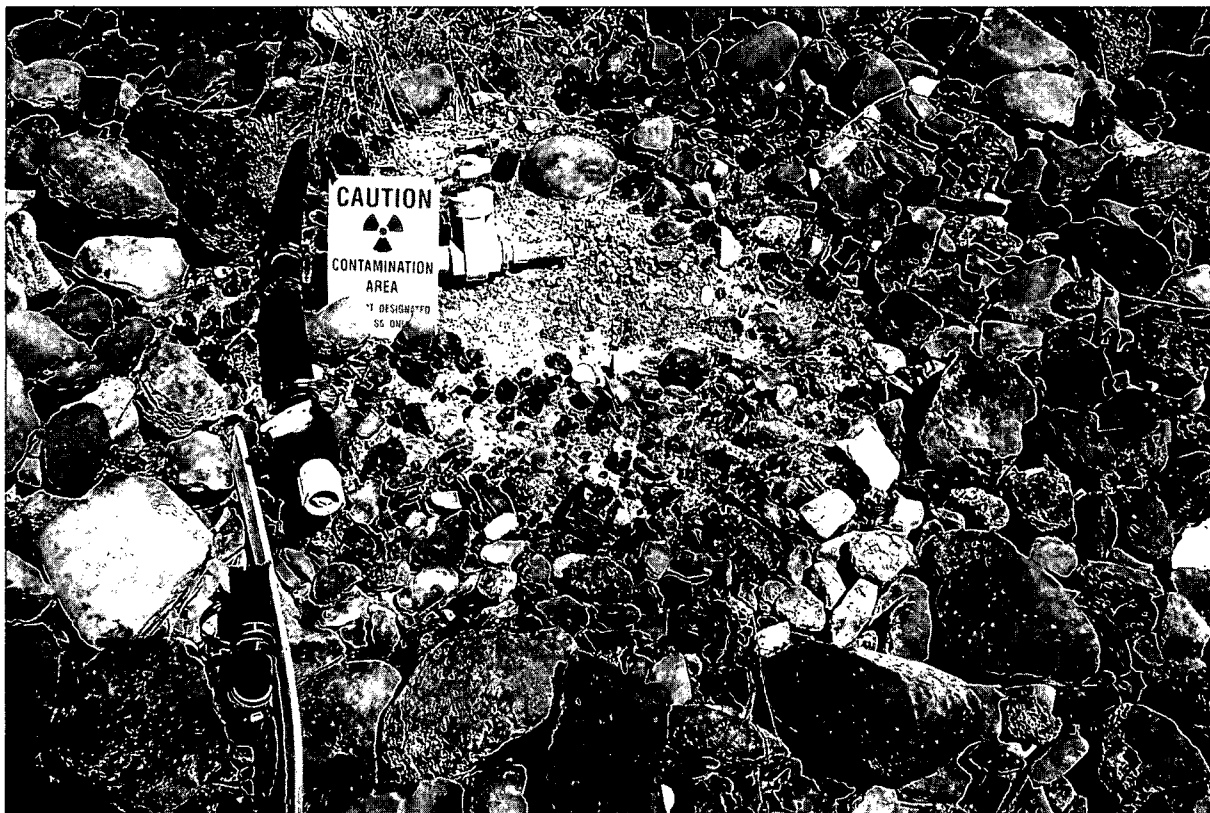
*BAR 8/2006. PL-7. Contaminated drain outlet #4 at the base of the containment dam.*

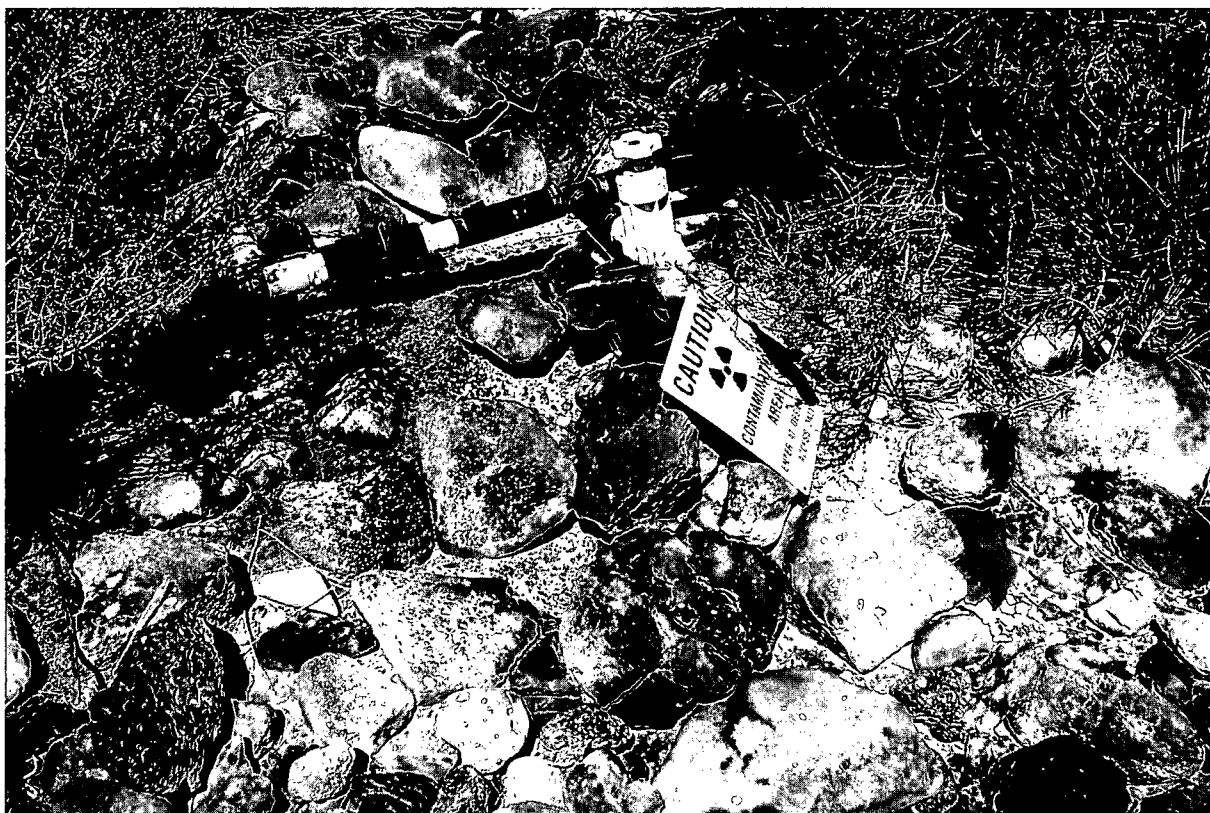
*BAR 8/2006. PL-8. Contaminated drain outlet #5 at the base of the containment dam.*

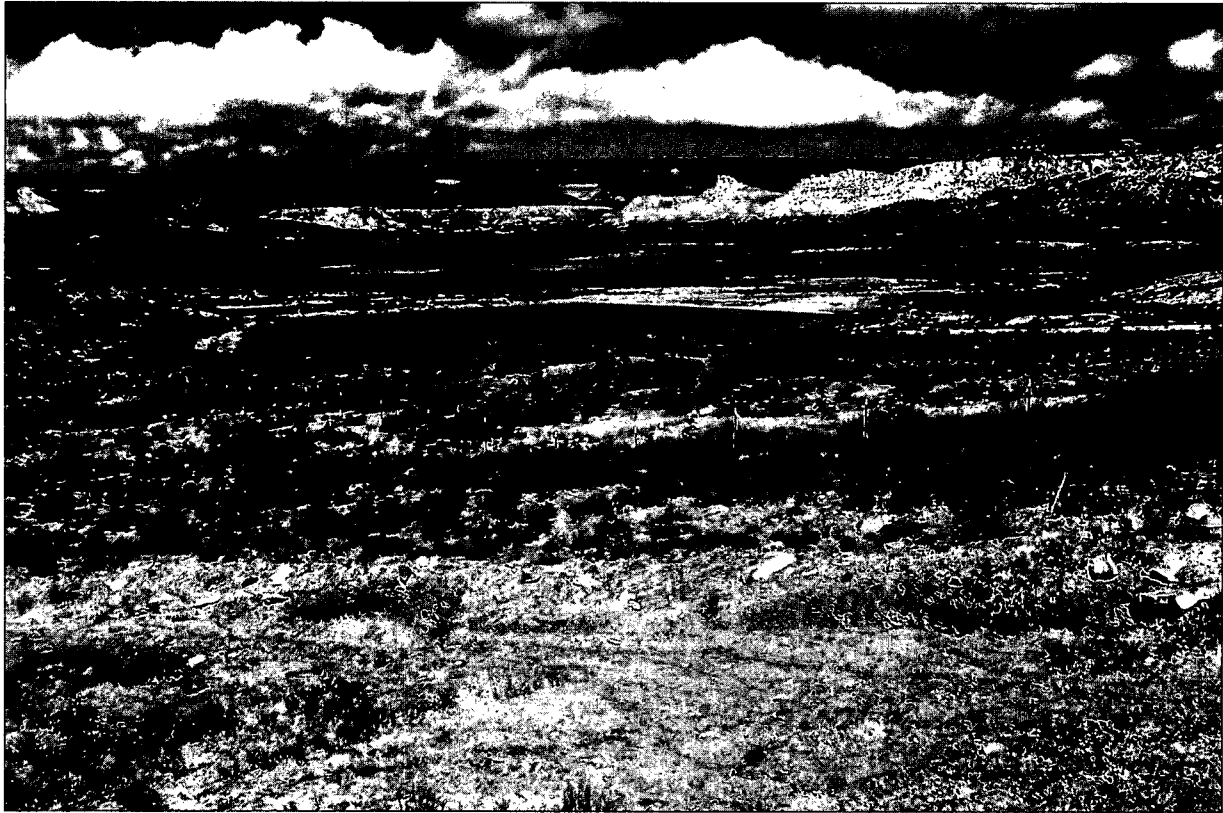
*BAR 8/2006. PL-9. Standing water in the Sediment Trap.*

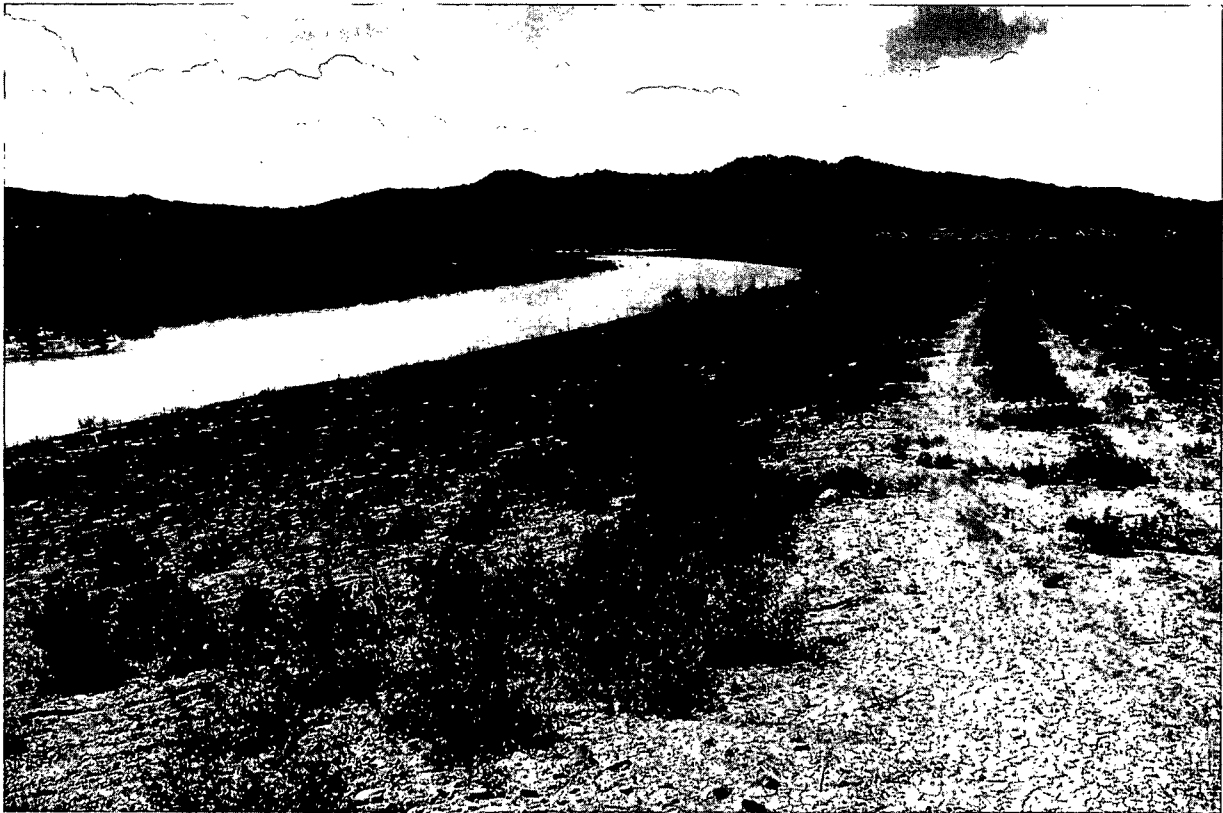
*BAR 8/2006. PL-10. Standing water in the East Channel.*

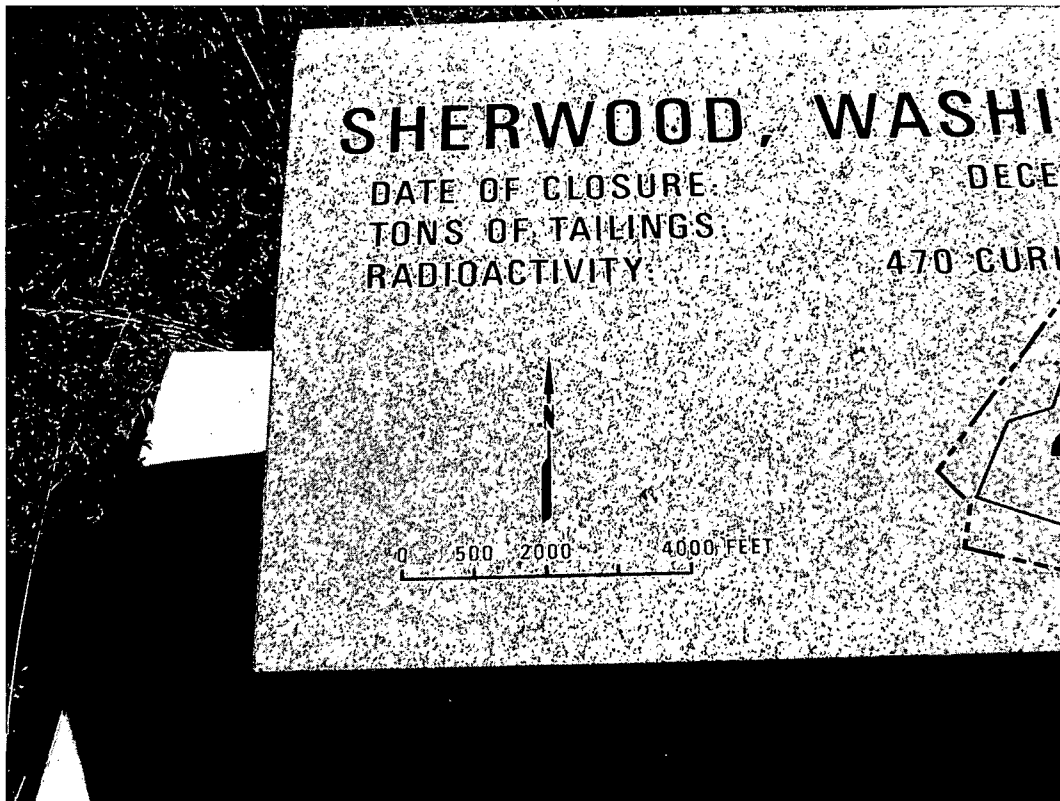
SHE 7/2006. PL-1. The site marker prior to repair of the scale.

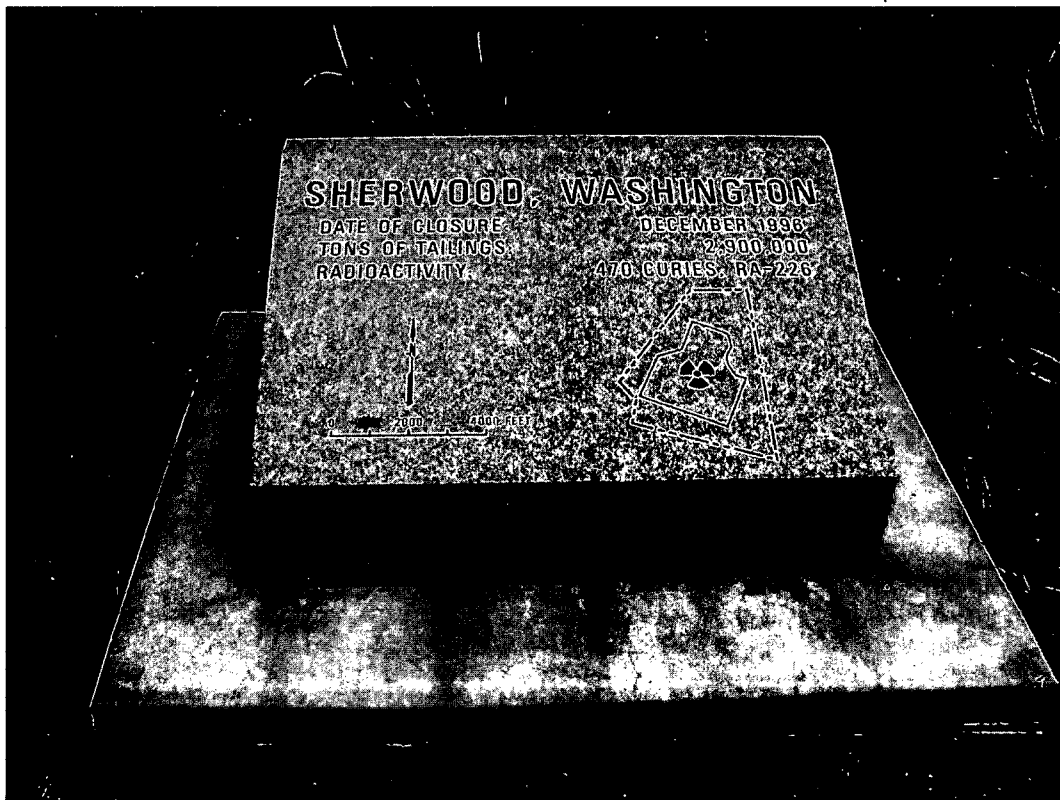
SHE 7/2006. PL-2. The site marker after repair of the scale.

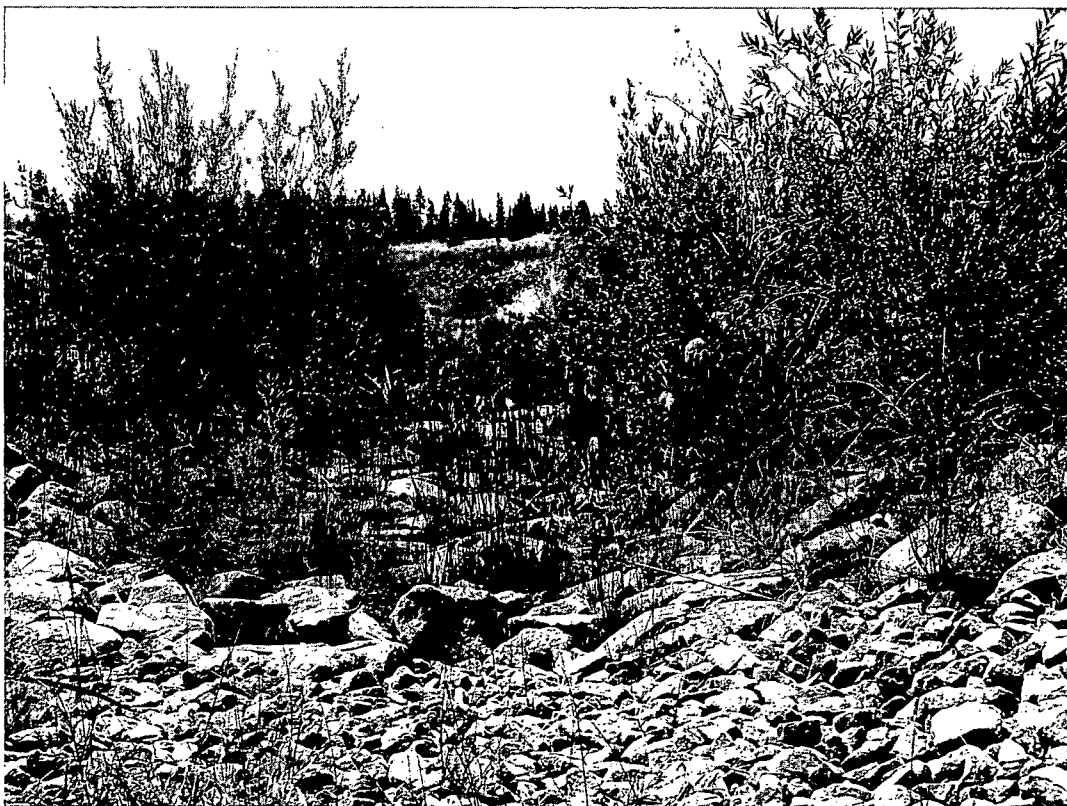
*SHE 7/2006. PL-4. Wetland vegetation in the diversion channel.*

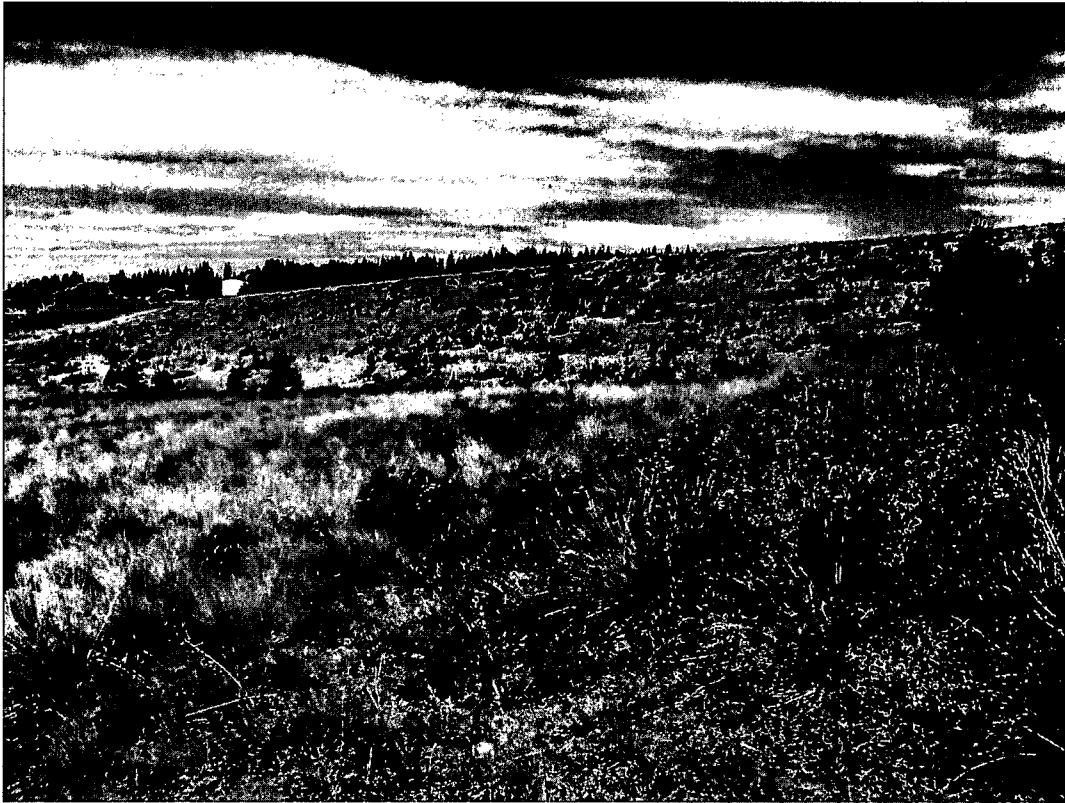
*SHE 7/2006. PL-5. Vegetation on the face of the tailings dam.*
