Attached is a collection of documents for the ACRS License Renewal Subcommittee meeting on January 18, 2007. The documents are associated with the Oyster Creek drywell.

SUBJECT: JERSEY CENTRAL POWER & LIGHT COMPANY  
DOCKET NO. 50-219

CO REPORT NO. 219/66-1

**OYSTER CREEK DRYWELL CORROSION**

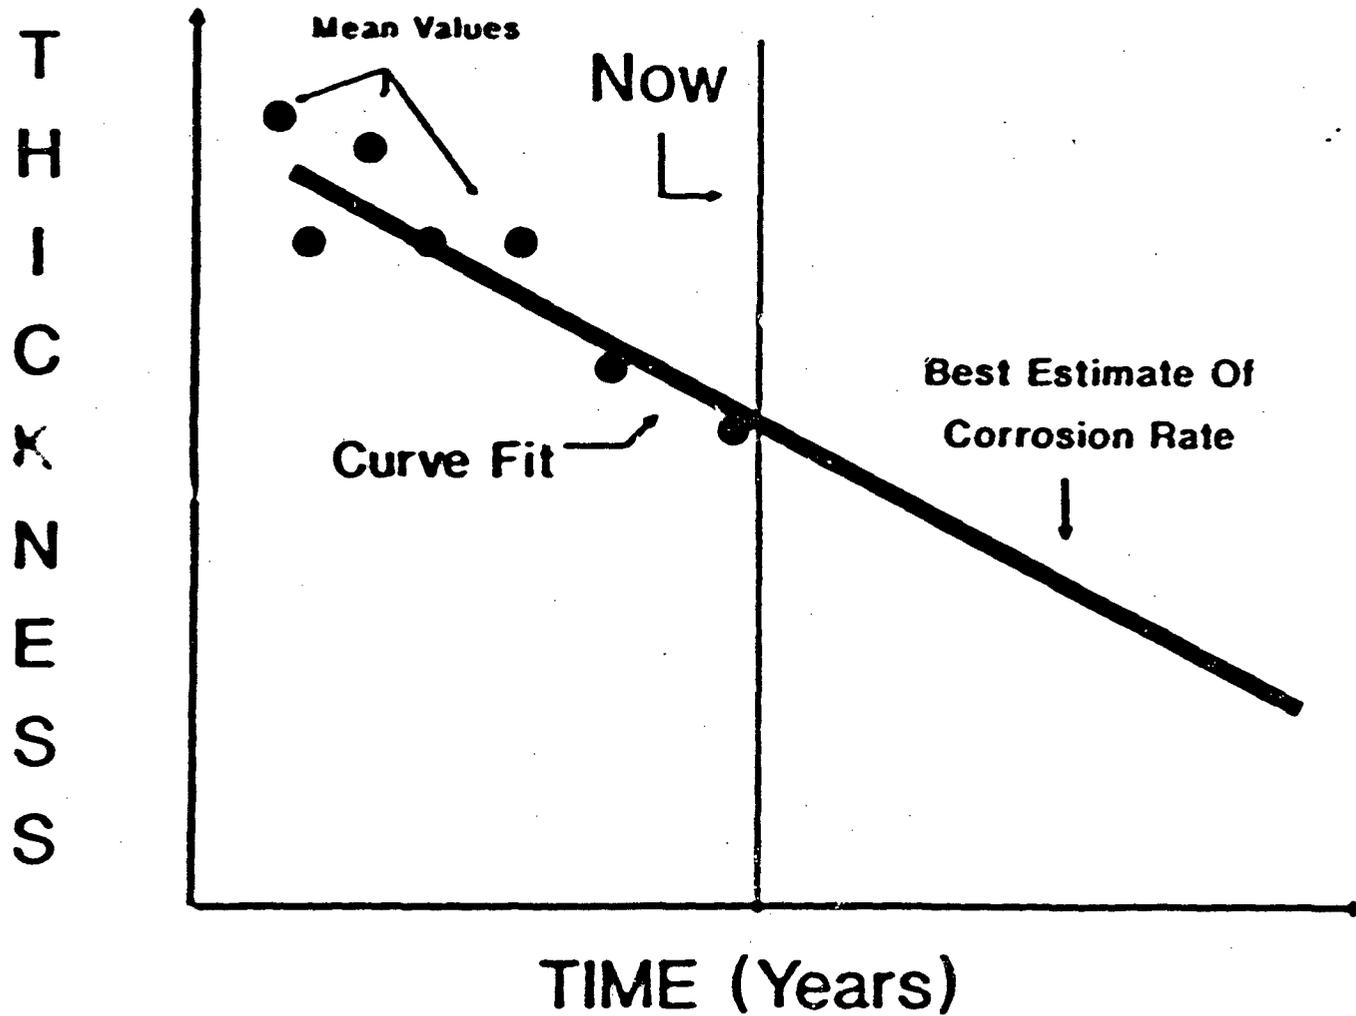
# Curve Fit Based On Linear Regression

- **Mean of 49 points**
- **Mean is plotted over time**
- **Linear regression model/curve fit?**
  - **Slope of curve - calculated corrosion rate**
- **Mean model/curve fit?**
  - **No slope - No corrosion rate**

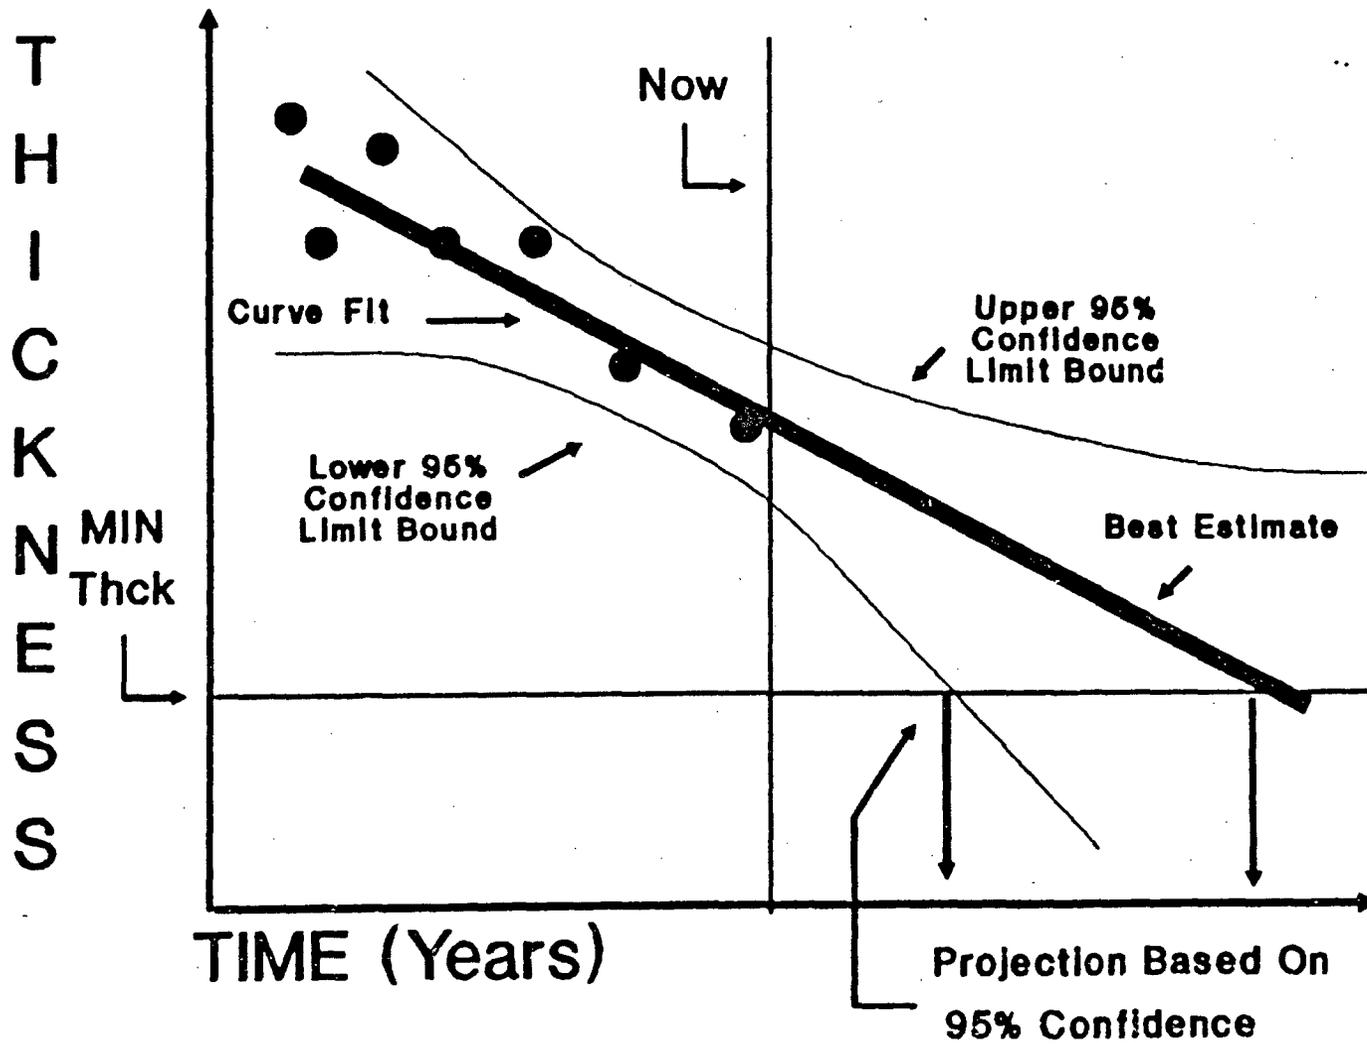
# Projections Based On Inverse Regression (SCHEMATIC)

- **Spherical region, elevation 50' - 2''**
  - **Bounding calculated corrosion rate =  $4.6 \pm 1.6$  MPY**
- **Sandbed region, elevation 11' - 3''**
  - **Bounding calculated corrosion rate =  $39.1 \pm 3.4$  MPY**
- **Sandbed, cathodically protected regions**
  - **No significant corrosion rate reduction (15 to 25 MPY)**
- **Cylindrical region elevation 87' - 5''**
  - **No observed ongoing corrosion**
- **Spherical region elevation 51' - 10''**
  - **Calculated corrosion rate not available**

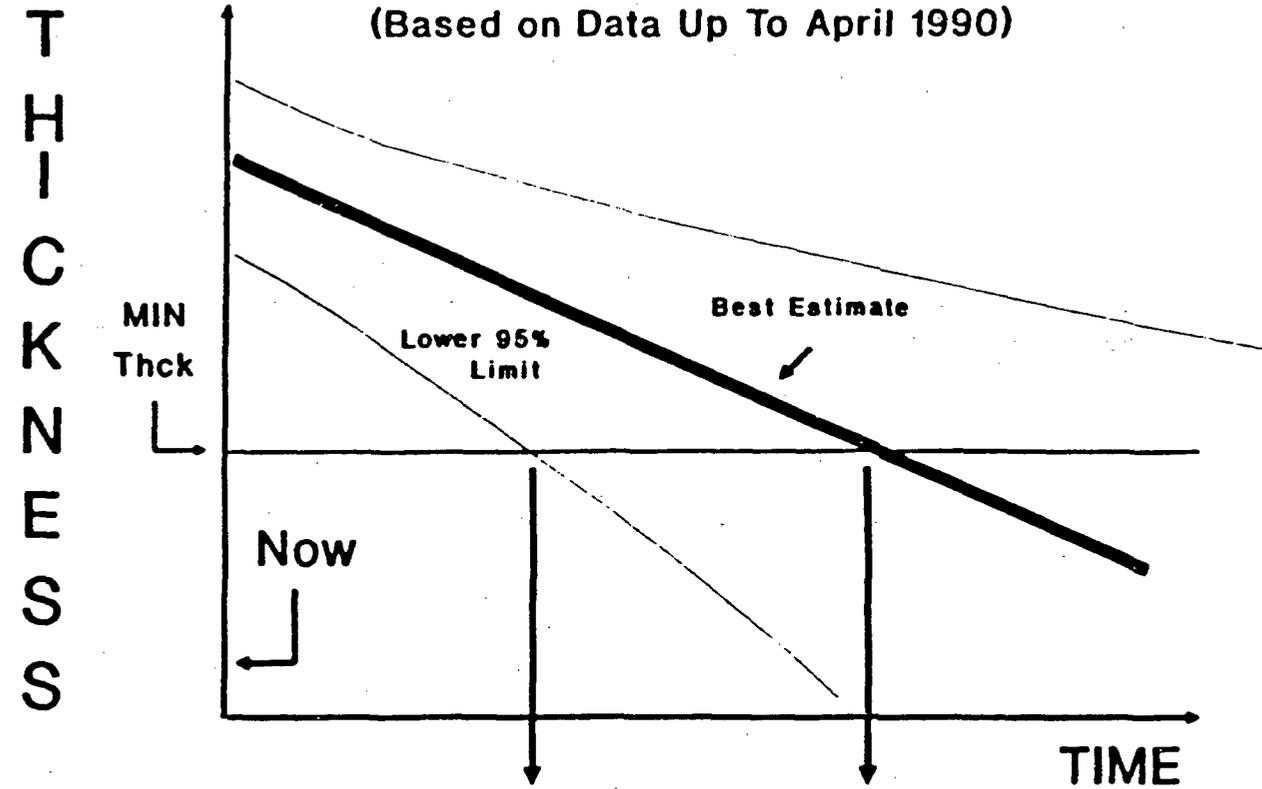
# Current Projections

Sandbed	Jul 1993	Mar 1994
Elev. 50'-2"	Jun 1992	Sep 1994
Elev. 51'-10"	Oct 1991 *	Jul 1993

\*NOTE: Projection Based on Elev. 50'-2" Corrosion Rate
