Oyster Creek License Renewal Project Drywell Monitoring Program

Information for ACRS Subcommittee

Subject: Response to NRC Request for Additional Information, dated March 10, 2006,
Related to Oyster Creek Generating Station License Renewal Application (TAC
No. MC7624)

Subject O.C. Drywell Ext. UT Evaluation in Sandbed		Calc No. C-1302-187-5320-024	Rev. No. 1	Sheet No. 21 of 114
Originator Mark Yekta	Date 01/12/93	Reviewed by S. C. Tumminelli		Date

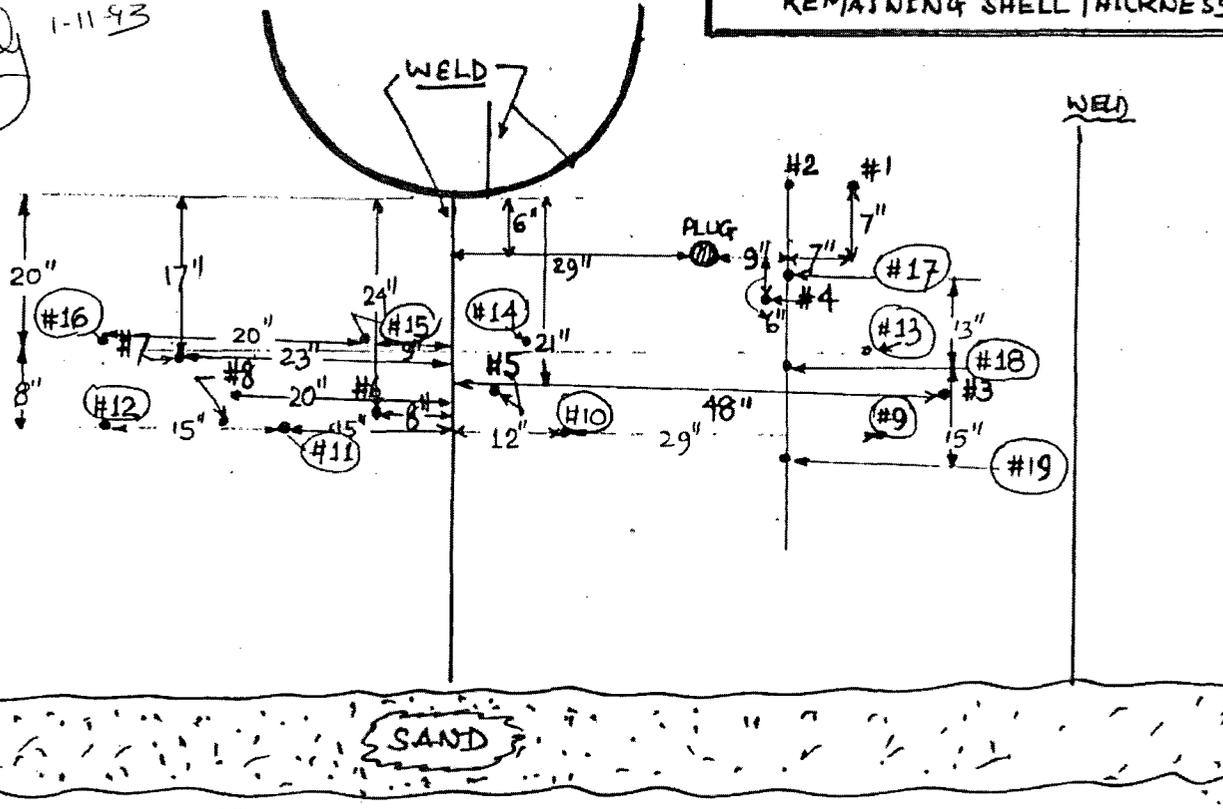
- PLUG UNCORRODED - LOCATED IN A DEEP VALLEY.
- "TUB RING" LESS PROMINENT.
- SHELL & FLOOR NEEDS MORE CLEANING.
