**Oyster Creek  
License Renewal Project  
Drywell Monitoring Program**

**Information for ACRS Subcommittee**

Subject: Response to NRC Request for Additional Information, dated March 10, 2006,  
Related to Oyster Creek Generating Station License Renewal Application (TAC  
No. MC7624)

TITLE: OC Drywell Ext. UT Evaluation in Sandbed

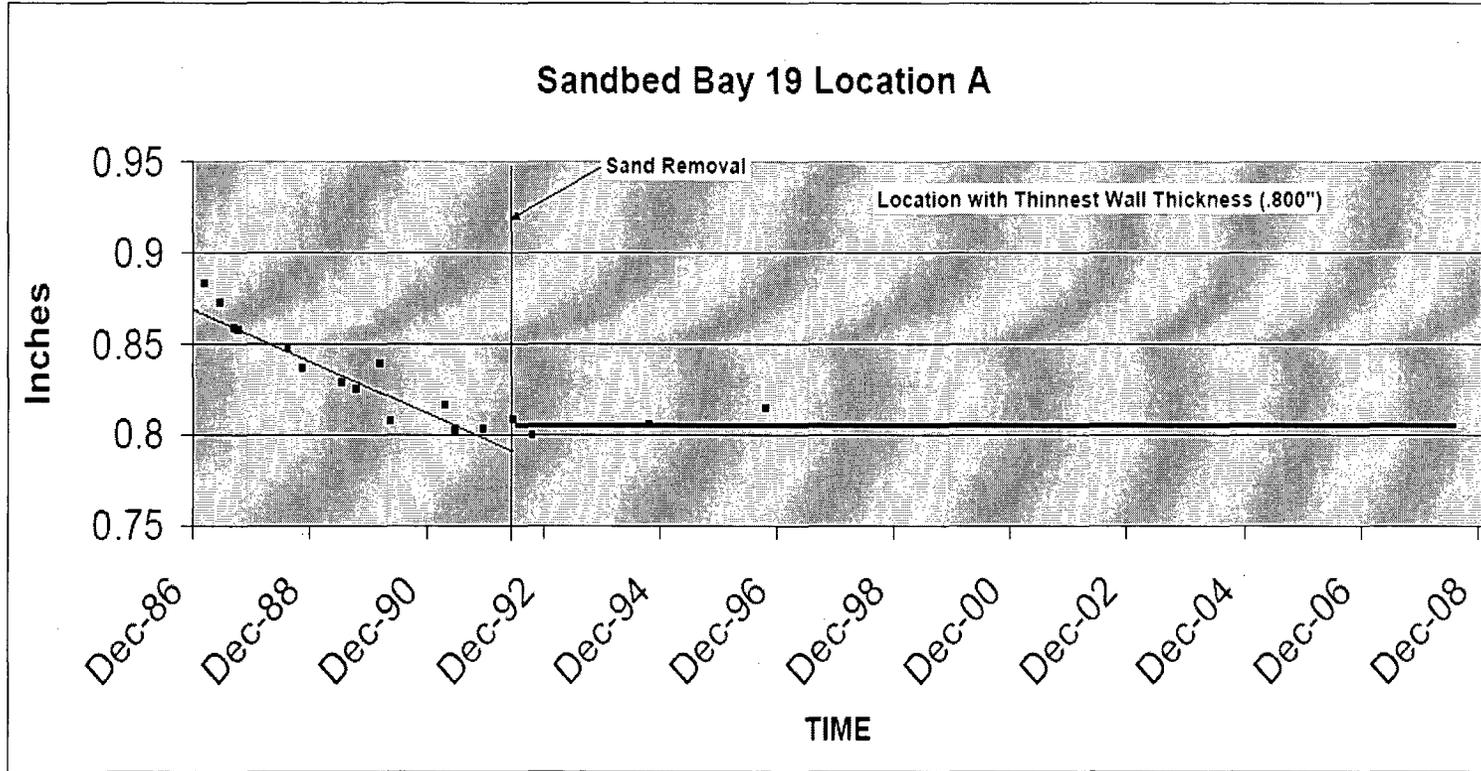
**Fig. – 3 Corrosion Trend in Sand Bed Region Bay with highest Drywell Shell Wall Thinning**

Based on Calculation C-1302-187-5300-021

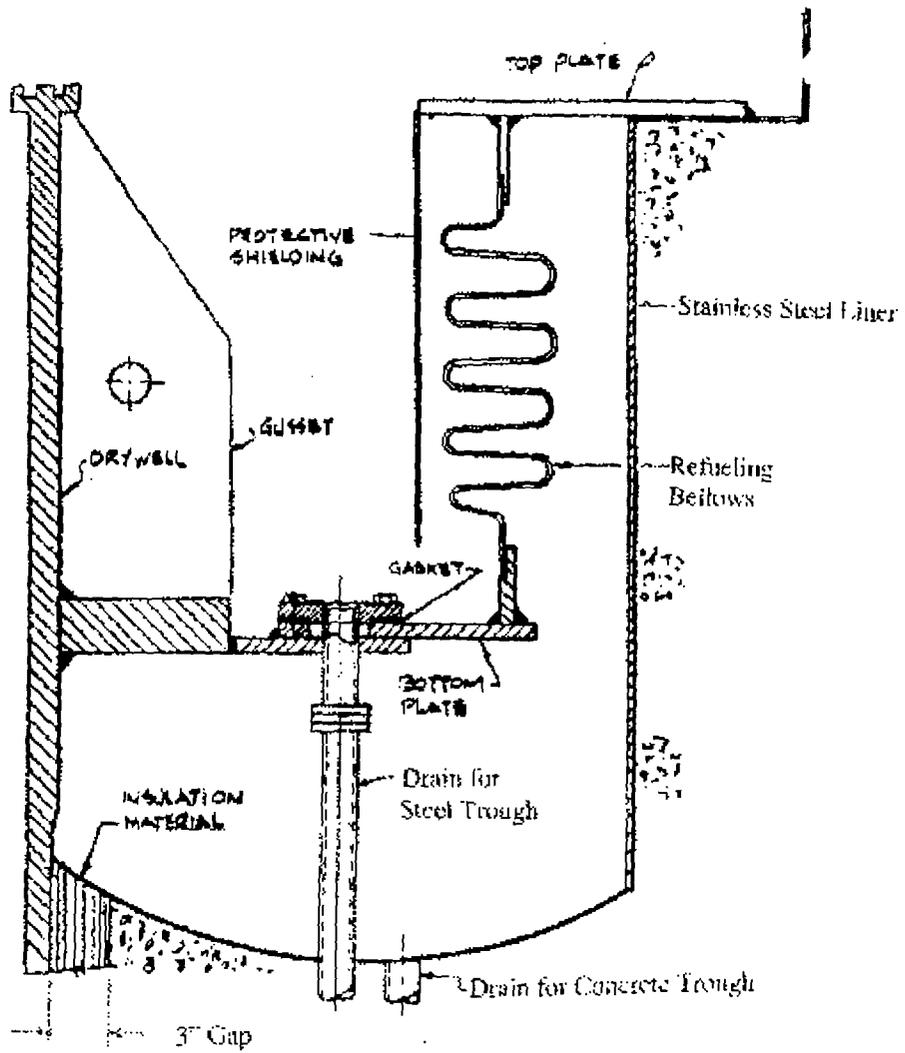
**Figure 2 - Drywell to Reactor Cavity Seal Detail**

- Cleared the former sand bed region drains to improve drainage
- Replaced reactor cavity steel trough drain gasket, which was found to be leaking (see Fig. 1 & Fig.-2).

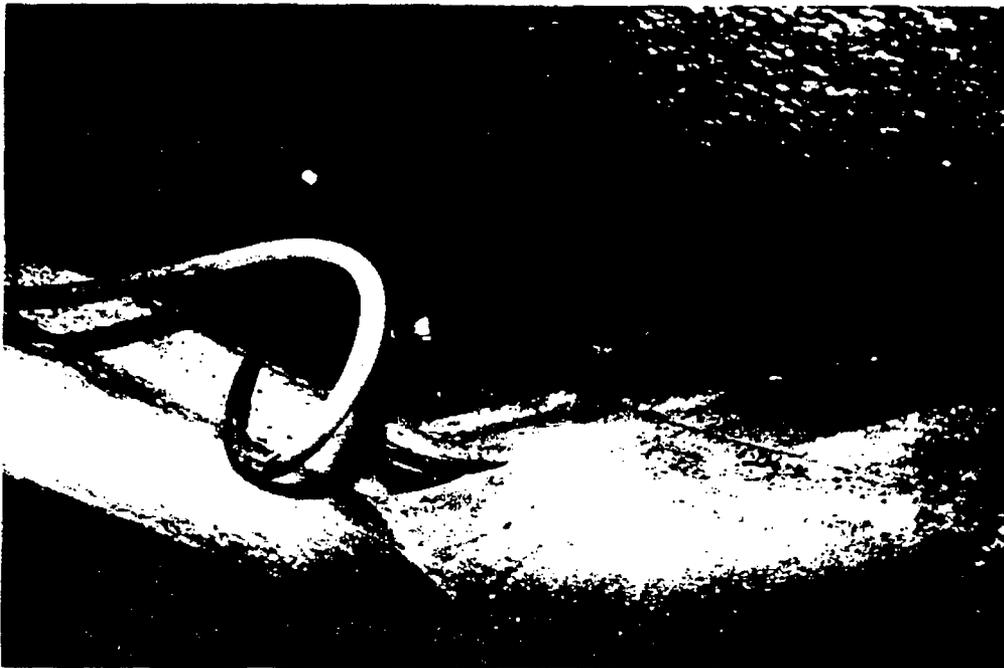
**Bay #13** - Looking toward **Bay #15** - This photo captures the concrete floor condition and a portion of lower shell corroded surface in very great detail. The floor in this area
