NUREG-1275
Vol. 6

Operating Experience Feedback Report – Solenoid-Operated Valve Problems

Commercial Power Reactors

U.S. Nuclear Regulatory Commission

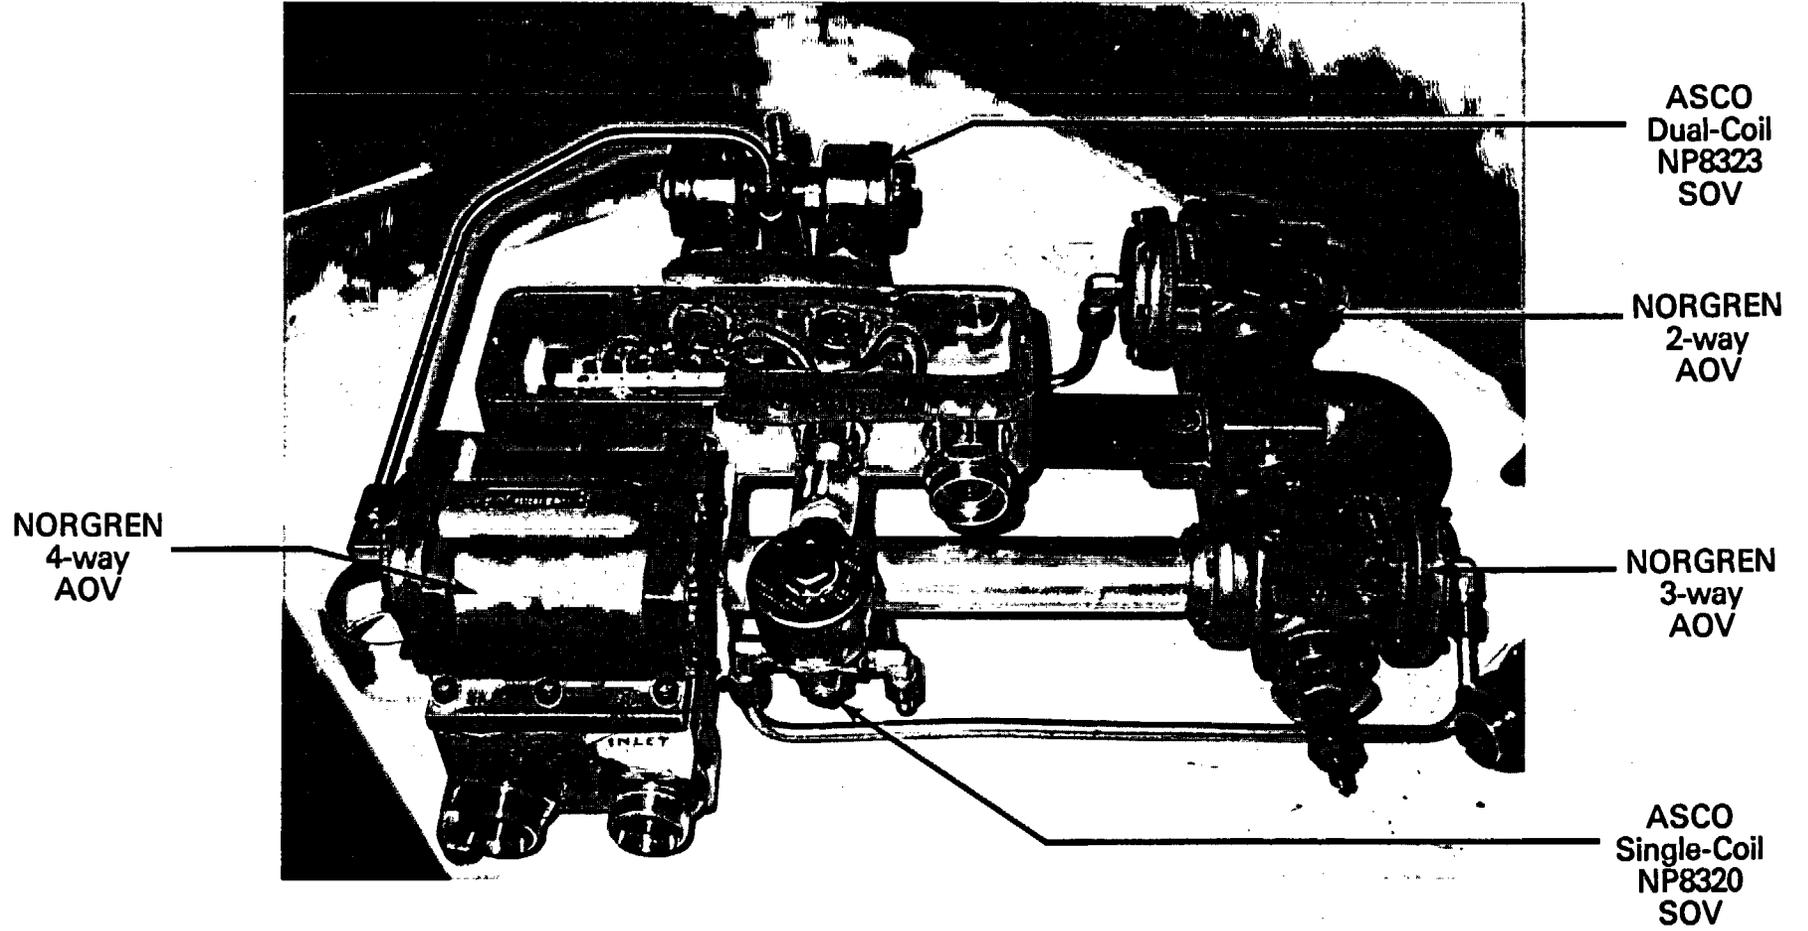
Figure 5 MSIV air pack from Perry Nuclear Power Plant, November 1987

5.1.1.1 Main Steam Isolation Valves (MSIVs) at Perry—Excessive Heat From Steam Leaks

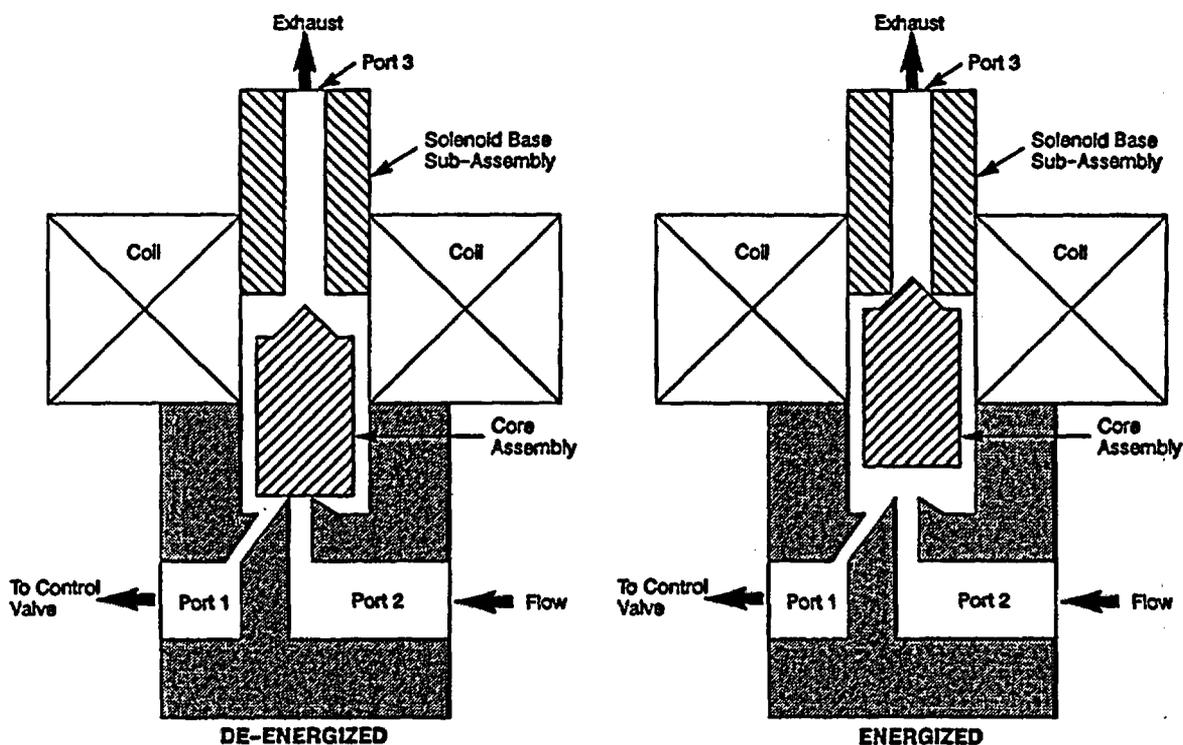
Figure 6 Schematic of a solenoid-operated valve illustrating effect of operating pressure differentials

In May 1988, the NRC issued Information Notice 88-24 (Ref.24), which informed licensees of two SOV failures that were experienced at Kewaunee (Ref. 25) and of the potential for additional failures at Kewaunee and Calvert Cliffs 1 and 2 (Refs. 26-28). Subsequently, several licensees informed the NRC of similar discoveries at their plants, where the potential for overpressurizing SOVs existed, which could prevent the SOVs from performing their safety-related functions. At some plants, the task of verifying the potential for overpressurizing SOVs has been complicated by the fact that documentation is not readily available. For example, Millstone 1 and 2 (Ref. 29) and Crystal River 3 (Ref. 30), have reported that documentation to identify SOVs in containment is not readily available and that containment walkdowns are necessary for their identification.

It is not clear that all licensees have taken appropriate corrective action on the issue of SOV overpressurization as presented in Information Notice 88-24. This concern is predicated on the Crystal River 3 event (Ref. 30) and a followup discussion in which the licensee stated that its review of the potential for SOV overpressurization assumed the proper operation of in-line pressure regulators, it did not address the consequences of pressure regulator failures.* One of the events described in Information Notice 88-24 involved the discovery at Calvert Cliffs that several safety systems were vulnerable to single failures of pressure regulators in the air supply system.

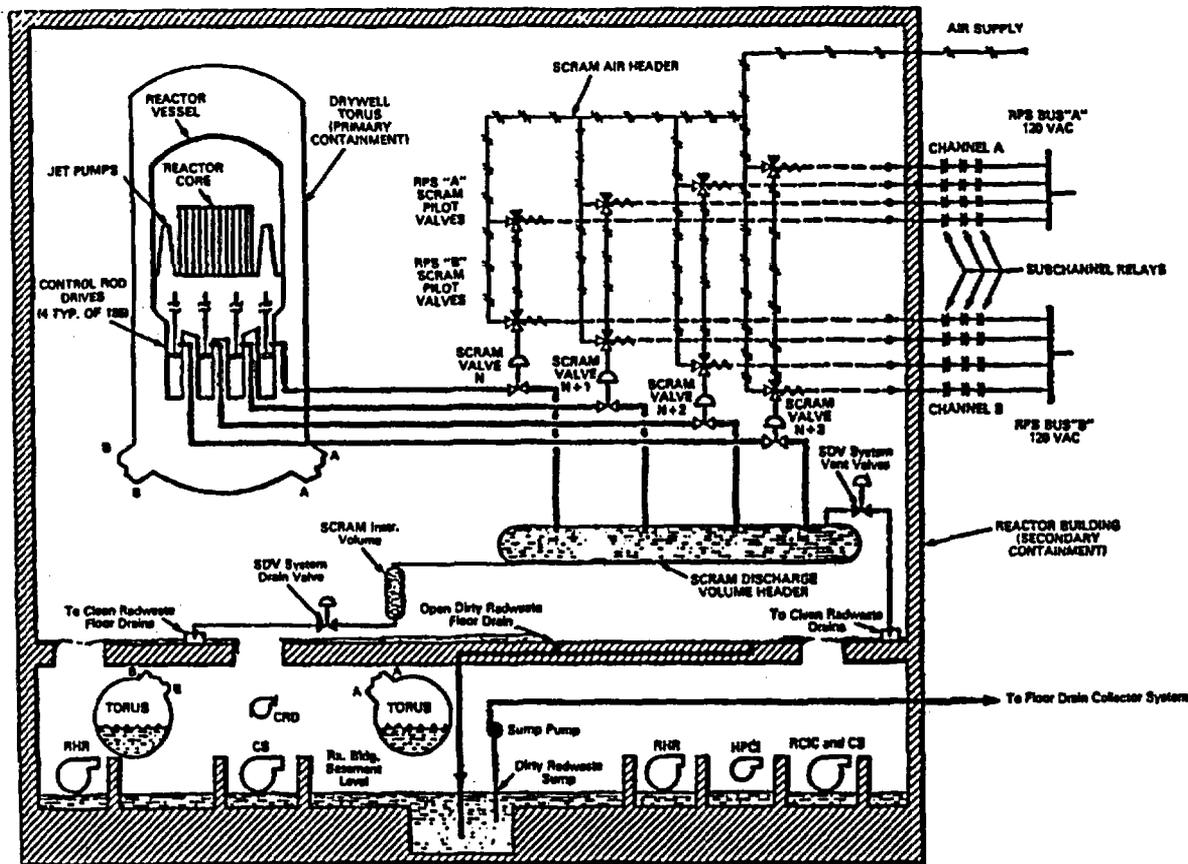
Figure 7 BWR scram system illustrating leakage path outside containment

Discussion with GE has indicated that since Information Notice 85-95 was issued, BWR owners have made improvements in their SDV systems so that there are redundant SDV vent and drain valves at all U.S. BWRs vs. only one vent and one drain valve per SDV header prior to the modification.* However, it is not certain that all U.S. BWRs have manual handwheel overrides for the SDV vent and drain valves to limit reactor water leakage outside primary containment in the event of a common-mode failure of the SOVs piloting the SDV vent and drain systems.
