**Wolf Creek – Pressurizer
Alloy 600/82/182 Location Summary**

NSD-EPRI-06-43

December 15, 2006

The following summarizes the review of the design and fabrication information of the surge, spray, safety, and relief nozzles of the Wolf Creek pressurizer. For each location (Figure 1) the following information will be provided:

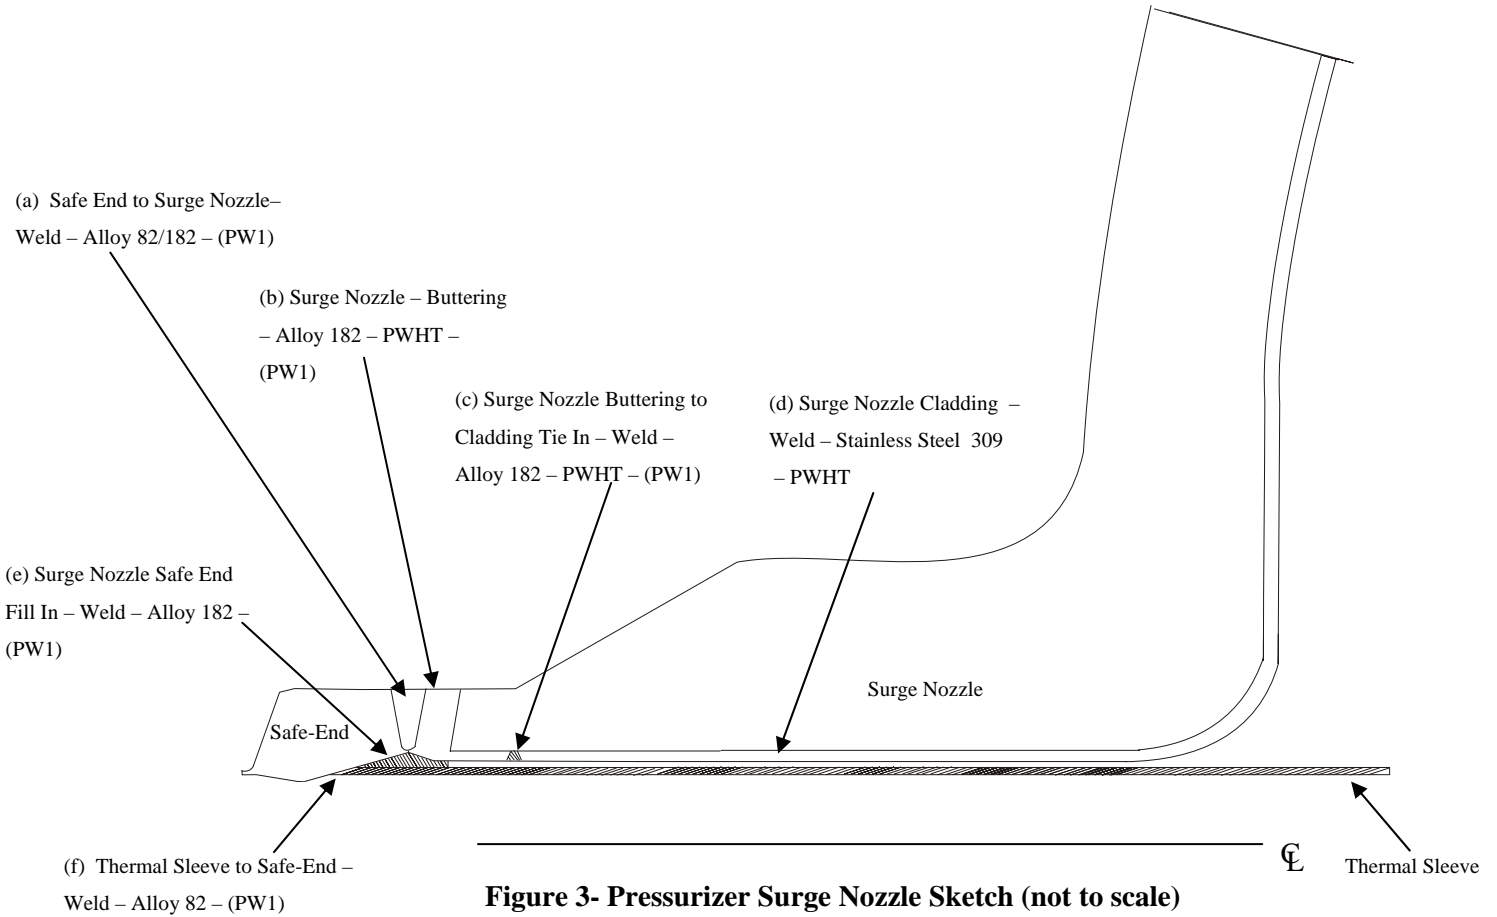
Figure 3- Pressurizer Surge Nozzle Sketch (not to scale)

Figure	ID Letter	Location Area	Location Description	Location Type (Weld, Buttering, Base Metal)	Material	Post Weld Heat Treat? (Yes, No)
3	a	Surge Nozzle	Safe End to Surge Nozzle	Weld	1 st Pass - Alloy 82 Weld - Alloy 182	No
	b			Buttering	Alloy 182	Yes
	c		Surge Nozzle Buttering to Nozzle Cladding Tie In	Weld	Alloy 182	Yes
	d		Surge Nozzle Cladding	Weld	Stainless Steel 309	Yes
	e		Surge Nozzle Safe End Fill In	Weld	Alloy 182	No
	f		SS Thermal Sleeve to Safe-End	Weld	Alloy 82 (45° of circumference affected)	No

Reference Repair #	Part Description	Defect Description	Repair Description
1	Surge Nozzle Buttering	The surge nozzle end build up (safe end prep) was insufficient. There was not enough weld build up to clean up during machining of the outside diameter.	Alloy 182 was welded to the nozzle end until the nozzle had sufficient weld buildup to support final machining. PWHT was completed during normal cycle operations.
2	Surge Nozzle Buttering	During the Repair # 1 radiography test (RT) indications were identified: <ol style="list-style-type: none"> 1. Length 7/8 inch, Depth 9/16 inch OD. 2. Length 1 1/8 inch, Depth 1 inch OD 	<ul style="list-style-type: none"> • Indication removed • Dye Penetrate test (PT) excavations • Preheat and prepare to weld • Weld repair area using Alloy 182 • PT repaired area • Check nozzle dimensions • PWHT normal cycle.
3	Safe End to Surge Nozzle Weld	Radiography test (RT) rejection of safe end to surge nozzle weld. <ol style="list-style-type: none"> 1. Length 1 inch, Depth 13/64 to 7/16 inch – Inside Diameter (ID) 	<ul style="list-style-type: none"> • Remove indication • Dye Penetrate test (PT) excavation • Preheat and prepare to weld • Weld repair area using Alloy 82 • PT and RT repaired area • PWHT normal cycle

4	Surge Nozzle Cladding	A measurement of the surge nozzle cladding thickness was not taken during the proper operation. So three slots were cut into the surge nozzle cladding to the base metal to obtain clad thickness measurements. These slots were cut after intermediate post weld heat treat.	<ul style="list-style-type: none"> • Weld repair area using 308L stainless steel • PWHT normal cycle • PT repaired area after PWHT

Reference Repair #	Part Description	Defect Description	Repair Description
5	Surge Nozzle Cladding	This repair is a result of Repair #4. PT of the repaired areas in the surge nozzle after PWHT was not completed. This was identified by a review of the feeder travelers. The unit was sealed, purged, and on rail car for shipment when this was identified.	<ul style="list-style-type: none"> • Covers and gaskets were removed from the surge nozzle and manway. • The basket was cut from the surge nozzle. The cut was made as close to the weld clad as possible. • The thermal sleeve was then removed from the surge nozzle by grinding the connection welds. • It was then verified that the basket and thermal sleeve were removed without exposing base metal. • The surge nozzle outside diameter was then cleaned to remove paint residue. • The repair areas noted in Repair #4 were then removed via grinding. • The excavations were then inspected using dye penetrant examination (PT). • The affected areas were then weld repaired using 308L and 309L stainless steel. • Local PWHT of weld repair was then completed. • The repaired area underwent PT. • The thermal sleeve was then reinstalled using Alloy 82. The weld area was PT. • The basket was then reinstalled. • Replace all covers and gaskets. • Repaint area.

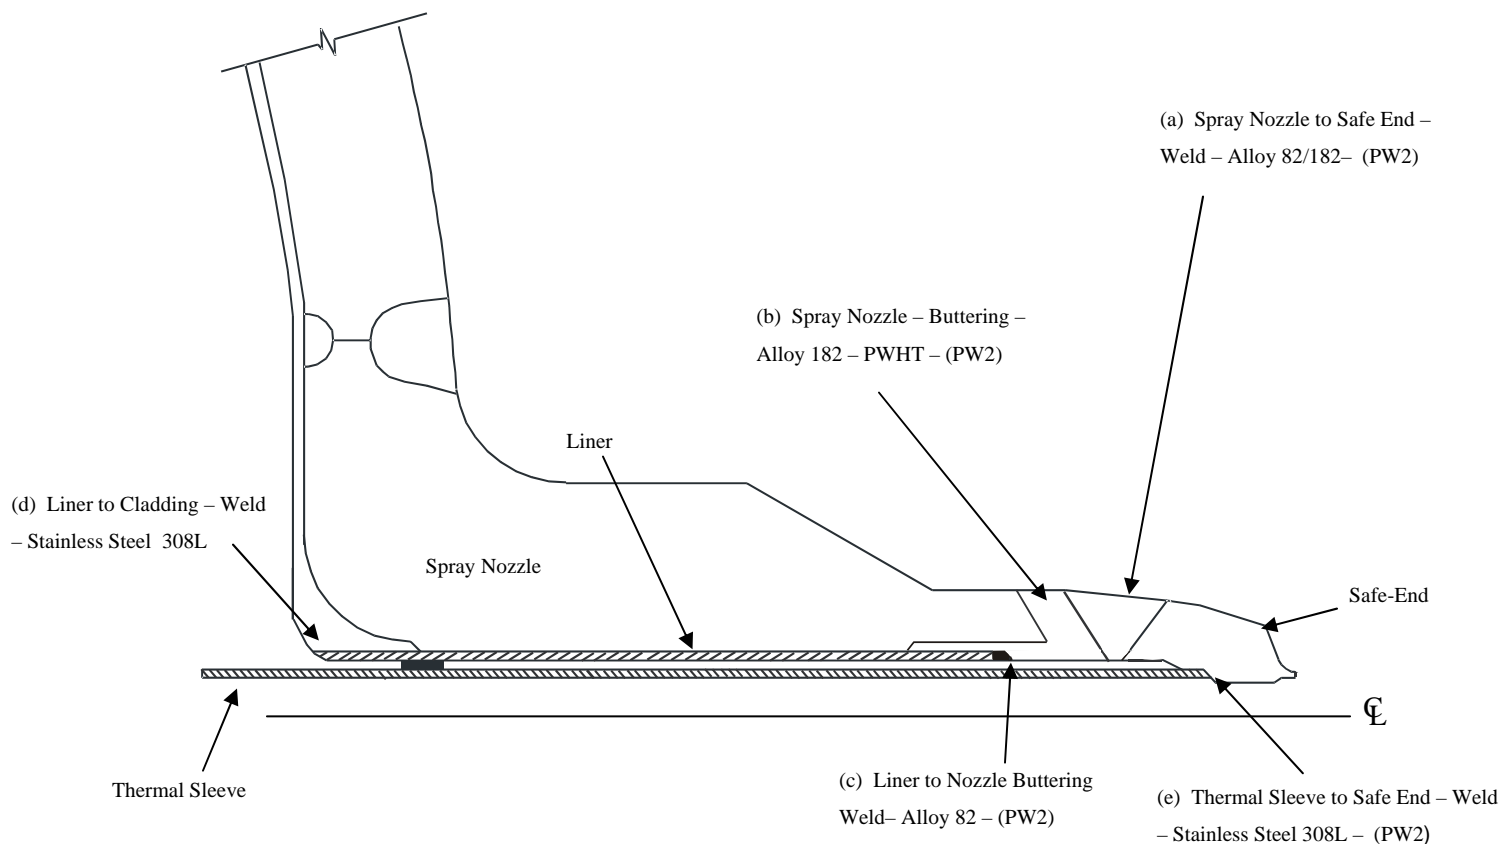
Figure 4 - Pressurizer Spray Nozzle Sketch (not to scale)

Figure	ID Letter	Location Area	Location Description	Location Type (Weld, Buttering, Base Metal)	Material	Post Weld Heat Treat? (Yes, No)
4	a	Spray Nozzle	Spray Nozzle to Safe-End	Weld	1 st Pass – Alloy 82 Weld – Alloy 182	No
	b			Buttering	Alloy 182	Yes
	c		SS Liner to Nozzle Buttering	Weld	Alloy 82	No
	d		SS Liner to Nozzle Cladding	Weld	Stainless Steel 308L	No
	e		SS Thermal Sleeve to Safe-End	Weld	Stainless Steel 308L (45° of circumference affected)	No

Reference Repair #	Part Description	Defect Description	Repair Description
6	Spray Nozzle Buttering	PT indications found in lip of weld build up and along weld bond line. The indications were identified prior to PWHT.	<ul style="list-style-type: none">• Indications removed.• Areas were weld repaired using Alloy 82• PT repaired area before PWHT• PWHT normal cycle• PT repair area after PWHT

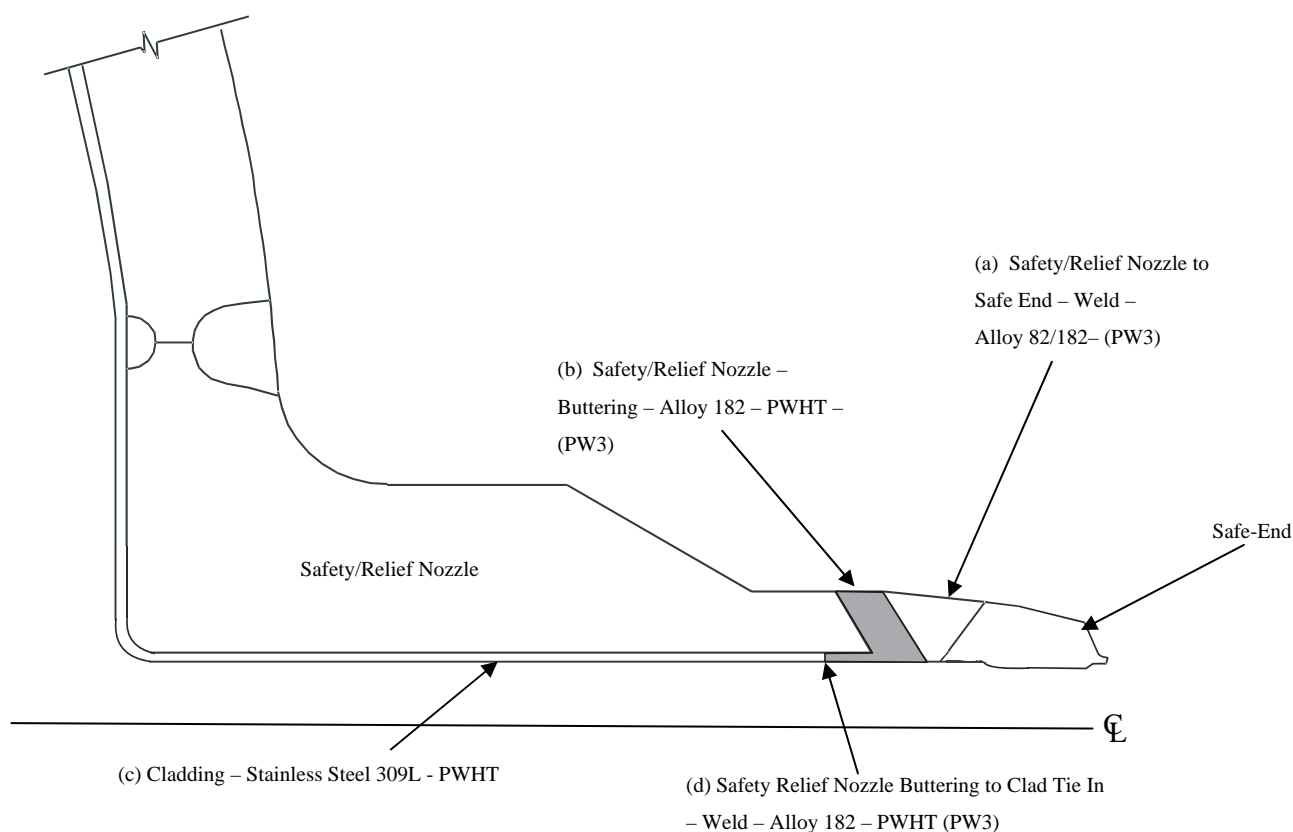
Figure 5 - Pressurizer Safety & Relief Nozzle(s) Sketch (not to scale)

Figure	ID Letter	Location Area	Location Description	Location Type (Weld, Buttering, Base Metal)	Material	Post Weld Heat Treat? (Yes, No)
5	a	Safety/Relief Nozzles	Safety/Relief Nozzle to Safe-End	Weld	1 st Pass - Alloy 82 Weld Alloy 182	No
	b			Buttering	Alloy 182	Yes
	c		Safety/Relief Nozzle Cladding	Weld	Stainless Steel 309L	Yes
	d		Safety/Relief Nozzle Buttering to Cladding Tie In	Weld	Alloy 182	Yes

Reference Repair #	Part Description	Defect Description	Repair Description
7	Nozzle "A" Buttering	After PT inspection of nozzle build up several grind outs were prevalent. The deepest grind out is 1/8 inch deep.	<ul style="list-style-type: none"> • The build up Weld repair build up using Alloy 182 • PT repaired areas. • PWHT during normal cycle. • PT repairs after PWHT.
8	Nozzle "A" Safe End to Nozzle Weld	Radiography test indications at the following areas of the safe end to nozzle weld due to operator error. <ol style="list-style-type: none"> 1. Length 1-1/4 inch, Depth 11/32 inch ID 2. Length 7/8 inch, Depth 11/32 inch ID 	<ul style="list-style-type: none"> • Indications removed • PT excavations • Weld repair area using Alloy 82 • PT and RT repaired area
9	Nozzle "B" Safe End to Nozzle Weld	Radiography test indications at the following areas of the nozzle to safe end weld due to improper cleaning of weld bead.. <ol style="list-style-type: none"> 1. Length 2-1/2 inch, Depth 1/4 to 3/4 inch ID 2. Length 1 inch, Depth 1/2 inch ID 3. Length 1-1/2 inch, Depth 1/2 inch ID 4. Length 1 inch, Depth 1/2 inch ID 5. Length 2-1/2 inch, Depth 1/4 to 3/4 inch ID 6. Length 2-1/2 inch, Depth 1/4 to 3/4 inch ID 	<ul style="list-style-type: none"> • Indications removed • PT excavations • Weld repair area using Alloy 82 • PT and RT repaired area

Reference Repair #	Part Description	Defect Description	Repair Description
10	Nozzle "B" Safe End to Nozzle Weld	Indications identified during previous Repair #9. Radiography test indications at the following areas of the nozzle to safe end weld due to improper cleaning of weld bead. <ol style="list-style-type: none"> 1. Length 1-1/2 inch, Depth 1/2 inch ID 2. Length 1-1/4 inch, Depth 1 inch ID 3. Length 3/4 inch, Depth 7/8 inch ID 4. Length 1-1/2 inch, Depth 3/8 inch ID 5. Length 1 inch, Depth 1-1/16 inch ID 6. Length 1/2 inch, Depth 1/2inch ID 	<ul style="list-style-type: none"> • Indications removed • PT excavations • Weld repair area using Alloy 82 • PT and RT repaired area
11	Nozzle "B" Safe End	The safe end ID exceeded final drawing dimensions.	<ul style="list-style-type: none"> • Using 308L stainless steel weld ID of nozzle. 1/2 inch from edge of safe end to approximately 2 inches inside of bore approximately 1/8 inch thick. • Blend taper of bore to 4:1 smooth transition • PT machined area. • Remove and weld repair PT indications with 308L stainless steel • PT area.

12	Nozzle "D" Buttering	After removing all unacceptable PT indications from the nozzle cladding and nozzle build up some areas require repair. The nozzle was not PWHT.	<ul style="list-style-type: none"> • Indications removed. • Areas were weld repaired using Alloy 82 and Alloy 182 • PT repaired area before PWHT • PWHT normal cycle • PT after PWHT
13	Nozzle "D" Buttering and Cladding	Linear indication present in the nozzle weld build up, RT rejected area. <ol style="list-style-type: none"> 1. Length 1/2 inch, Depth 7/16 inch ID 2. Length 1 inch, Depth 7/16 inch OD 	<ul style="list-style-type: none"> • Indications removed • PT excavations • Weld repair area using Alloy 82 • PT repaired area before PWHT • PT and RT area after PWHT

Reference Repair #	Part Description	Defect Description	Repair Description
14	Nozzle "D" Buttering	Identified after Repair #13. Radiography test indication at the following area of the nozzle buttering. Indication is due to operator error. 1. Length 1 inch, Depth 3/4 inch OD	<ul style="list-style-type: none"> • Indication removed • PT and RT excavated area. • RT failed, indication is still present. Excavated area too small. • Excavated area made wider via grinding. • RT excavated area – clear. • Weld repair area using Alloy 182 • PT and RT repaired area • PWHT buttering
15	Nozzle "D" Buttering	Following PWHT defect areas were located that were not present prior to PWHT. 1. Length 3/4 inch, Depth 3/8 to 3/4 inch ID 2. Length 2-1/4 inch, Depth 3/8 to 3/4 inch ID 3. Length 1/2 inch, Depth 3/8 to 3/4 inch ID	<ul style="list-style-type: none"> • Indication removed • PT excavations • Weld repair area using Alloy 82

16	Nozzle "D" Buttering	Identified after completion of Repair #15. Following PWHT defect areas were located that were not present prior to PWHT. 1. Length 1 inch, Depth 3/8 to 3/4 inch OD 2. Length 2-1/4 inch, Depth 3/8 to 3/4 inch OD 3. Length 1/2 inch, Depth 3/8 to 3/4 inch OD	<ul style="list-style-type: none"> • Indication removed • PT excavations • Weld repair area using Alloy 182 • PT and RT repaired area • PWHT
17	Nozzle "D" Buttering and Cladding	Occurred as a result of Repair #16. During the grinding of the RT indications noted previously the ID of the nozzle was damaged. PT of the nozzle ID revealed indications.	<ul style="list-style-type: none"> • Clad weld repaired in defected areas using Alloy 82 • Repaired areas were then cleaned up via grinding and PT inspected. • PT inspection was acceptable.
18	Nozzle "D" Safe End to Nozzle Weld	Radiography test indication at the following area of the safe end to nozzle weld. Deposited weld not properly cleaned before subsequent weld layer deposited, due to operator error. 1. Length 1-1/4 inch, Depth 1/2 inch OD	<ul style="list-style-type: none"> • Indication removed • PT excavations • Weld repair area using Alloy 82 • PT and RT repaired area

Reference Repair #	Part Description	Defect Description	Repair Description
19	Nozzle "D" Safe End to Nozzle Weld	Radiography test indication at the following area of the safe end to nozzle weld due to operator error. Lack of fusion between weld beads 1. Length 1/2 inch, Depth 1/2 inch ID	<ul style="list-style-type: none"> • Indication removed • PT excavations • Weld repair area using Alloy 82 • PT and RT repaired area
20	Nozzle "D" Safe End	The safe end ID exceeded final drawing dimensions.	<ul style="list-style-type: none"> • Using 308L stainless steel apply weld build up to the ID of the nozzle. [1/2 inch from edge of safe end to approximately 2 inches inside of bore approximately 1/8 inch thick.] • Blend taper of bore to 4:1 smooth transition • PT machined area.
21	Nozzle "D" Safe End	PT indications found on the ID of nozzle safe end. The indications were identified after final PWHT and hydro test. 1. Length 1.88 inch, Width 2.38 inch, Depth 0.12 inch ID	<ul style="list-style-type: none"> • Indication removed • Weld repair area using Alloy 82 • PT repaired area
