Potential Criticality Accident
at the General Electric
Nuclear Fuel and Component
Manufacturing Facility,
May 29, 1991

U.S. Nuclear Regulatory Commission

Manuscript Completed: July 1991
Date Published: August 1991

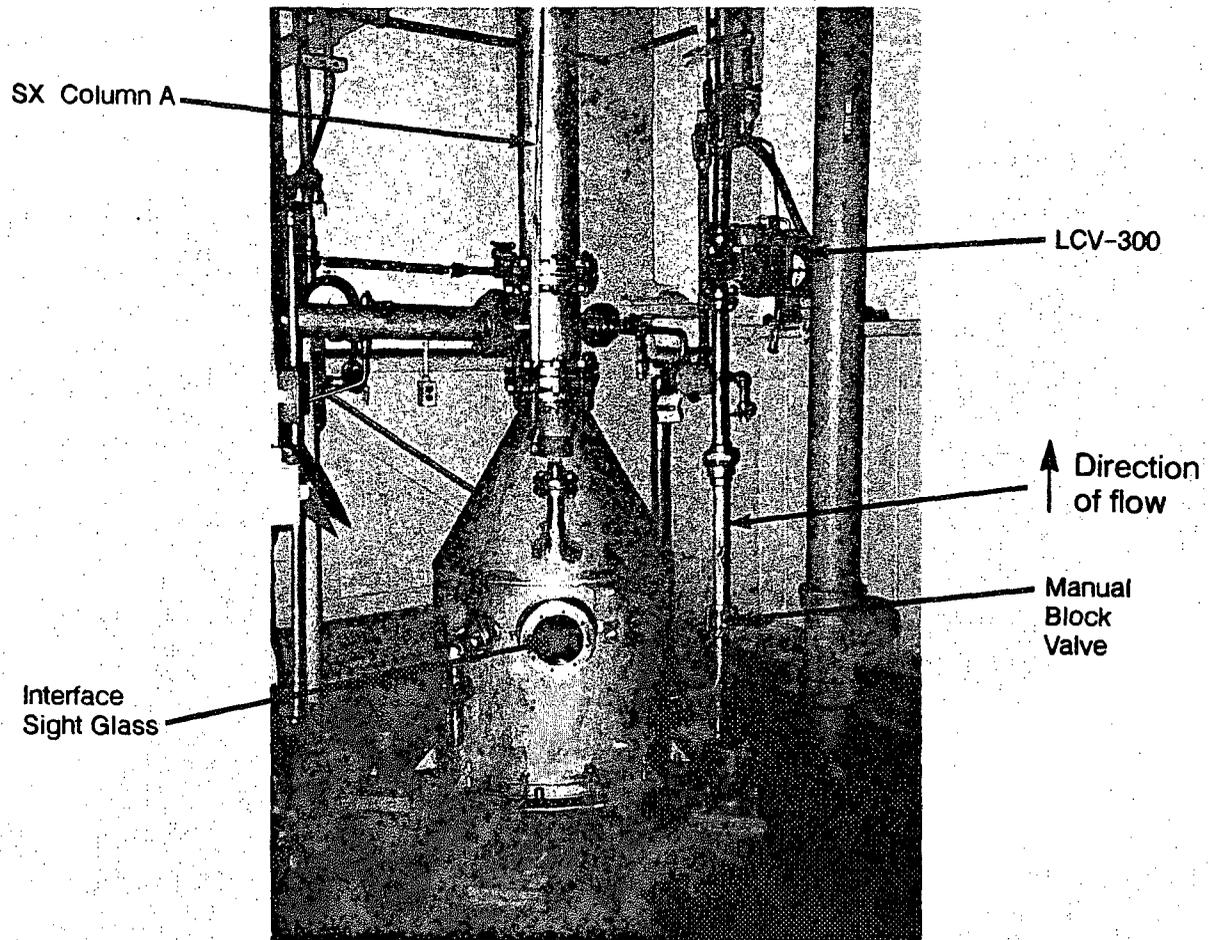
Figure 3.6 LCV-300 and Upstream Manual Valve

9:30 p.m.	Control Room Operator A (CRO A) noted that SX Column A had interface and density problems. The process floor operator indicated that the SX Column A level control valve (LCV-300) was not actuating and did not respond to demand signals. The LCV-300 is a 1" globe valve with a pneumatic positioner actuator. SX operations continued by throttling a manual valve adjacent to LCV-300.

11:15 p.m.	CRO A calls instrumentation maintenance to troubleshoot and repair LCV-300. Records show that SX interface is lost in this time frame.
		CRO A instructs a floor operator to close the manual block valve upstream of LCV-300.

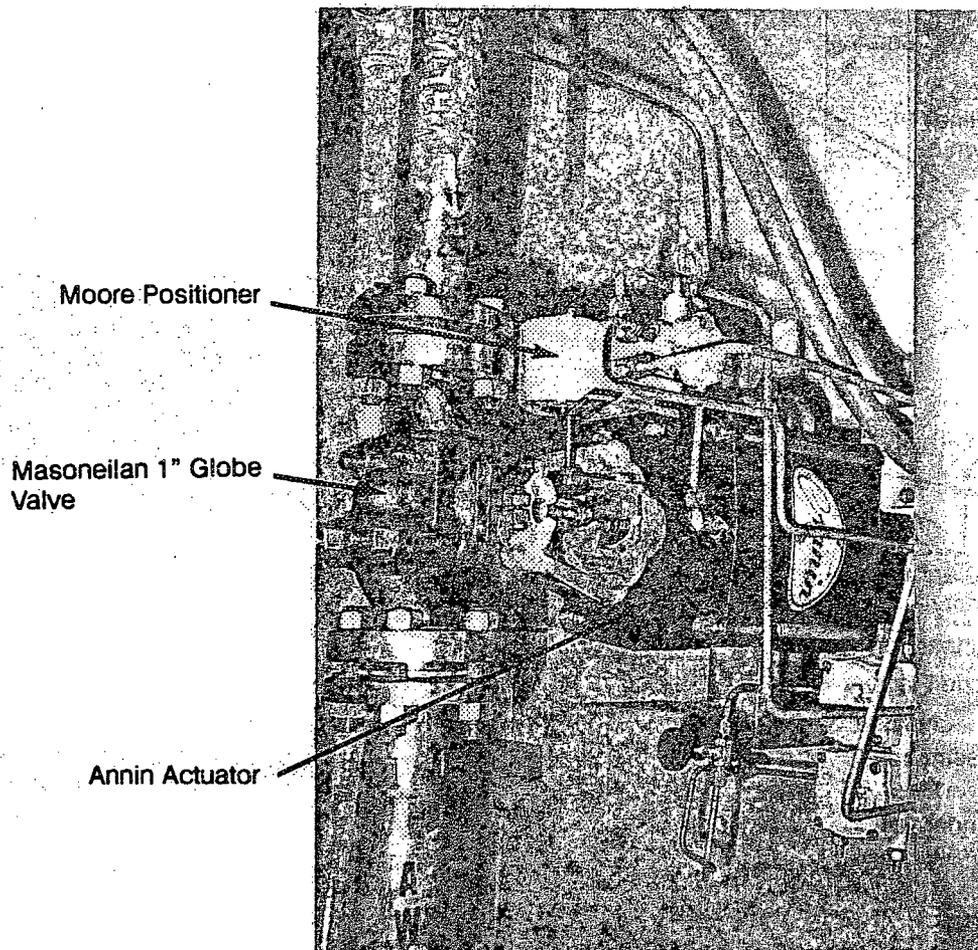
Figure 9.1 LCV - 300

At approximately 1:30 a.m., instrumentation maintenance personnel entered the solvent-extraction area to inspect LCV-300. Subsequently, they found the valve stuck open in mid-position. When maintenance personnel removed the air supply to repair the valve positioner, LCV-300 closed as designed. During this part of the attempted repair process, verbal communications were maintained between process floor operators A and B and maintenance personnel. The control room operator, who was located in the control room remote from that part of the process floor, was unaware of the maintenance activities and valve closure. With LCV-300 closed, the uranium solvent/organic mixture interface level and density values increased and eventually flooded (i.e., backflow) the A and B solvent-extraction columns.

Sometime between 2:30 a.m. and 3:00 a.m., instrumentation maintenance personnel completed their troubleshooting of the LCV-300 positioner. Upon testing, the valve stuck in the closed position. The positioner was disassembled again and further examination revealed that replacement parts were needed. The instrumentation maintenance personnel left the solvent-extraction area to look for replacement parts while the valve remained stuck in the closed position.

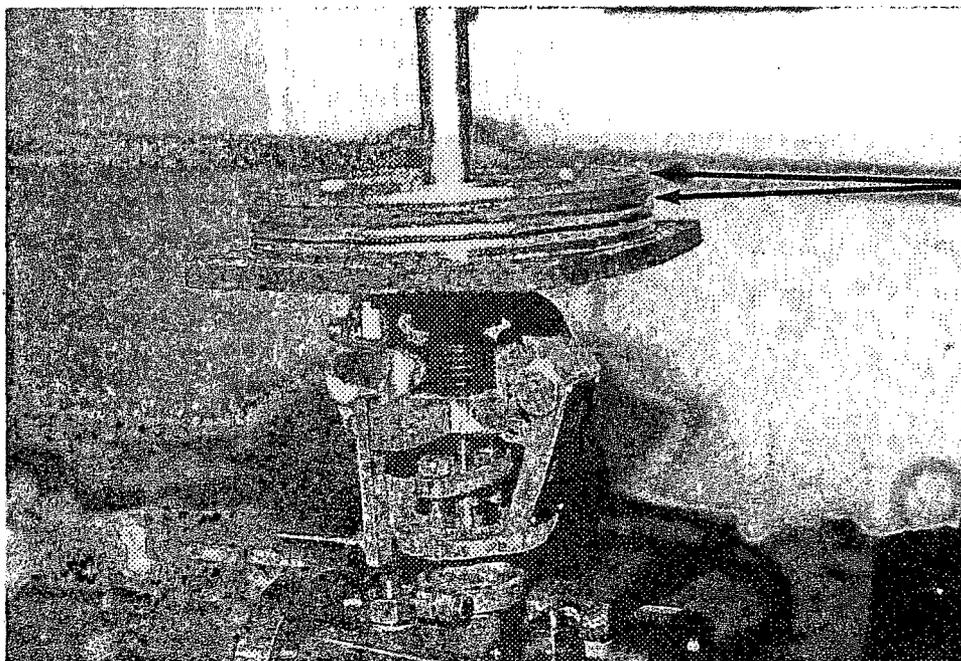
Figure 9.8 Annin actuator with cannister and spring removed

O-ring and Silicon Fabrication
