UNITED STATES
NUCLEAR REGULATORY COMMISSION

January 5, 2007

SUBJECT: CATAWBA NUCLEAR STATION – SPECIAL INSPECTON REPORT
05000413/2006010 AND 05000414/2006010

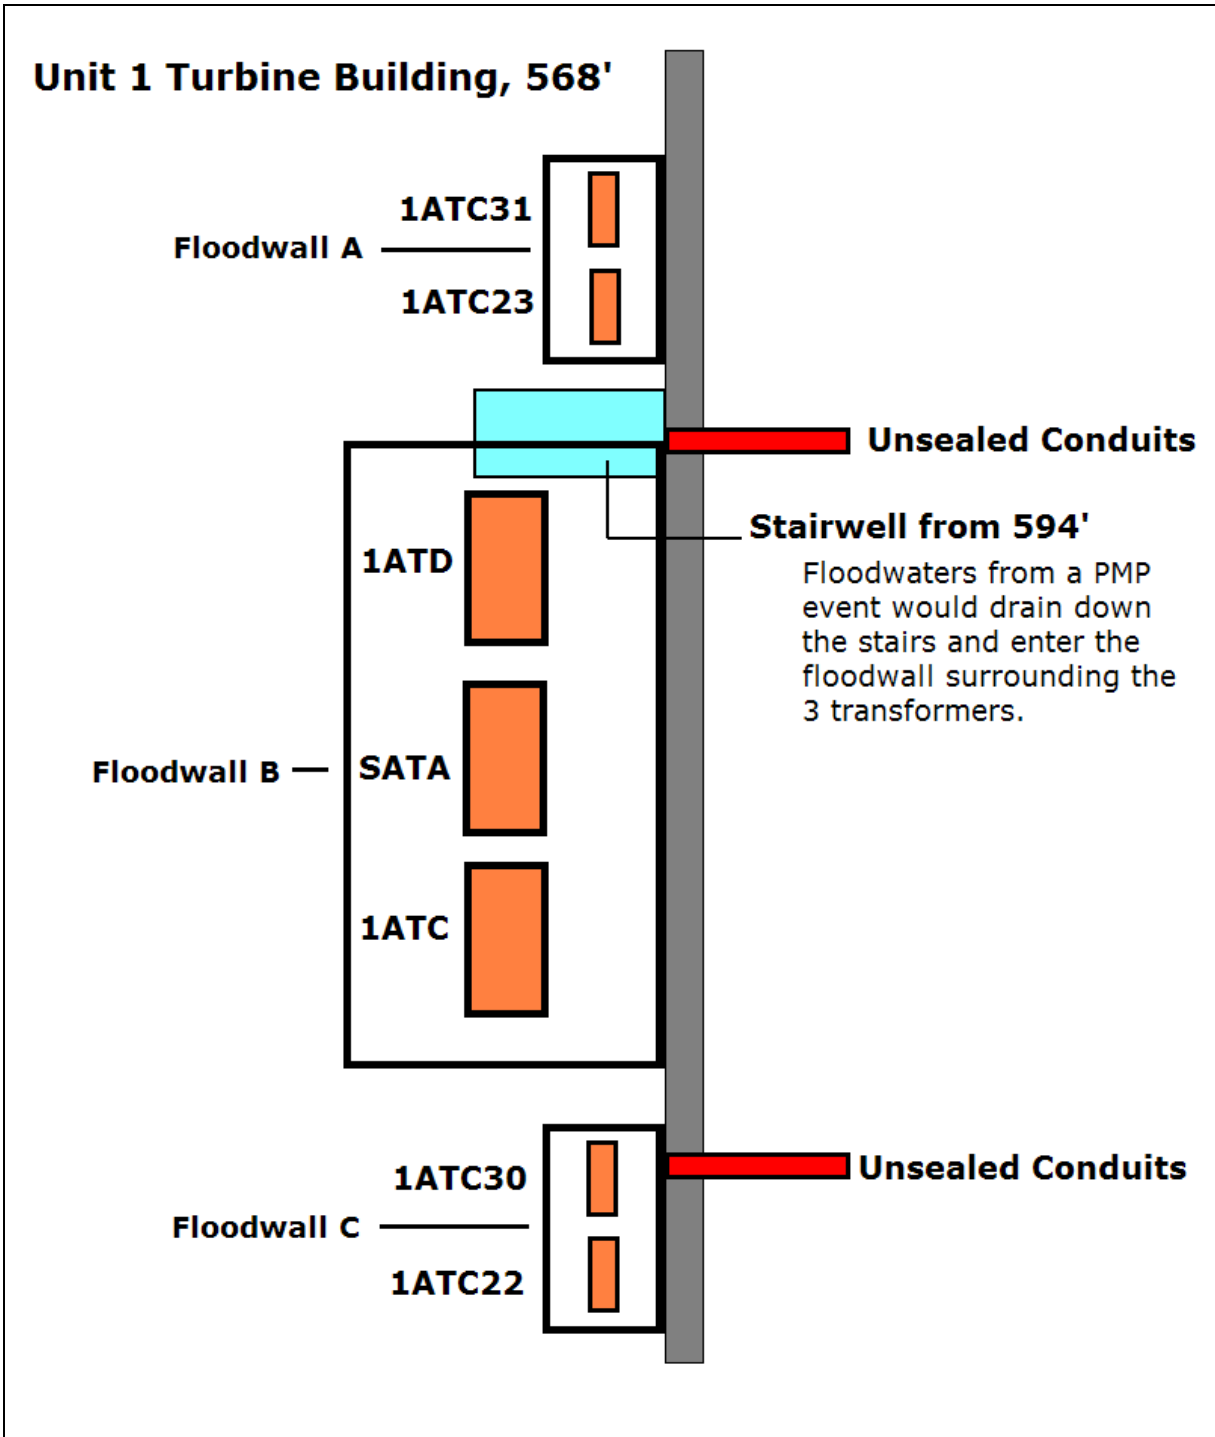
Turbine Building Floodwall Enclosure drawings

There are three (3) floodwall enclosures in each unit's turbine building basement designed to protect transformers 1ATC, 2ATC, 1ATD, 2ATD, SATA and SATB along with their associated terminal cabinets 1ATC22, 2ATC22, 1ATC23, 2ATC23, 1ATC30 and 1ATC31. The floodwalls were constructed to reduce the PRA model's risk that resulted from a postulated break of a pipe within the turbine building and subsequent loss of these components. The following summarizes what the impact could be on station operation if one of these components was lost due to flooding. Attachment 9 contains drawings showing the floodwalls for each unit, what equipment is enclosed by each and the water ingress flow paths that existed prior to their repair in September 2006.

Water entering a terminal cabinet enclosure is unpredictable and could vary based on the water's condition (i.e. temperature, pressure, flow) and the operating state of enclosed equipment (i.e. cabinet cooling fans on/off). Once moisture enters a terminal cabinet enclosure, the assurance of equipment reliability cannot be guaranteed.

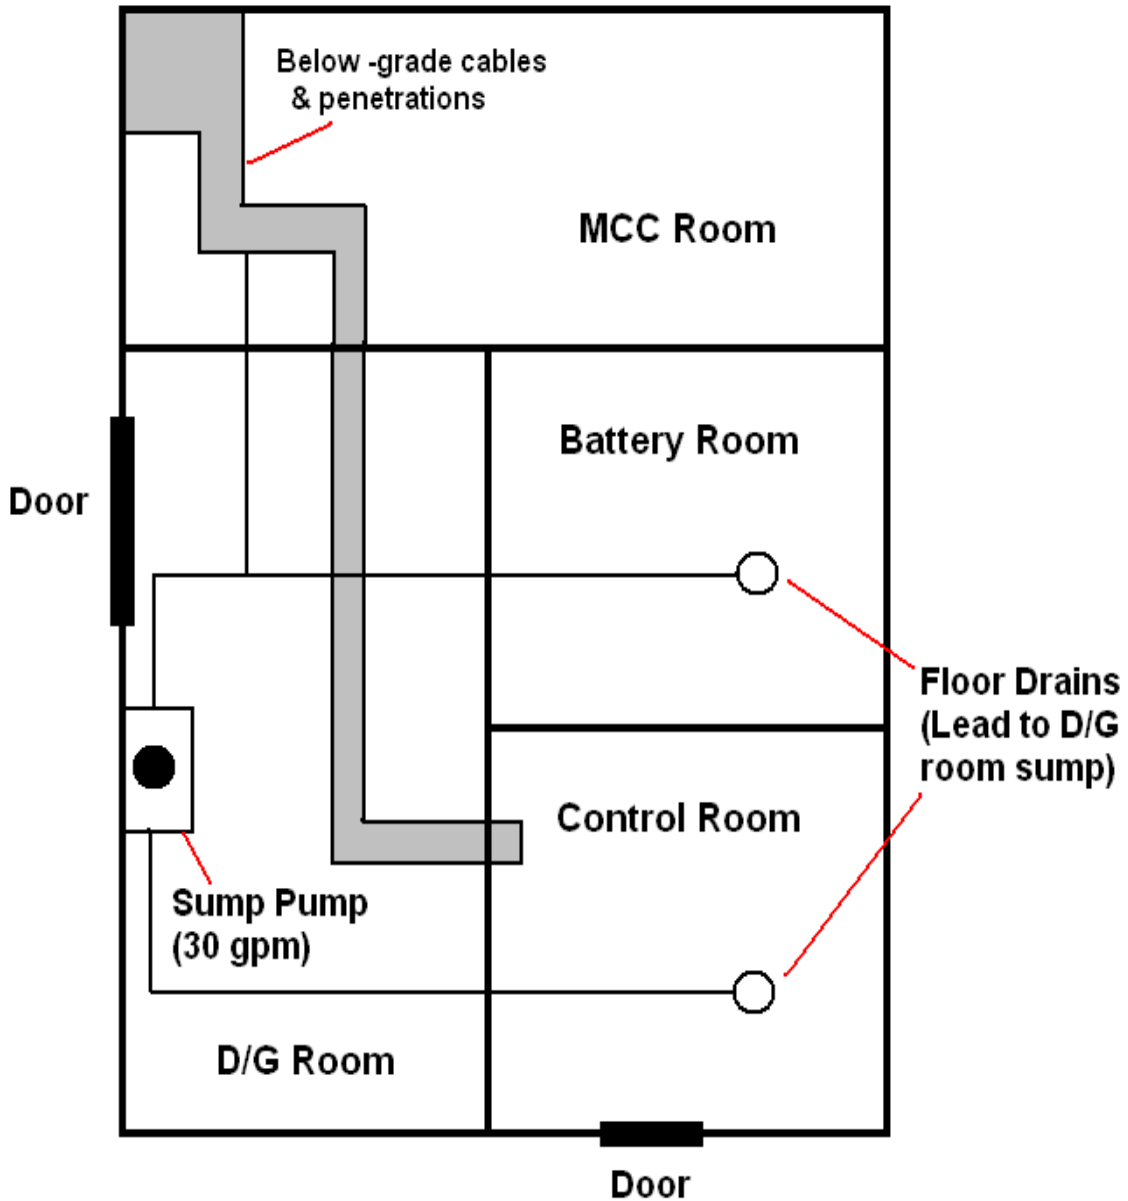
Standby Shutdown Facility - Catawba Nuclear Station

inspectors determined that water could enter the SSF during a PMP flooding event through the building's two doors and diesel room ventilation panels. The degraded conduit seals had not been inspected following either of the two previous 2006 flooding events due to the licensee failing to recognize the risk-significance of the SSF. The fact that the SSF would be rendered inoperable in the event of a PMP was not identified by the licensee following the revision of the calculated PMP flood level because the SSF is not designed to be a safety-related structure and site engineering personnel did not recognize the risk significance that the SSF had in terms of the Catawba PRA model.

NOTE: The floor elevation of the SSF is at 594' above Mean Sea Level (MSL). The PMP flood level at Catawba is currently 594' 9" above MSL.
