UNITED STATES
NUCLEAR REGULATORY COMMISSION
OFFICE OF INSPECTION AND ENFORCEMENT
WASHINGTON, D.C. 20555

March 2, 1984

IE INFORMATION NOTICE NO. 84-16: FAILURE OF AUTOMATIC SPRINKLER SYSTEM VALVES
TO OPERATE

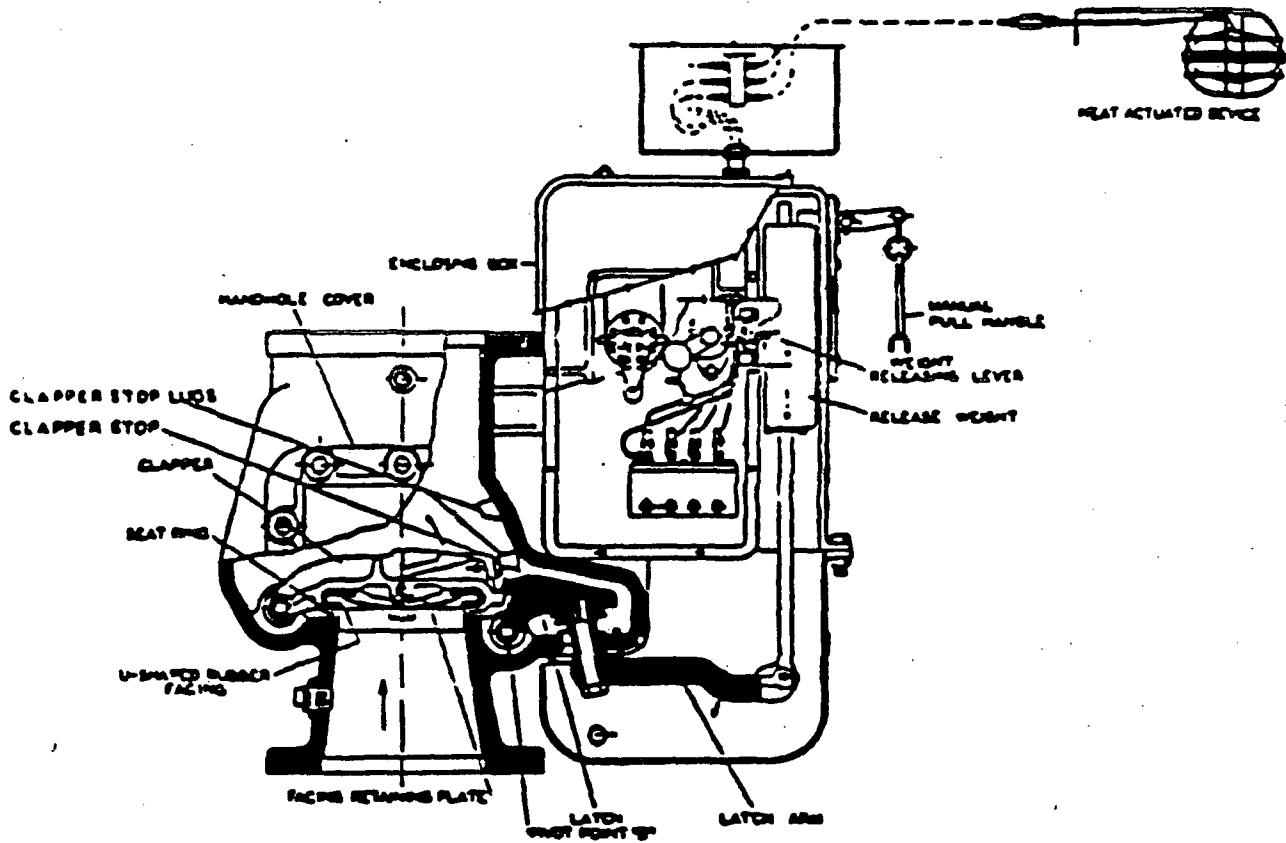
MODEL C VALVE

During subsequent testing and examination, excessive friction was noted between the weight and the weight guide rod; bowing (0.005-inch) was observed in the weight guide rod; evidence of scoring was found in two locations on the rod's surface; the weight's upper guide collar had an inside diameter (ID) of 0.637 inch rather than the manufacturer's recommended minimum of 0.647 inch; and scoring was noted on the enclosing box along the path that the weight guide bushing traces during actuation.

The licensee's preliminary investigation indicates that these failures may be related to the surface condition of the latch which holds the water clapper in the normally closed position. If the mating surfaces of the latch and clapper are not smooth, the latch may fail to disengage when the actuation weight hits the latch arm. If the normal water system pressure applied to the clapper valve exceeds 140 psig, the problem becomes more acute. The water pressure at Grand Gulf is maintained at 140 psig.

MP&L has sanded and trued the guide rod; reworked the ID of the weight's upper guide collar; lubricated the rod, latch pin, clapper hinge pin, and the enclosed box along the path of the weight guide bushings; temporarily increased the testing frequency of the valves; and revised the surveillance procedures to visually verify that the clapper has lifted and locked open following the test under normal system pressure.
