UNITED STATES  
NUCLEAR REGULATORY COMMISSION  
OFFICE OF INSPECTION AND ENFORCEMENT  
WASHINGTON, D. C. 20555

December 22, 1982

IE INFORMATION NOTICE NO. 82-53: MAIN TRANSFORMER FAILURES AT THE NORTH ANNA  
NUCLEAR POWER STATION

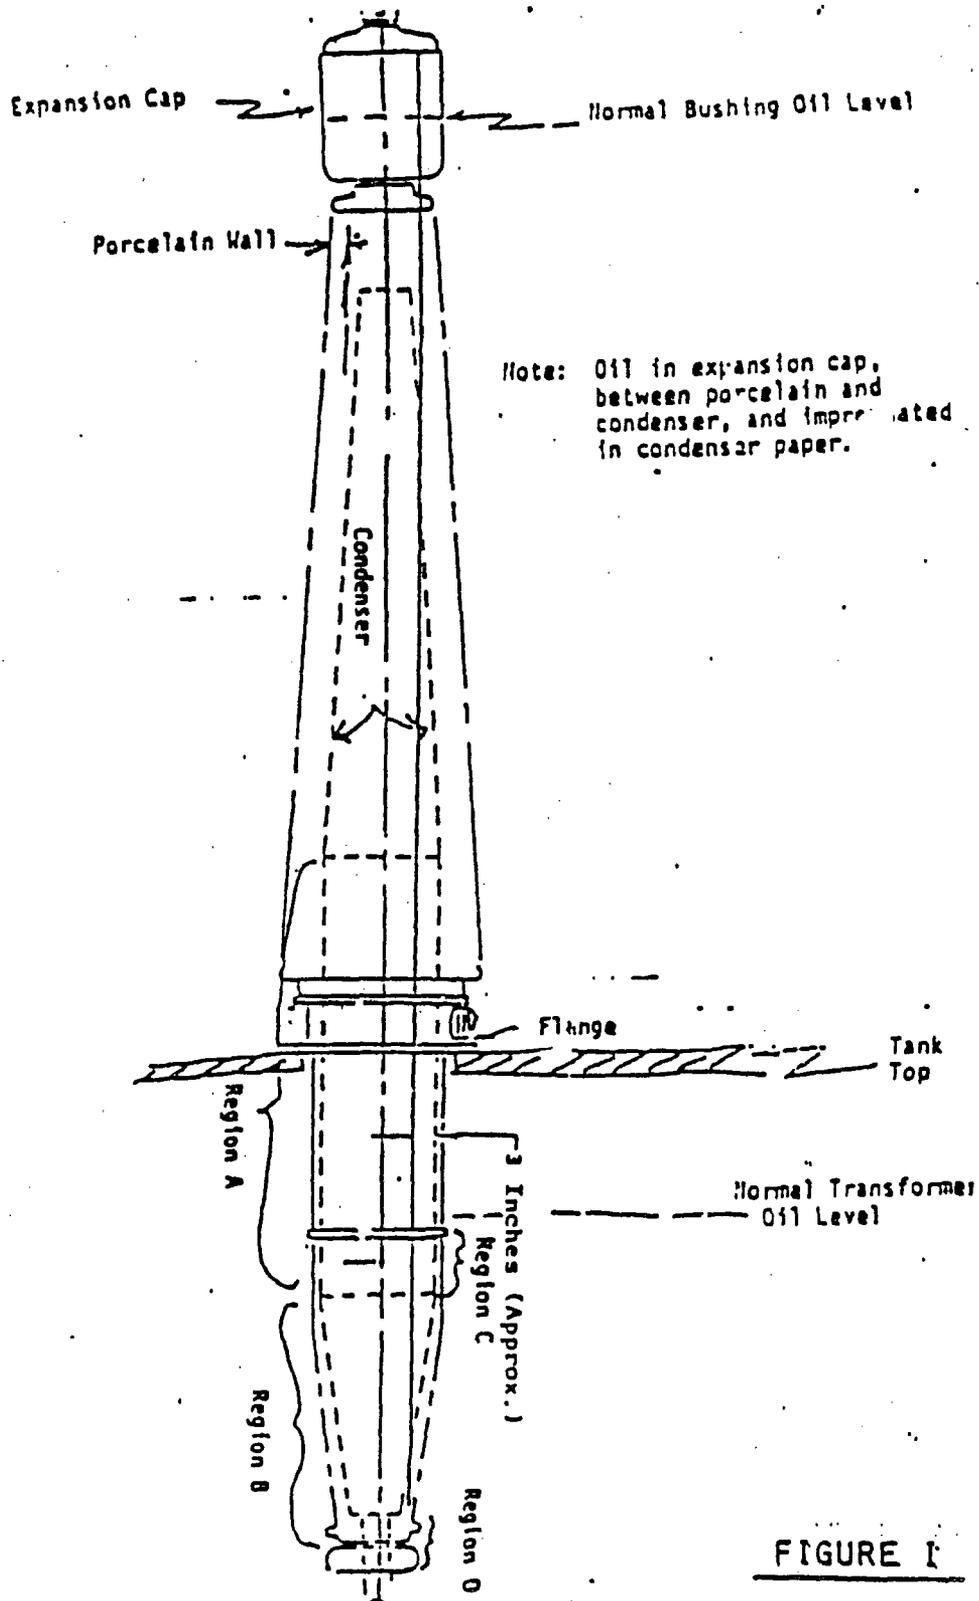
FIGURE 1

Factory inspections of these bushings (see attached Figure 1) disclosed burning of the tap and ground foils on the straight portion of the condenser where the flange and ground sleeve are attached (Region A of Figure 1). The insulating paper between these foils was wrinkled and burned on the edges in this region and across the surface of the condenser from Region A to the bottom end of the condenser taper. Arc marks were found on the lower bushing corona end shield and the ground sleeve of Phase C transformer, and on the HV lead tank wall of Phase B transformer. Based on the factory inspections, it was concluded that the failures originated as arcs between the ground and tap foils in the straight portion of the condenser (Region A). These arcs then propagated across the surface of the tapered portion of the condenser (Region B). On Phase C transformer, the gas generated by this burning disintegrated the lower portion of the bushing and established an arc path from the lower corona shield to the steel ground sleeve. The arc path on the Phase B transformer included the high voltage lead connected to the bottom of the bushing, the tank wall, and windings.

Since the bushings were improperly positioned (i.e., in the near-horizontal position) during their transportation and storage periods, portions of the condenser were not completely covered by oil. The absence of oil allowed the gas in the expansion cap to permeate the exposed paper layers. Once gas permeates the paper region the bushings are degraded electrically and long time periods are required to completely reimpregnate the paper with oil. Such degraded bushings are susceptible to corona discharges on overvoltage conditions such as those experienced by these bushings before their ultimate failures.

Corona discharges are usually extinguished when the voltage returns to normal; however, the dielectric quality of the bushing is reduced each time a corona discharge occurs. As a result, new corona discharges will occur at lower voltage levels than those of the previous discharges. This process is cumulative and can continue until the corona extinction voltage level is less than the normal operating level, in which case disruptive failures will occur. Unlike previous disruptive events at North Anna, the transformer failure of July 3 generated such great internal forces that the transformer box and one oil pump discharge pipe ruptured. The oil that erupted from these two breaks ignited, and the resultant fire shorted out the overhead bus bars from a three-phase reserve station service (RSS) transformer. The affected RSS transformer is one of three transformers that supply Unit 1 and 2 with offsite power (startup power) whenever a unit generator is not available. These transformers are also the preferred sources of power for the Class 1E loads whenever a unit generator is not available. Underground cables serve the 4160-V emergency buses from these RSS transformers, and the overhead bus bars and cables serve the normal service station buses; however, there are no isolation breakers near the RSS transformer for the overhead bus bars.
