UNITED STATES
NUCLEAR REGULATORY COMMISSION
OFFICE OF INSPECTION AND ENFORCEMENT
WASHINGTON, D. C. 20555

December 22, 1982

IE INFORMATION NOTICE NO. 82-53: MAIN TRANSFORMER FAILURES AT THE NORTH ANNA
NUCLEAR POWER STATION

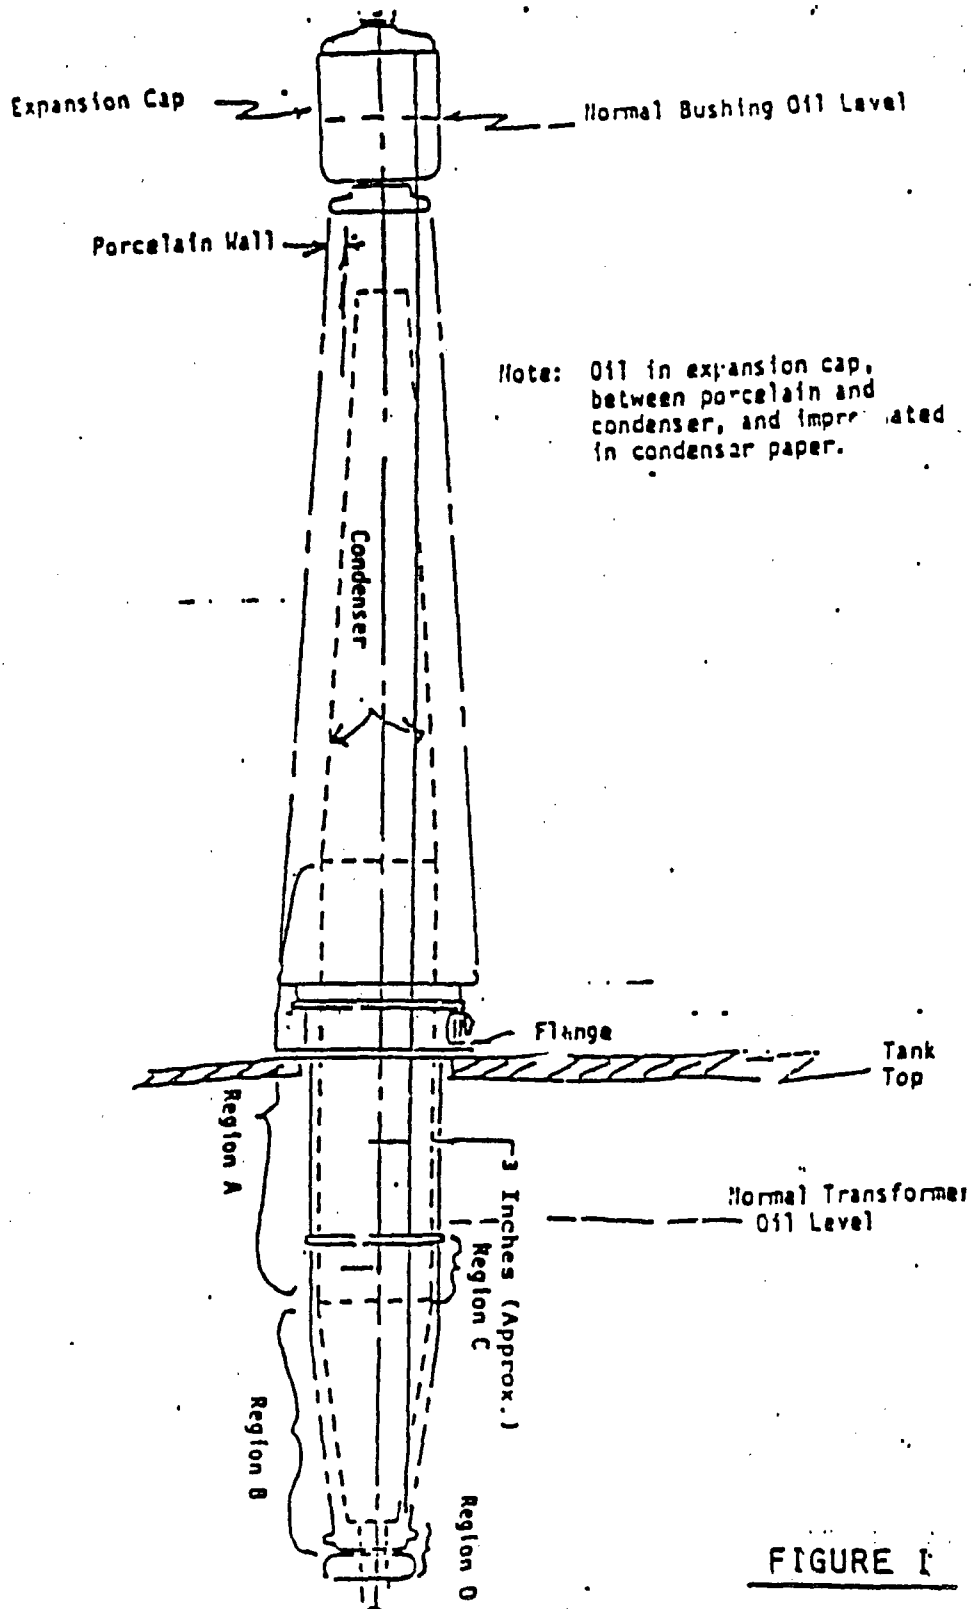
FIGURE 1

Factory inspections of these bushings (see attached Figure 1) disclosed burning of the tap and ground foils on the straight portion of the condenser where the flange and ground sleeve are attached (Region A of Figure 1). The insulating paper between these foils was wrinkled and burned on the edges in this region and across the surface of the condenser from Region A to the bottom end of the condenser taper. Arc marks were found on the lower bushing corona end shield and the ground sleeve of Phase C transformer, and on the HV lead tank wall of Phase B transformer. Based on the factory inspections, it was concluded that the failures originated as arcs between the ground and tap foils in the straight portion of the condenser (Region A). These arcs then propagated across the surface of the tapered portion of the condenser (Region B). On Phase C transformer, the gas generated by this burning disintegrated the lower portion of the bushing and established an arc path from the lower corona shield to the steel ground sleeve. The arc path on the Phase B transformer included the high voltage lead connected to the bottom of the bushing, the tank wall, and windings.

Since the bushings were improperly positioned (i.e., in the near-horizontal position) during their transportation and storage periods, portions of the condenser were not completely covered by oil. The absence of oil allowed the gas in the expansion cap to permeate the exposed paper layers. Once gas permeates the paper region the bushings are degraded electrically and long time periods are required to completely reimpregnate the paper with oil. Such degraded bushings are susceptible to corona discharges on overvoltage conditions such as those experienced by these bushings before their ultimate failures.

Corona discharges are usually extinguished when the voltage returns to normal; however, the dielectric quality of the bushing is reduced each time a corona discharge occurs. As a result, new corona discharges will occur at lower voltage levels than those of the previous discharges. This process is cumulative and can continue until the corona extinction voltage level is less than the normal operating level, in which case disruptive failures will occur. Unlike previous disruptive events at North Anna, the transformer failure of July 3 generated such great internal forces that the transformer box and one oil pump discharge pipe ruptured. The oil that erupted from these two breaks ignited, and the resultant fire shorted out the overhead bus bars from a three-phase reserve station service (RSS) transformer. The affected RSS transformer is one of three transformers that supply Unit 1 and 2 with offsite power (startup power) whenever a unit generator is not available. These transformers are also the preferred sources of power for the Class 1E loads whenever a unit generator is not available. Underground cables serve the 4160-V emergency buses from these RSS transformers, and the overhead bus bars and cables serve the normal service station buses; however, there are no isolation breakers near the RSS transformer for the overhead bus bars.
