Subject: Routine Inspection No. 040-07102/90-001

Report No. 040-07102/90-001

Facility Name: Shieldalloy Metallurgical Corporation

Routine, Announced Safety Inspection Conducted May 2-3, 1990
(Report No. 040-07102/90-001)

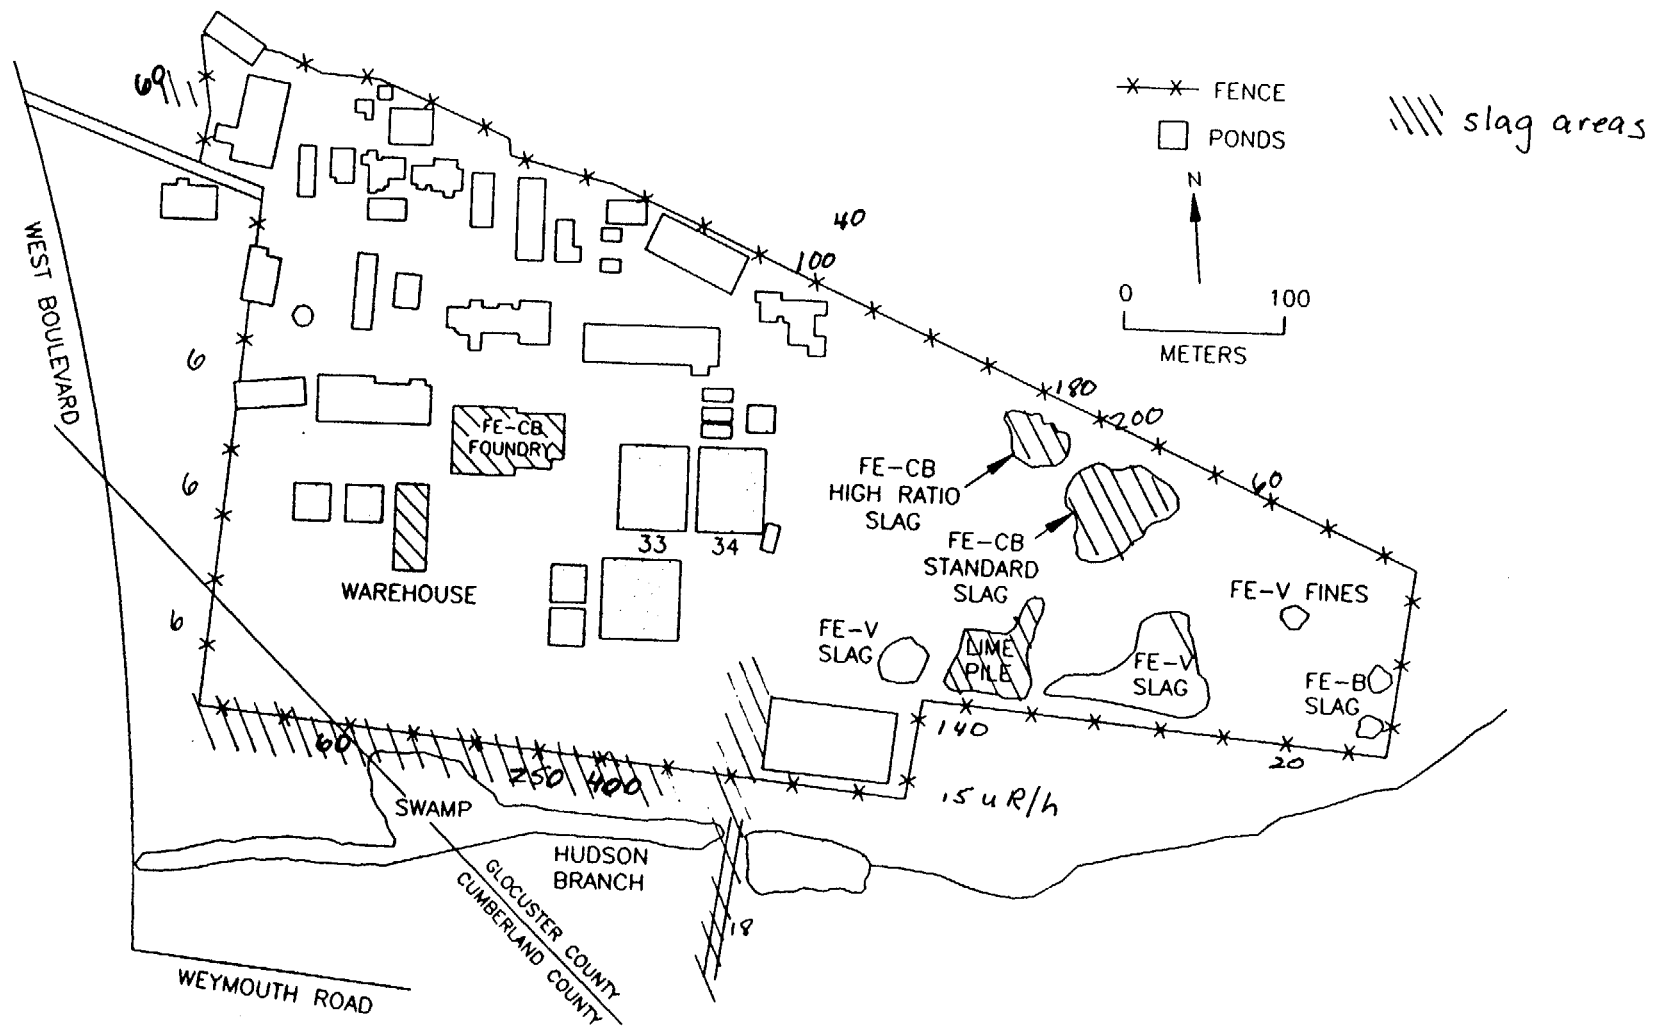
Radiation level surveys were performed outside of the fenced area by the inspectors with representatives of the State of New Jersey Department of Environmental Protection (NJDEP) and Region II of the Environmental Protection Agency. Results of this survey are included as Attachment B of this report. Radioactive slag appears to have been used in two areas as support material to build up the ground level. The first area begins at the corner of the fence along Weymouth road and extends along the fenceline to the access road, and about 10 feet from the fence. Radiation levels of 300-400 uR/h were noted in this area, but dropped to less than 20 uR/h at a distance of 25 feet from the fence. The second area is the access road from Weymouth Road through a gate into the fenced site. It is not known if the slag in the access road is ferro-columbium or ferro-vanadium.

Ambient radiation levels at the fence along the landfill range from 40 uR/h to 200 uR/h. The maximum radiation level at the fence by the ferro-columbium slag piles was 200 uR/h, and dropped to 40 uR/h at a distance of approximately 25 feet from the fence. A small area by the transformer station at the front of the property measured 60 uR/h.

Layout of the Shieldalloy Plant in Newfield, New Jersey
Radiation levels in microroentgen per hour.
