South Texas Project Electric Generating Station P.O. Box 289 Wadsworth, Texas 77483

South Texas Project
Unit 2
Docket No. STN 50-499
Licensee Event Report 2-06-001
Safety Injection Train Inoperable Longer Than Allowed Under Technical Specifications

4. TITLE
Safety Injection Train Inoperable Longer Than Allowed Under Technical Specifications

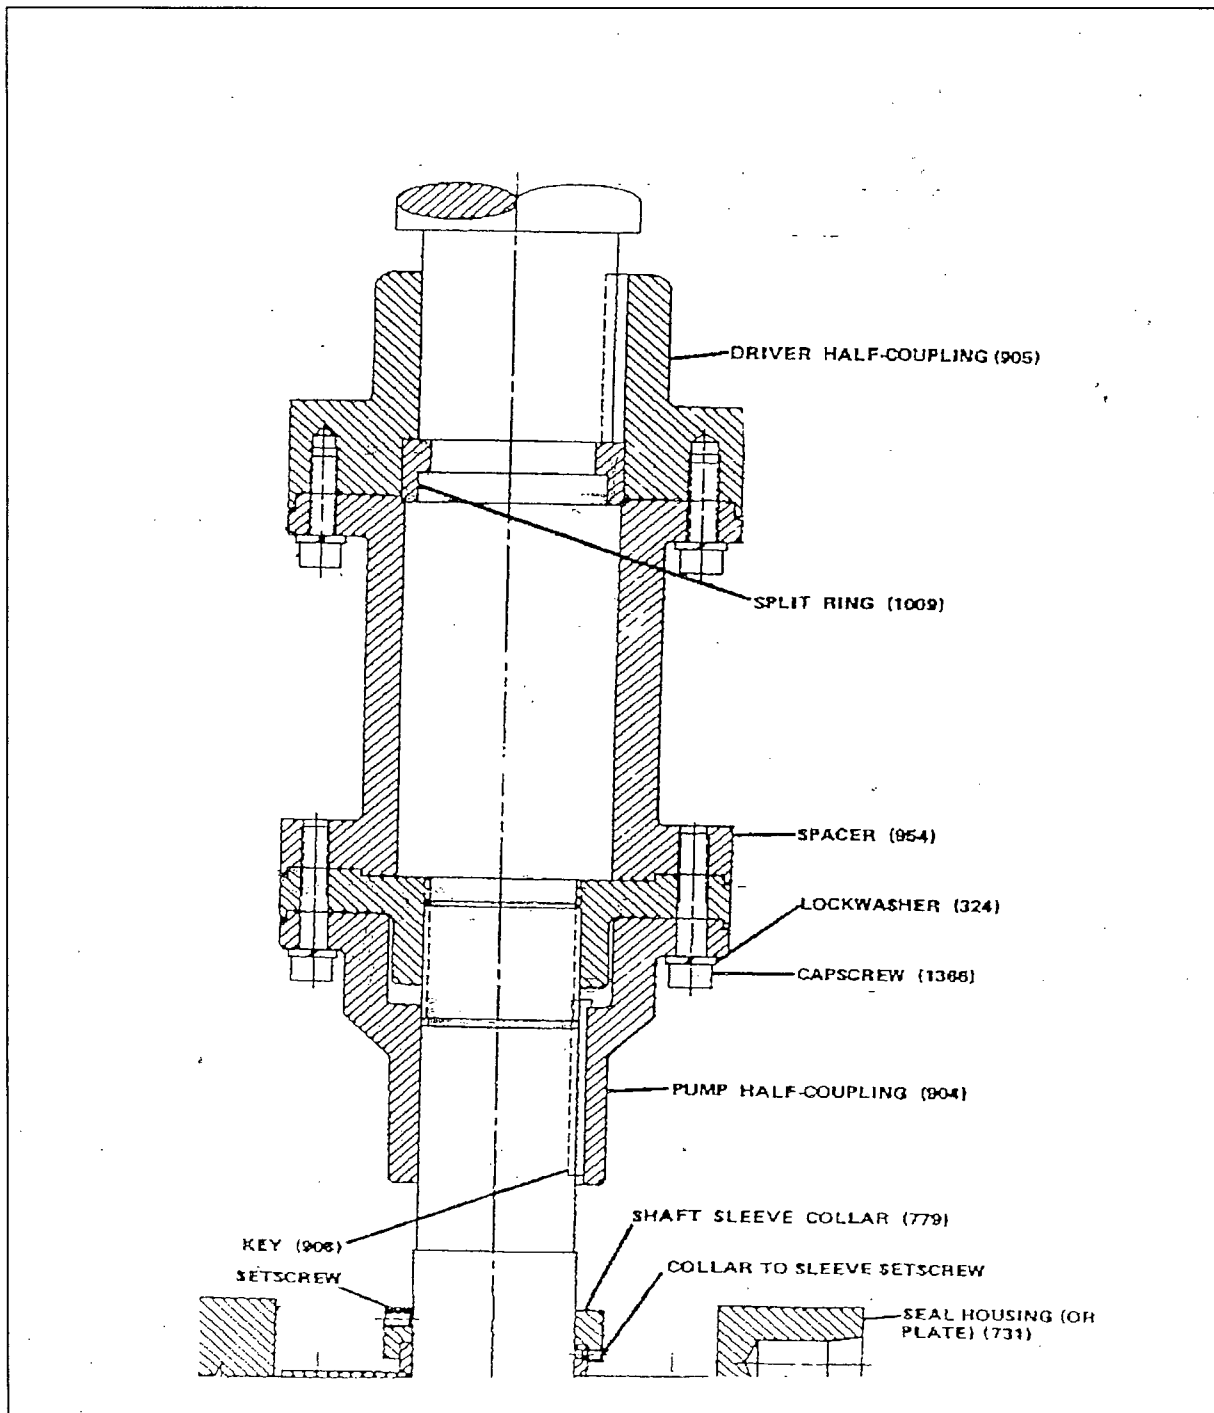
High Head Safety Injection Pump Shaft and Coupling

Access to the mechanical seal required removal of a pump half-coupling. However, the half-coupling was found to be stuck. To free the stuck half-coupling, use of hydraulic force was determined to be necessary. The force exerted in freeing the half-coupling apparently damaged the pump internals. The mechanical seal package was replaced and, during reassembly, a spacer connecting the half-coupling could not be reinstalled due to a lack of clearance. The pump casing was filled with water to check the pump shaft for freedom of rotation. However, the pump shaft would not rotate, with the following as probable causes:

- Internal obstruction resulting from application of excessive force to remove the half-coupling.
- Internal obstructions resulting from repeated vertical movement of the pump shaft without lubrication to the upper impeller bearings during reassembly, causing galling of the stainless steel bearings.

The unexpected condition of the stuck half-coupling was not sufficiently assessed and the potential hazards to the affected components were not identified prior to proceeding to use force in removing the pump half-coupling.

Affected personnel will be retrained on the Conduct of Maintenance and expectations on tool use.
