UNITED STATES
NUCLEAR REGULATORY COMMISSION
REGION IV
611 RYAN PLAZA DRIVE, SUITE 400
ARLINGTON, TEXAS 76011-4005

February 6, 2007

SUBJECT: PALO VERDE NUCLEAR GENERATING STATION - NRC INTEGRATED
INSPECTION REPORT 05000528/2006005, 05000529/2006005, AND
05000530/2006005

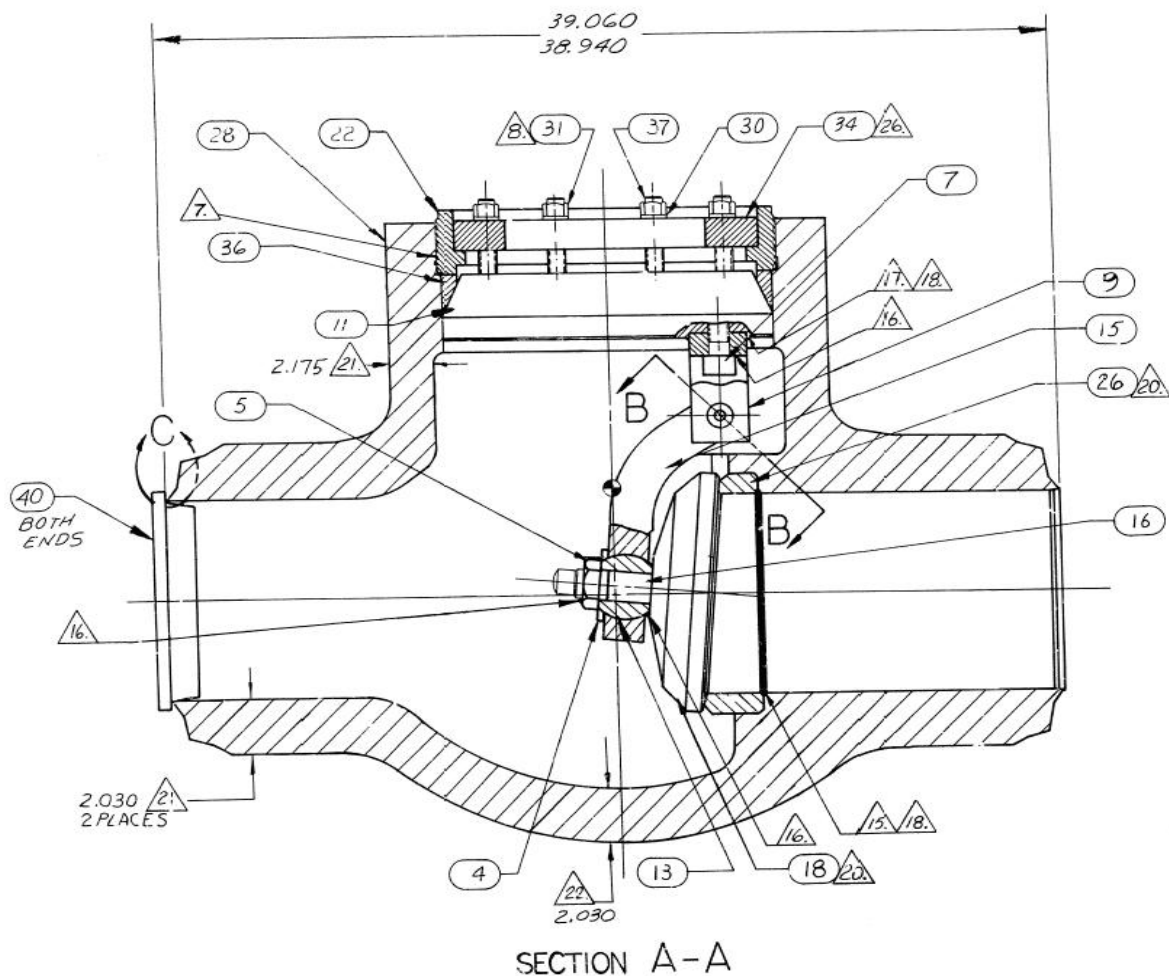
The disc assembly for this Borg Warner swing-check valve consists of the following parts:

Item	Part	P/N	Material
4	Washer	1 3/8" Type A	316 CRES
5	Nut	1 3/8"-12UNF	ASTM A194, Grade 8M
13	Ball (spherical bearing)	72114	Stellite #6B
15	Swing Arm	75497	17-4PH material (AMS 5398)
16	Stud	72108	ASTM A276, Type 316A
18	Disc	76865	ASME SA182, Type 316
