**Subject: Docket No. 50-362**  
**60-day Post Refueling Outage Reactor Pressure Vessel Head**  
**Inspection Report for San Onofre Nuclear Generating Station, Unit 3**

## 60-day Post Refueling Outage Reactor Pressure Vessel Head Inspection Report for San Onofre Nuclear Generating Station, Unit 3 Cycle 13

**SAN ONOFRE Unit 3  
Control Element Drive Mechanism (CEDM) #56  
November 2006 Ultrasonic Exam Re-evaluation**

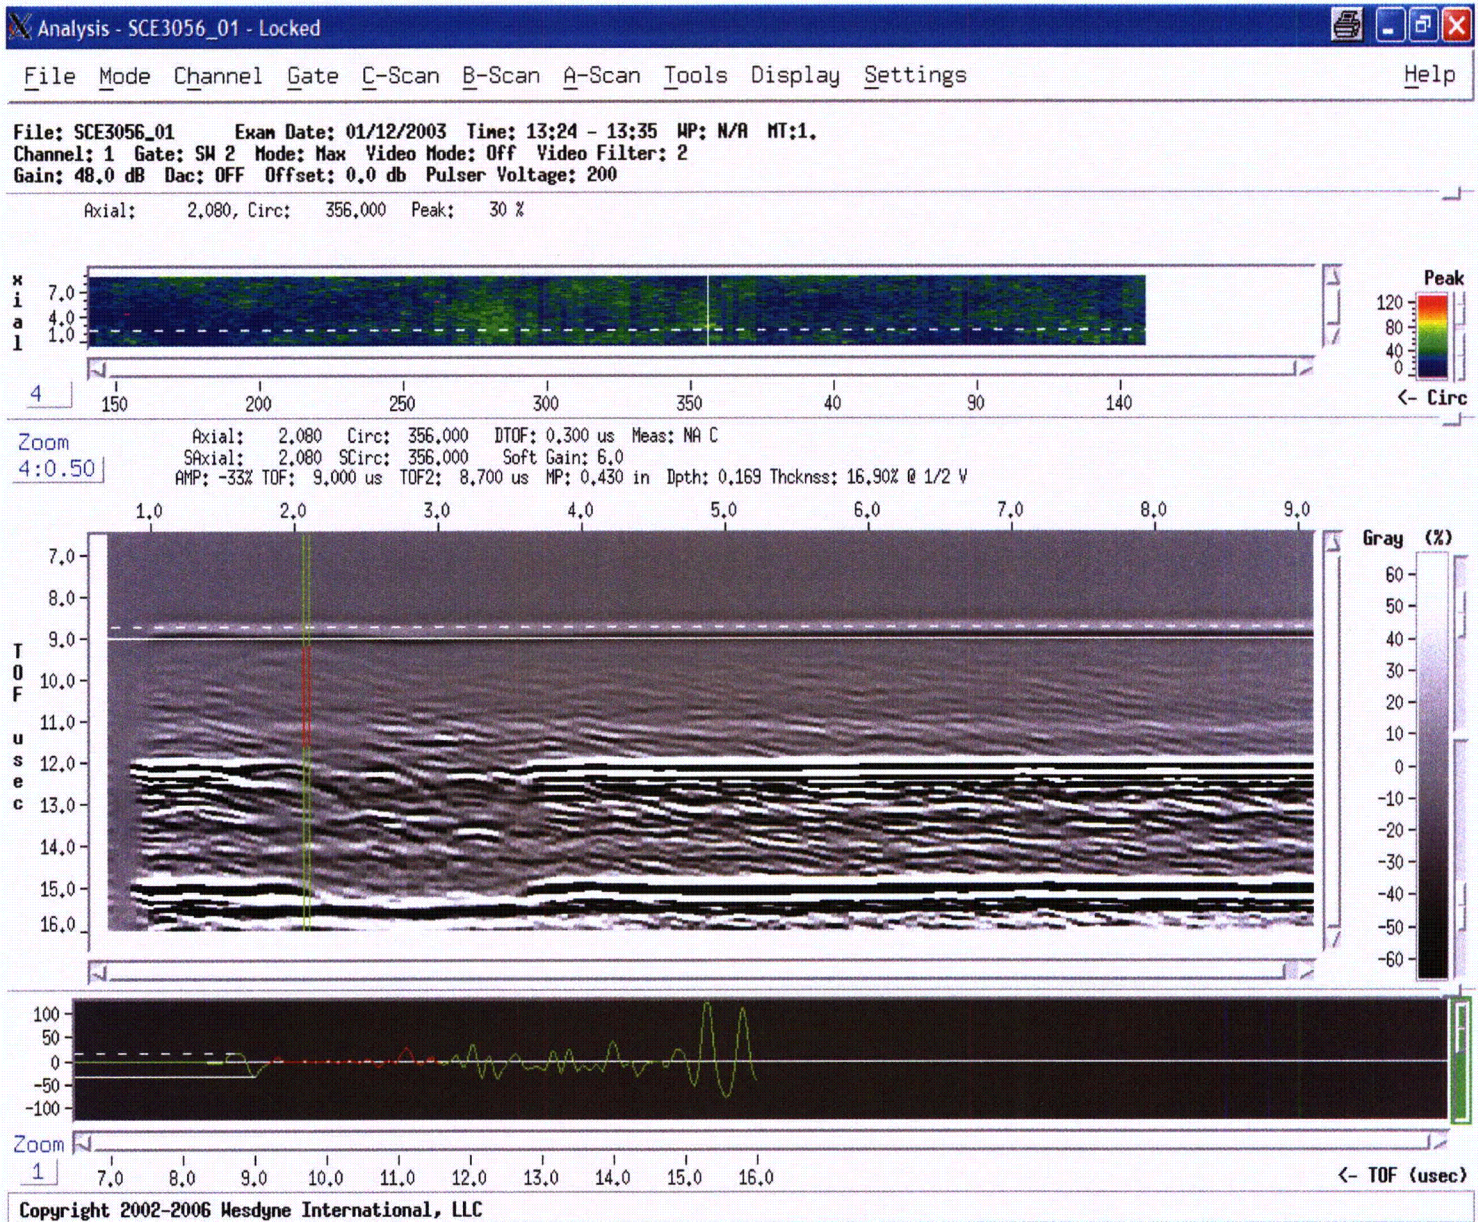
Figure 1A

During the inspection of CEDM #56 a Parent Tube Indication (PTI) was reported at a circumferential location of 356° near the lower extent of the weld. This indication was reported to have a remaining ligament of 0.293" (ID) and was dispositioned as grain noise after supplemental eddy current examination confirmed that there was no OD or ID surface connection.

Data from the 2003 inspection were re-evaluated in November 2006. Evaluation of the same indication has determined that the indication had a remaining wall of 0.169". This evaluation considered both the B and "B" prime scan (Figures 1A and 1B) for evaluation.

Comparing Figures 1A from the Cycle-12 inspection and Figure 4A from the Cycle-14 inspection shows that the depth of this indication in CEDM 56 has remained essentially the same from 2003 thru 2006. It is SCE's conclusion that this indication shows no growth from discovery in 2003.

Indication (Anomaly) #1  
B Scan Channel 1

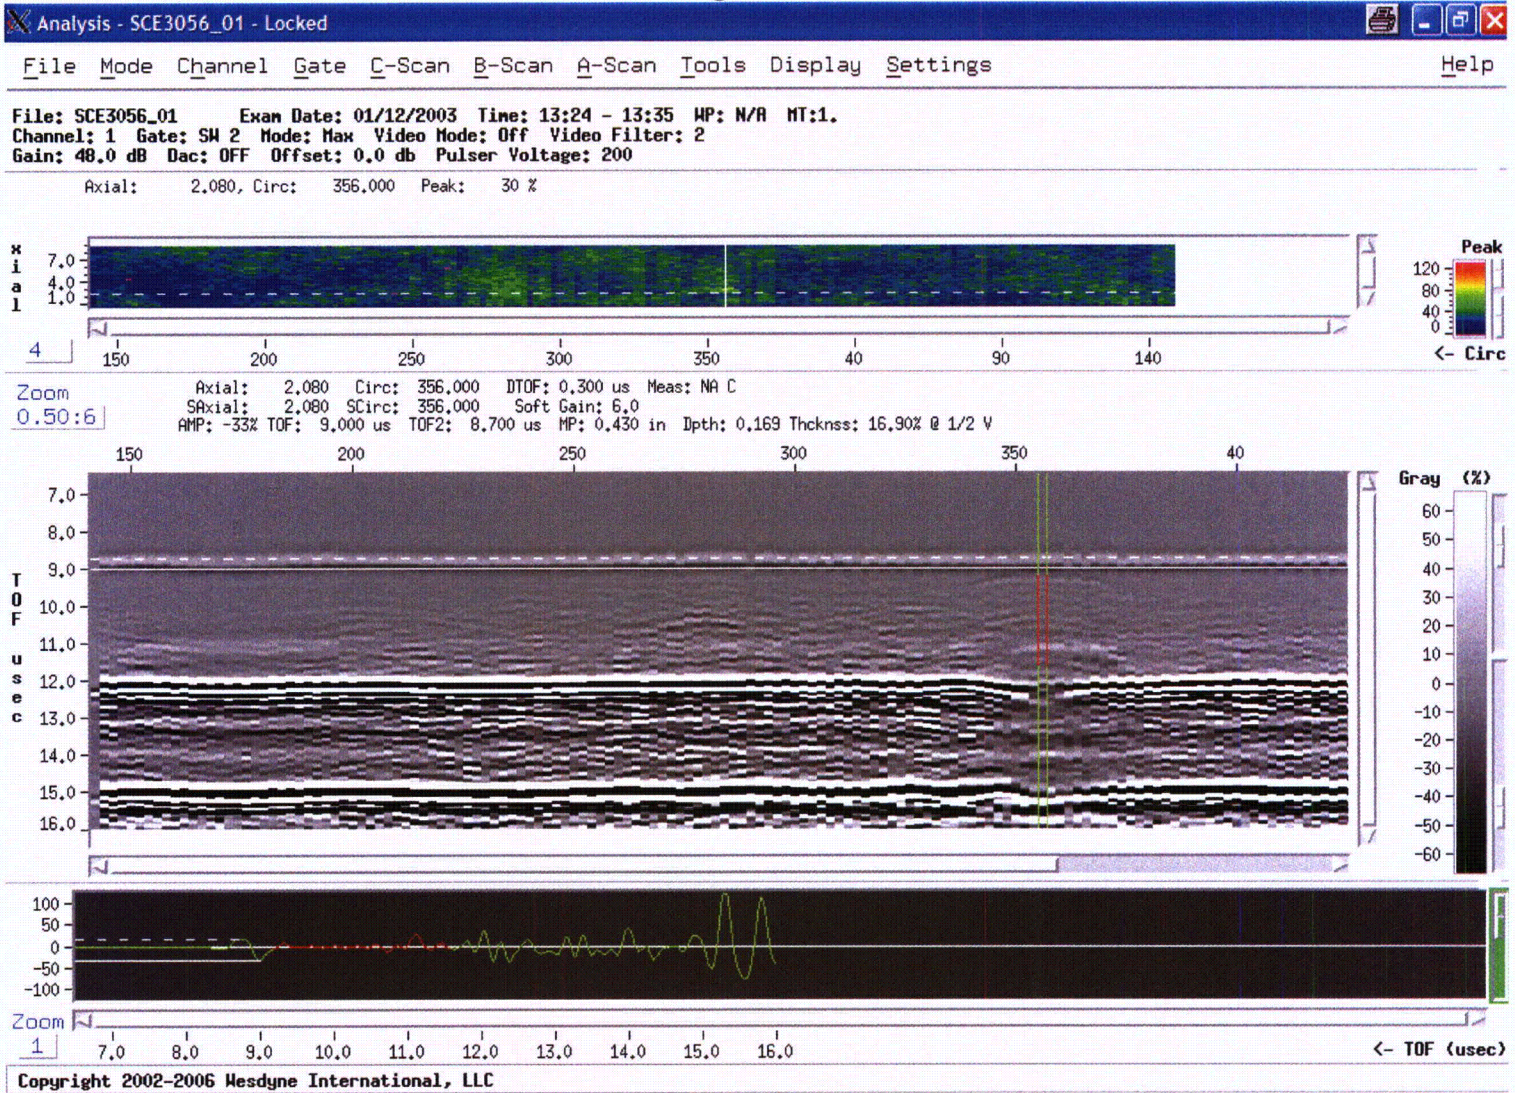
Figure 1B

Indication (Anomaly) #1  
"B" Prime Scan Channel 1

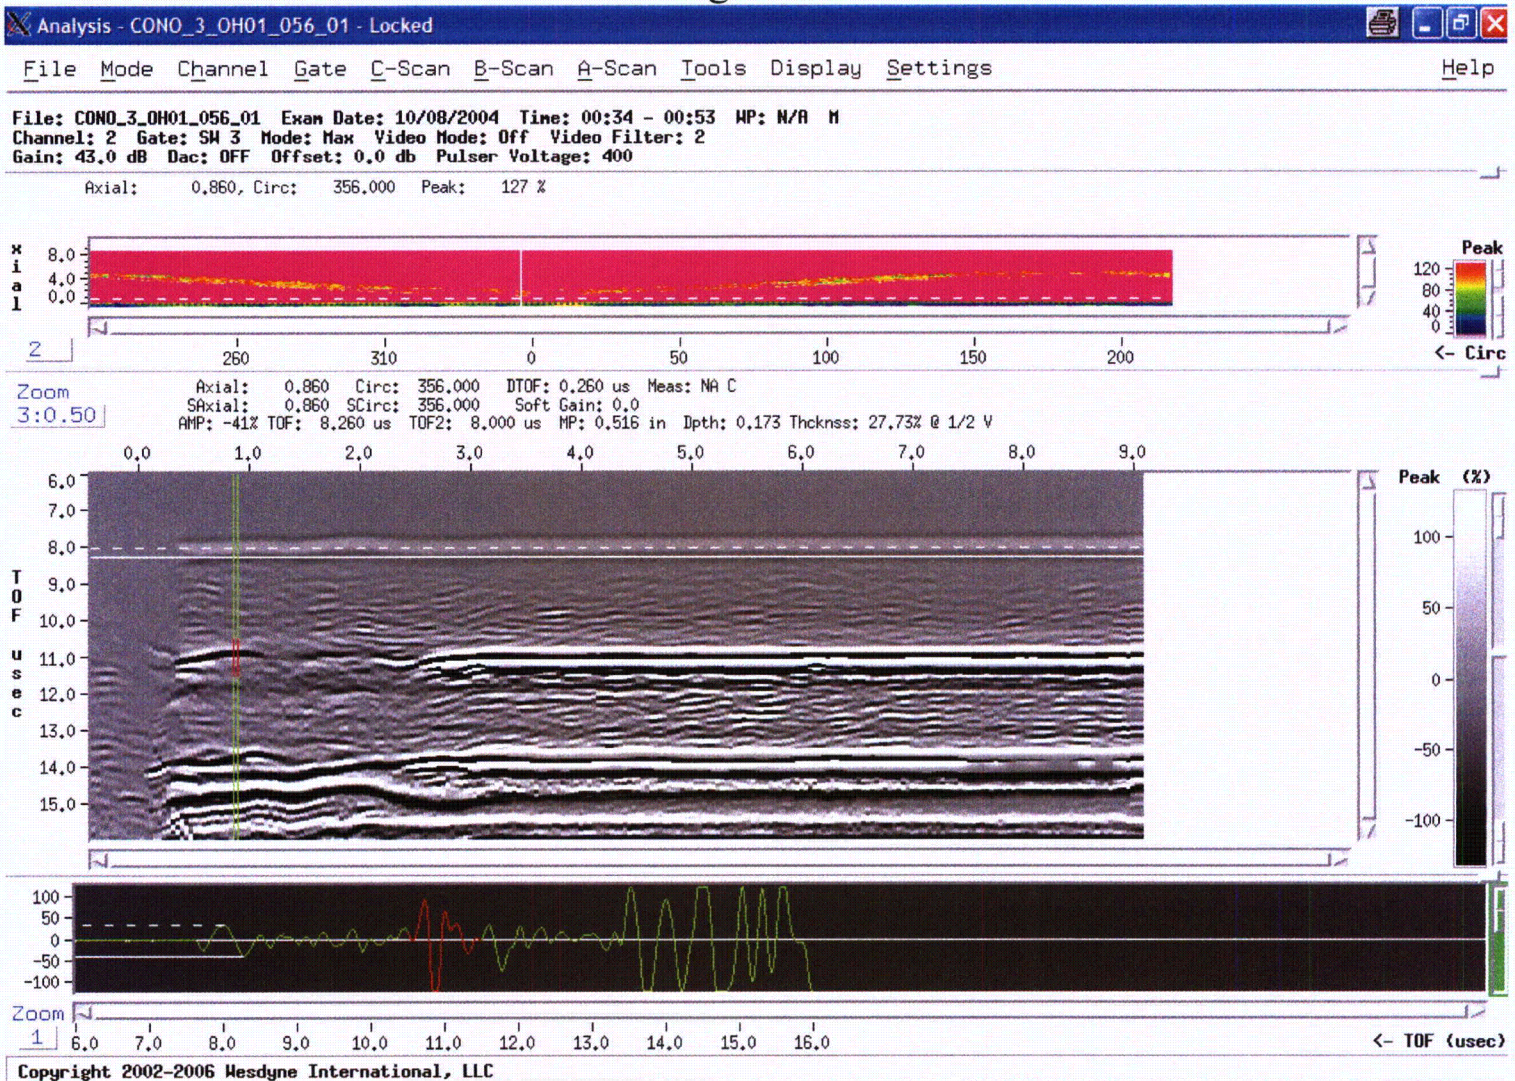
Figure 2A

During the inspection of CEDM #56 a PTI was reported. This Indication was reported at a circumferential location of 356° near the lower extent of the weld. This indication was reported to have a through wall depth of 0.513" with a remaining ligament of 0.148". The reported growth since the previous inspection led to a weld repair of the penetration.

Sizing results of this indication in November 2006 were similar to the 2004 inspection record. The indication through wall depth was 0.491" with a remaining ligament of 0.170". (See Figures 2A and 2B).

Indication (Anomaly) #1  
B Scan Channel 2

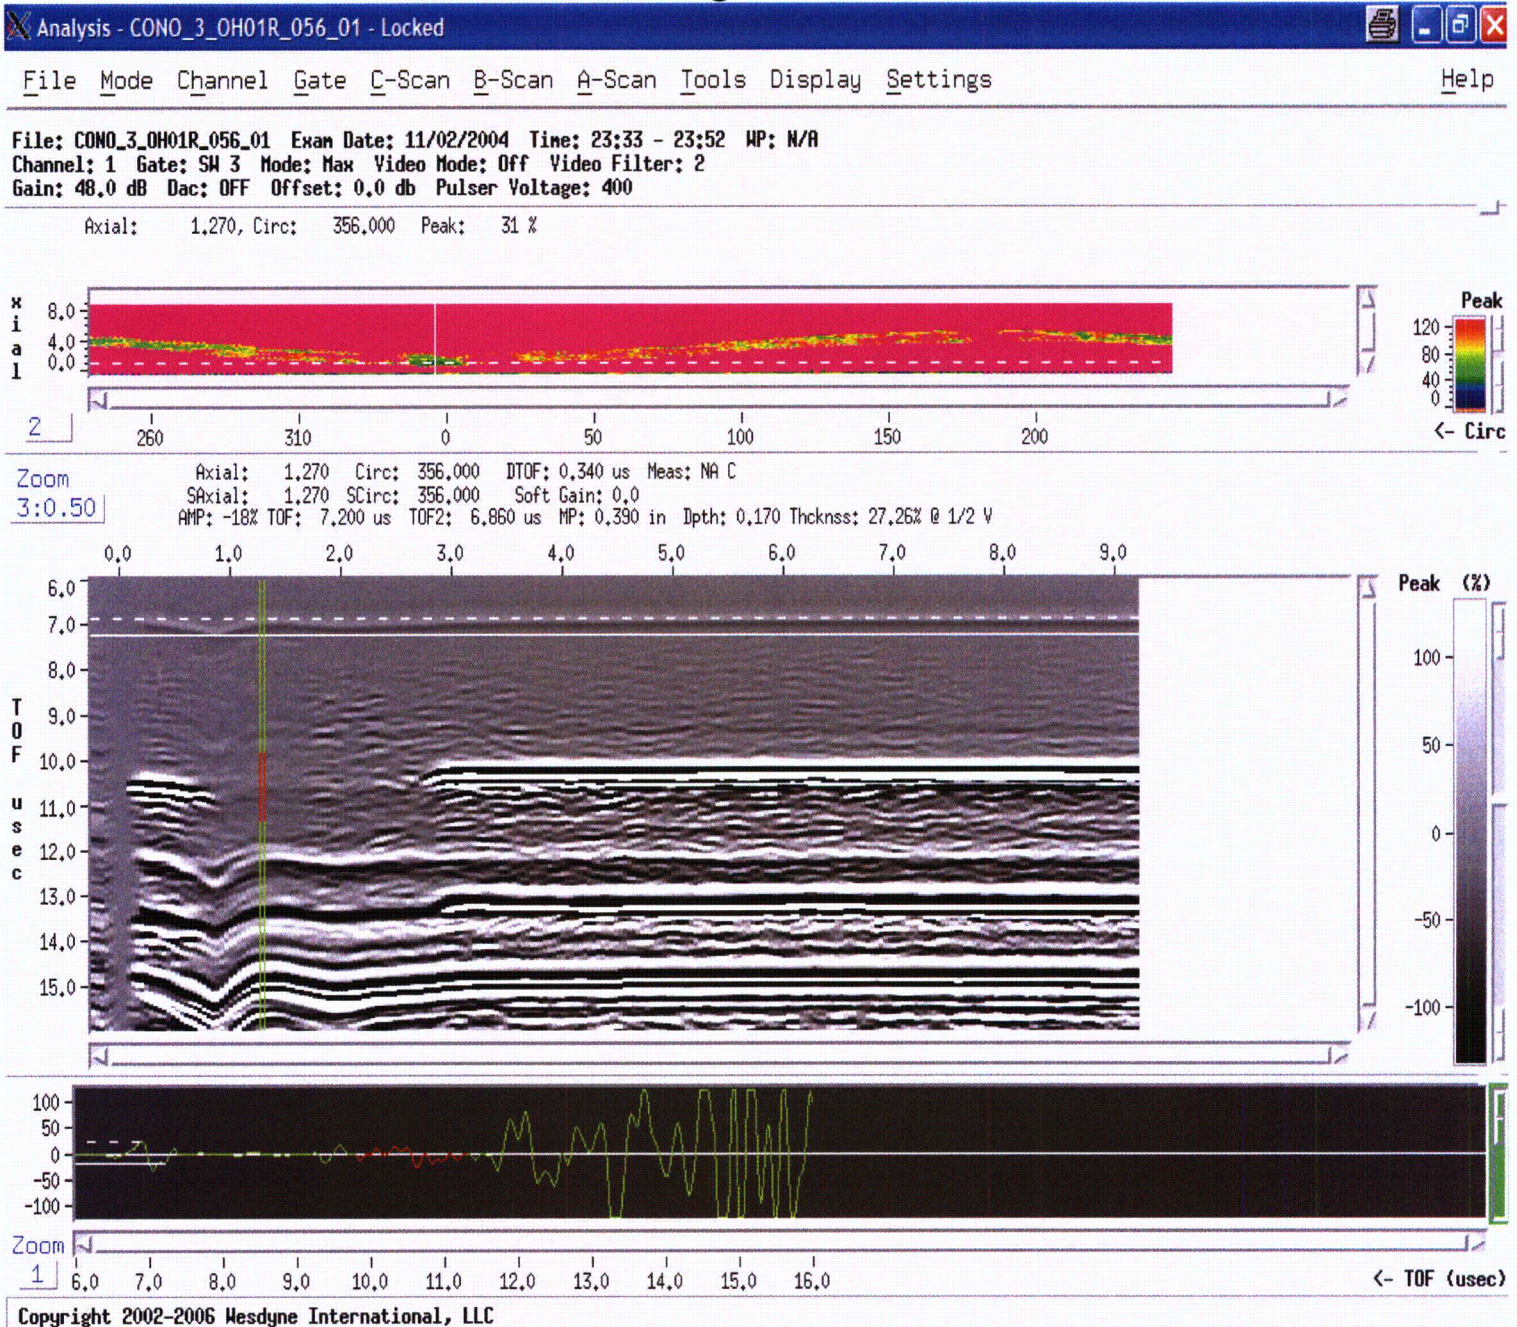
Figure 2B

Indication (Anomaly) #1  
B Scan Channel 1

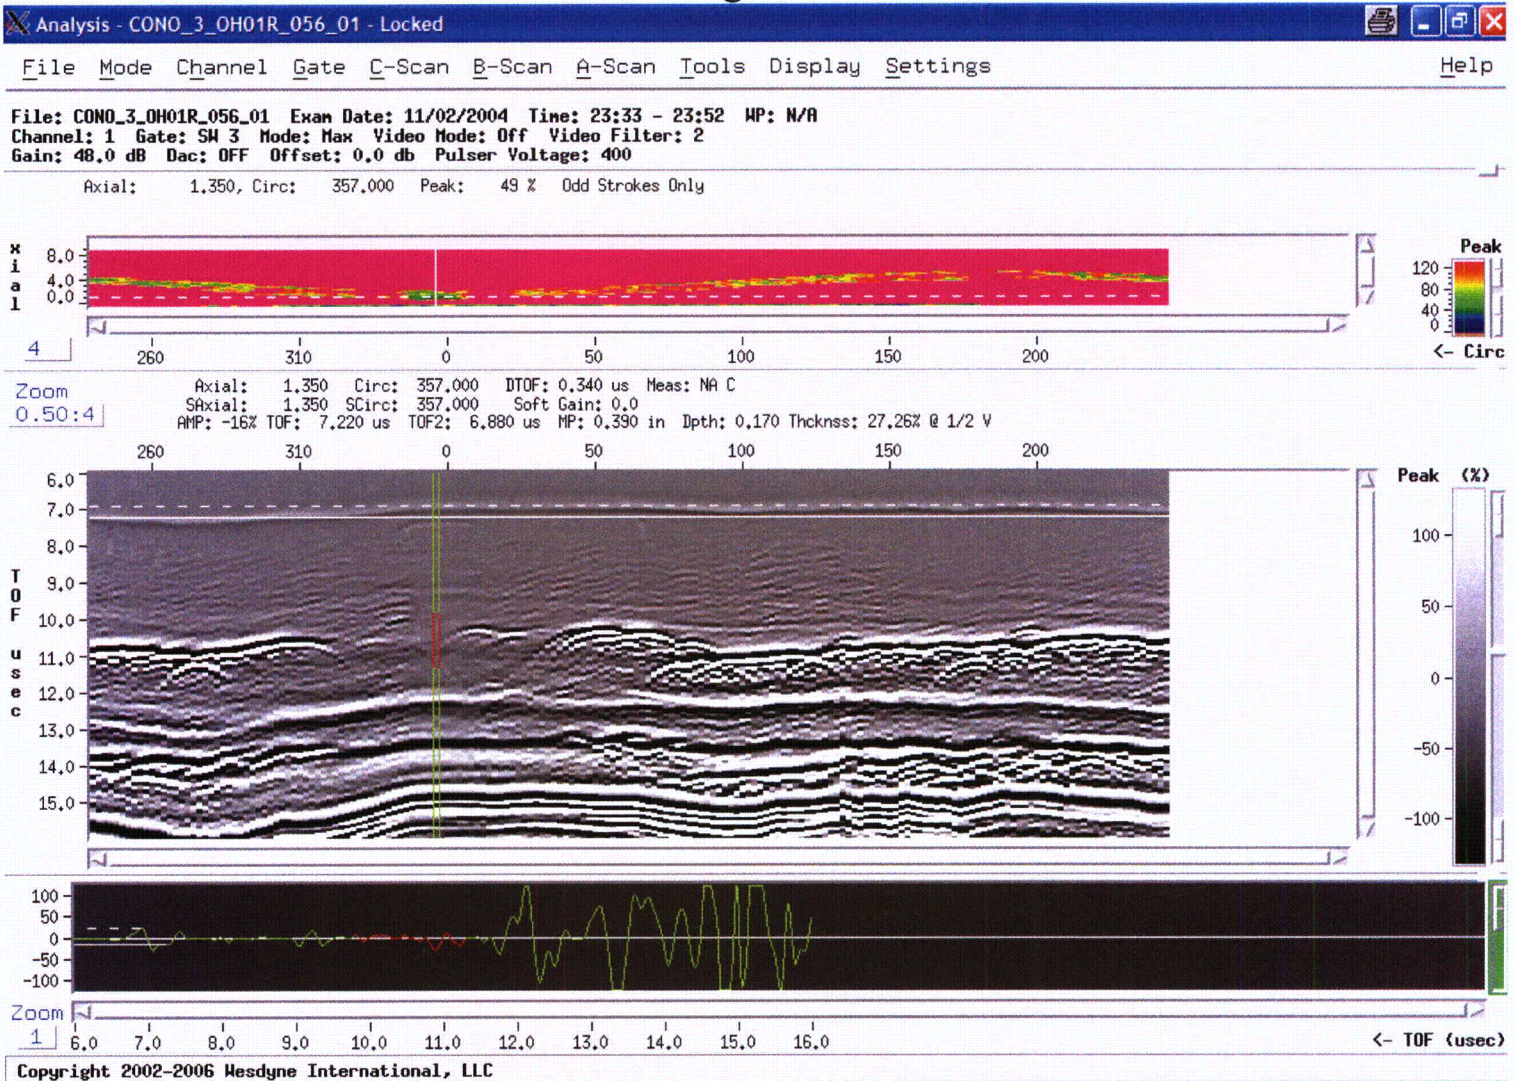
Figure 3

The November 2006 analysis of post repair inspection data found no change from the pre-repair inspection data. (See Figure 3)

Post Repair Examination  
"B" Prime Channel 1

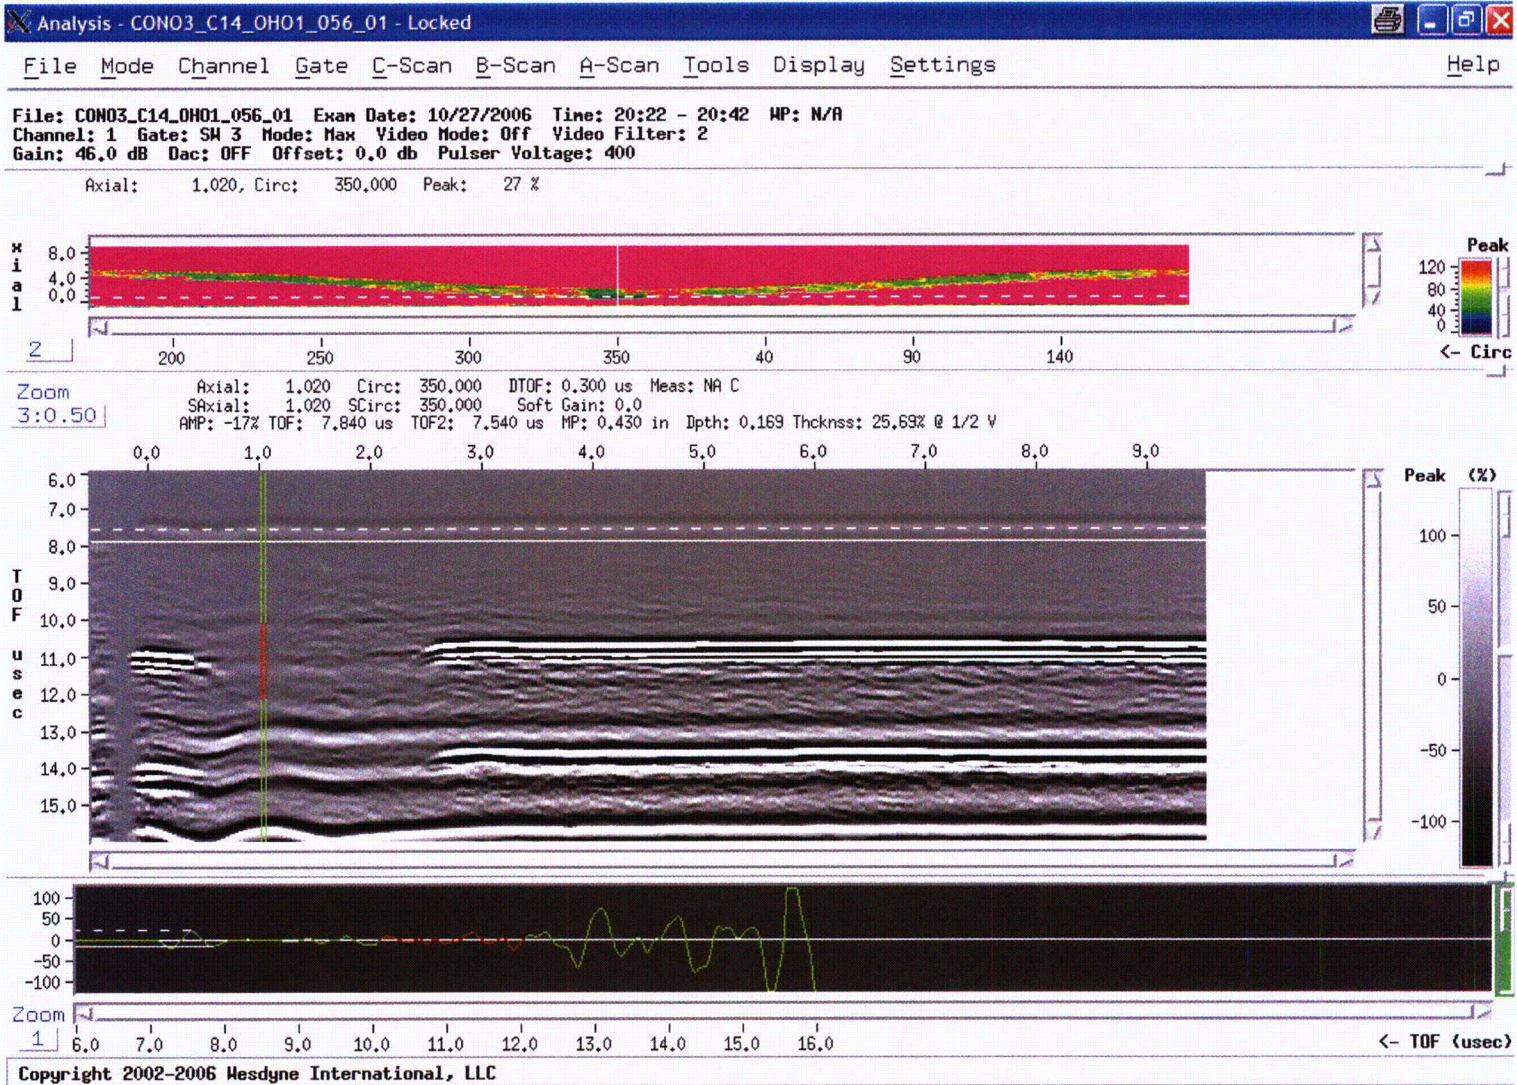
Figure 4A

During the inspection of CEDM #56 a PTI was reported. This was the same indication reported during the 2003 and 2004 pre and post repair inspections. This indication was reported at a circumferential location of 350° near the lower extent of the weld. This indication was reported to have a through wall depth of 0.464" with a remaining ligament of 0.197". The analyst noted there were no diffraction signals typical of PWSCC observed.

The November 2006 re-evaluation concluded that the Indication has a through wall depth of 0.492" and a remaining ligament of 0.169". (See Figures 4A and 4B).

Within this comparison there are slight changes in the grain noise due to refinement in calibration settings, better transducer contact and an increase in pulse voltage. It appears that the original sizing of this indication during the 2003 inspection did not accurately identify the indication's maximum depth. This is in part due to having determined in 2003 that the indication was not a PWSCC flaw. Under sizing of this indication in 2003 led to reported growth and repairs during the 2004 inspection.

Indication (Anomaly) #1  
B Scan Channel 1

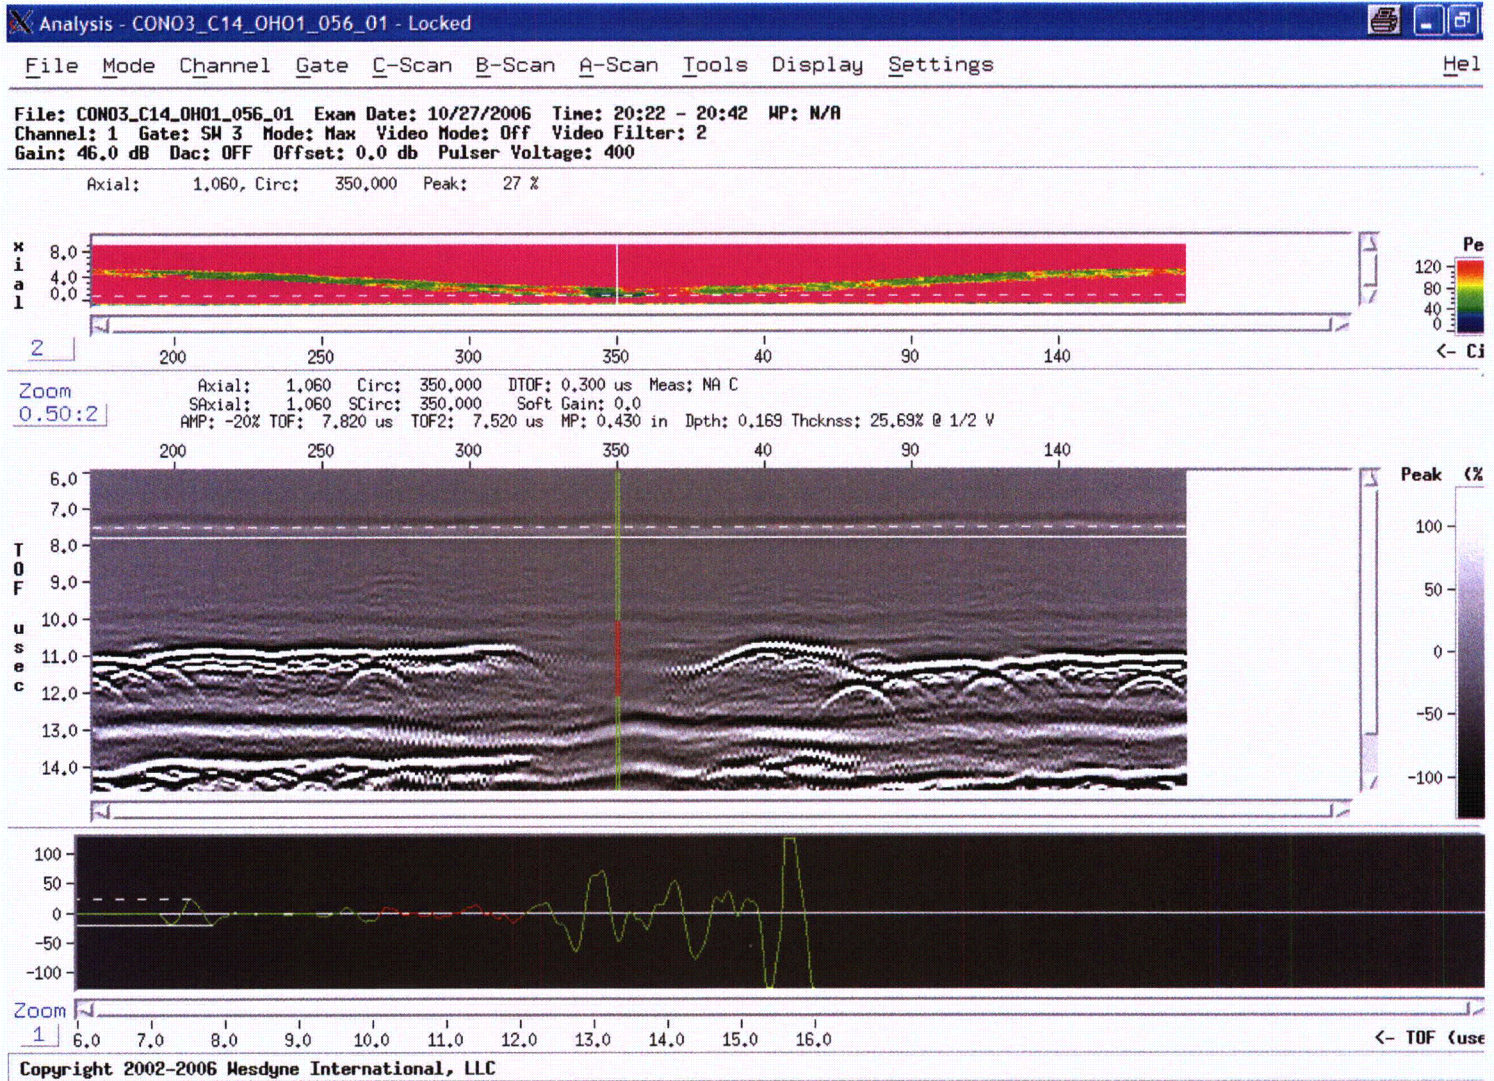
Figure 4B

Indication (Anomaly) #1  
"B" Prime Scan Channel 1
