From: "Hinrichs, Gary H" <ghinric@entergy.com>
To: "James Noggle" <JDN@nrc.gov>, "Timothy Rice" <tbrace@gw.dec.state.ny.us>
Date: Mon, Nov 20, 2006 4:24 PM
Subject: Unit 2 SFP fuel transfer canal pictures

Here are the photos we attached to the CR we wrote for the transfer canal indications:

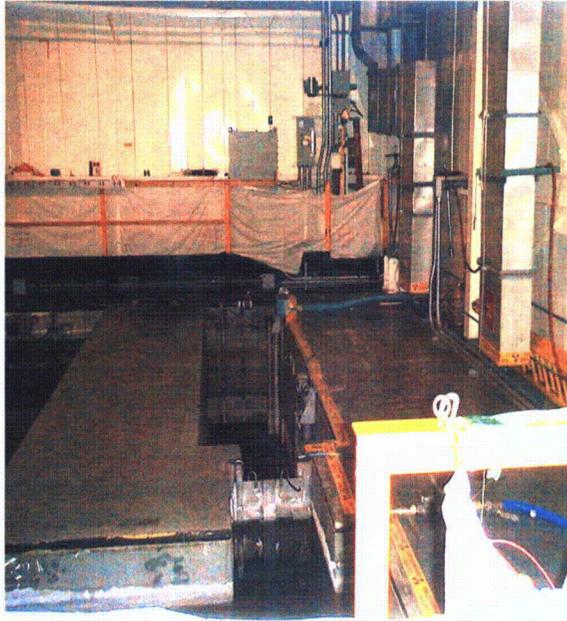
Figure 1
SFP's Transfer Canal (Top View)

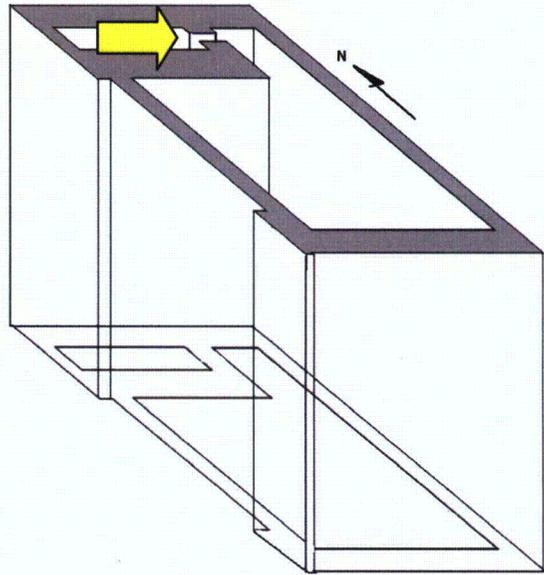
Figure 2
SFP's Transfer Canal (Location shown by arrow)

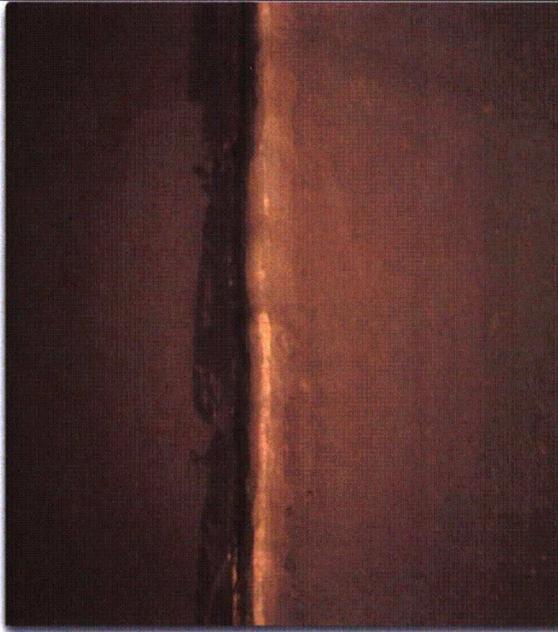
Figure 3
East Wall and South Wall - Outside Corner
Seam Weld

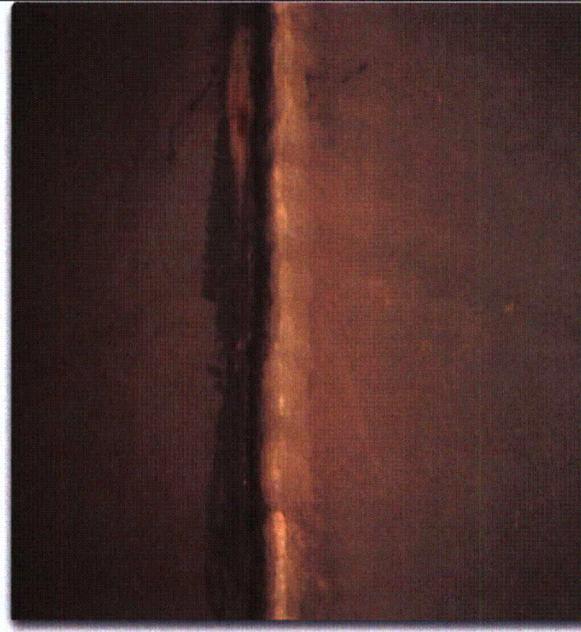
Figure 4
East Wall and South Wall - Outside Corner
Seam Weld

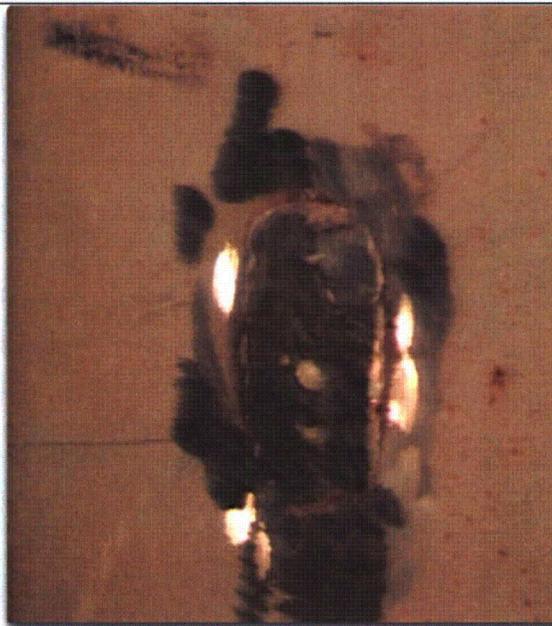
Figure 5
North Wall - Plug Weld

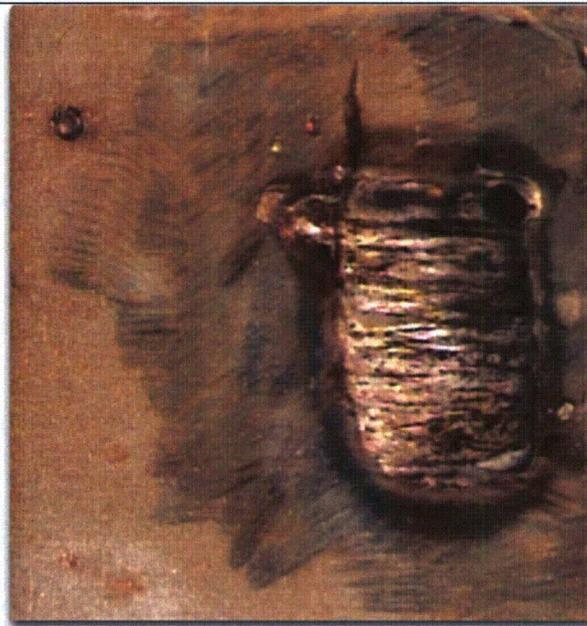
Figure 6
North Wall - Plug Weld

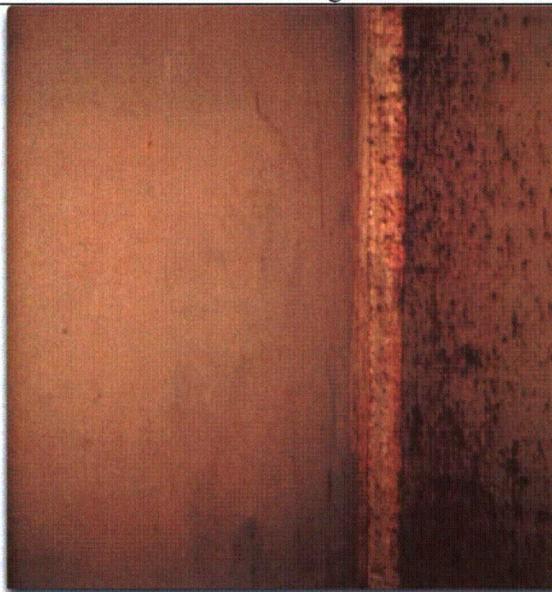
Figure 7
East Wall and North Wall - Inside Corner
Seam Weld

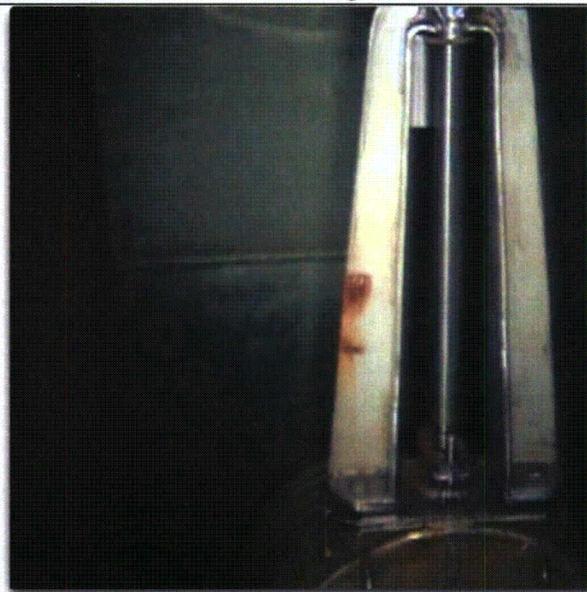
Figure 8
West Wall - Sleeve Penetration for Transfer
Tube
(Apparent Corrosion About Pen Weld)
