Nine Mile Point Nuclear Station

**SUBJECT:** Nine Mile Point Nuclear Station  
Unit No. 1; Docket No. 50-220

Generic Letter 94-03, "Intergranular Stress Corrosion Cracking of Core Shrouds in Boiling Water Reactors," Request for Authorization Under the Provision of 10 CFR 50.55a(a)(3)(i) for Modification of the Core Shroud Stabilizer Assemblies (Tie Rods)

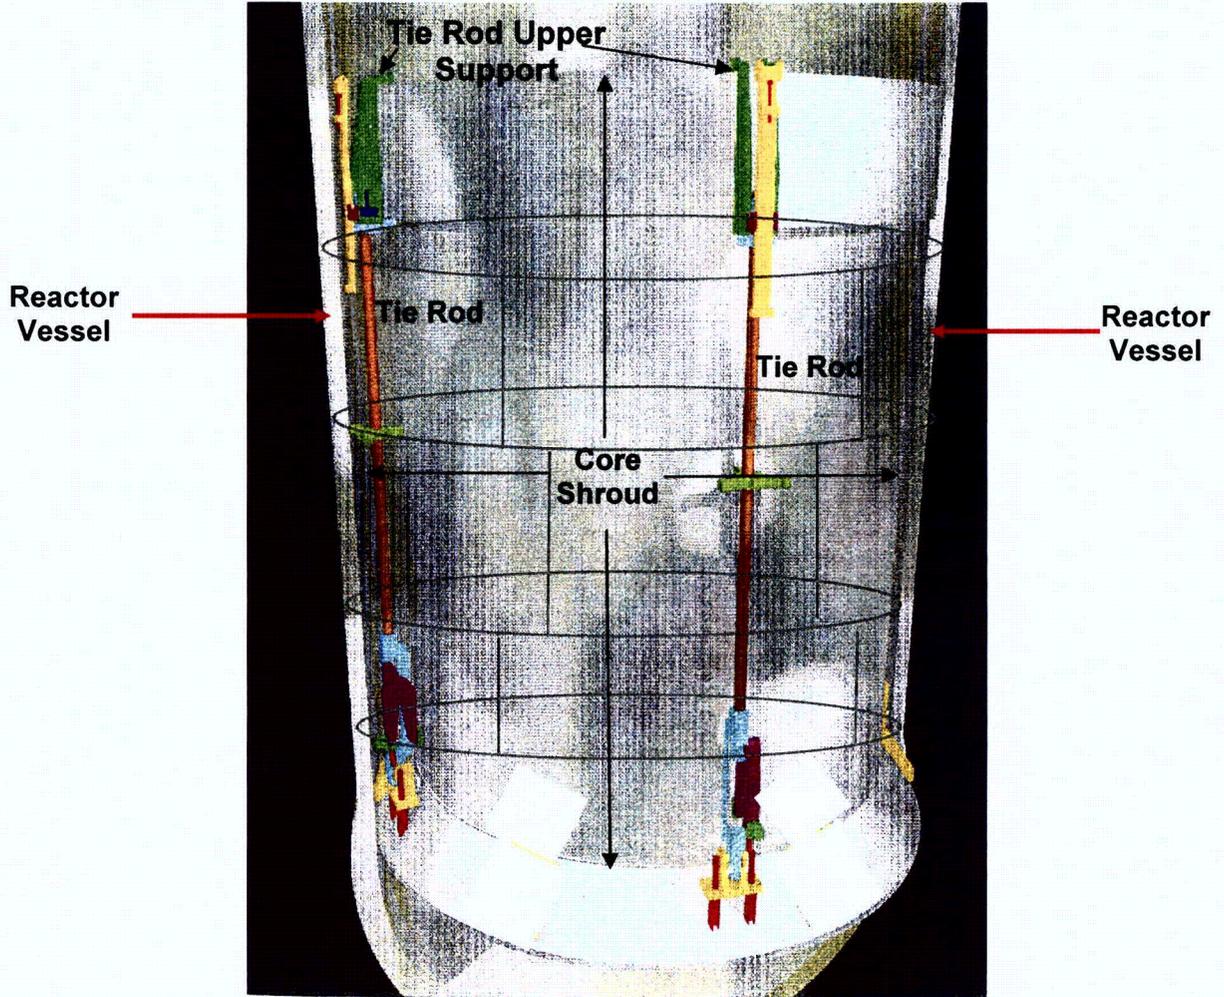
Figure A1-1

NMP1 Core Shroud Tie Rod Repair Assembly Hardware

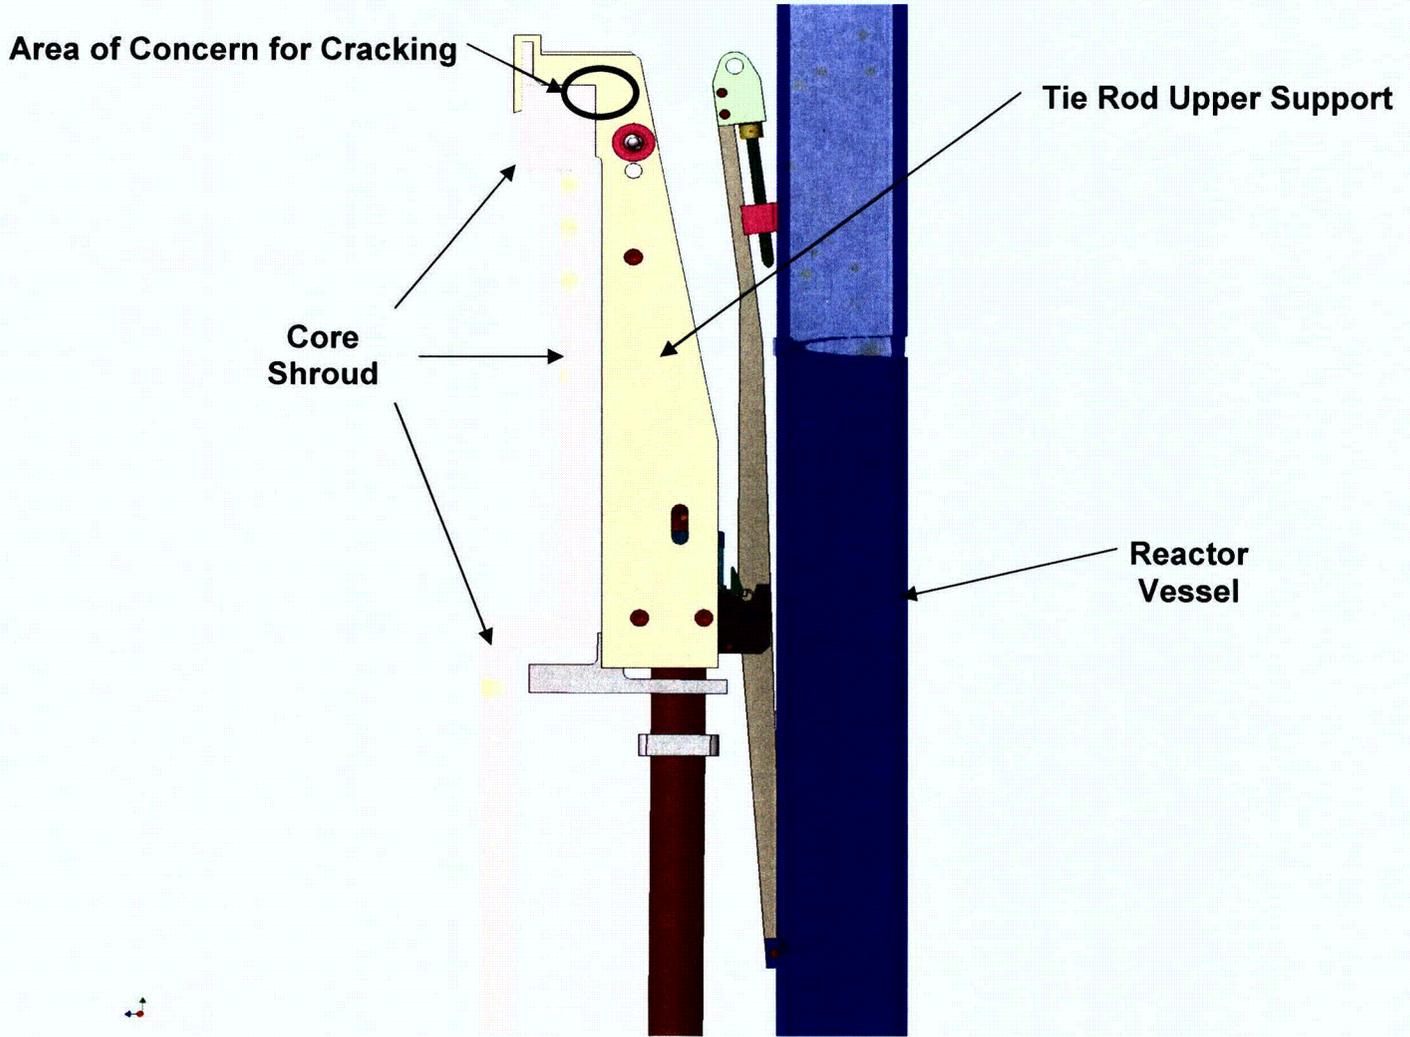
Figure A1-2

GE has determined that several other BWRs including NMP1 exceed the BWRVIP-84 criteria for the upper supports (in addition to the Hatch Unit 1 as-found condition). The results of the evaluation are included in the GE 10 CFR Part 21 Notification dated October 9, 2006 (Reference 1). Based on the Hatch Unit 1 finding, GE has revised the assessment of the GE tie rod upper support design life and determined that the potential for a high peak surface stress exists for the NMP1 tie rod design. This high peak stress reduces the design life of the tie rod upper support. Tie rod inspections performed during each refueling outage could justify continued operation on a cycle-by-cycle basis, and such an inspection was being planned as a contingency for the upcoming NMP1 refueling outage (RFO19); however, Nine Mile Point Nuclear Station, LLC (NMPNS) has determined that the most prudent course of action and the best long-term economic solution is pre-emptive replacement of the tie rod upper support with a modified upper support design capable of operation through the end of the renewed operating license term (2029).

Tie Rod Upper Support

Revised stress analyses for the existing tie rod upper support and tie rod nut have identified a high sustained peak stress condition at stress risers in the upper support and tie rod nut threads that increases the components' susceptibility to intergranular stress corrosion cracking (IGSCC). The increased IGSCC susceptibility decreases the design life of the components as originally described in the NRC safety evaluation (SE) dated March 31, 1995. The NRC SE stated that the core shroud repair hardware design life was 25 years based on information contained in the original NMP1 core shroud repair submittals. The design objective of the proposed tie rod modifications is to design and install replacement upper support assemblies and tie rod top nuts that will remain resistant to IGSCC over the remaining plant life (i.e., until 2029). The modification to the tie rod upper support and nut will include features to reduce the sustained peak stress in the components, thus reducing the susceptibility of the Alloy X-750 material to cracking.

The geometry of the replacement hardware (upper support, tie rod nut, and other associated upper support components) is shown on Figure 1 of the GE stress analysis report (Attachment 5). These newly-designed components incorporate features that improve their ability to resist IGSCC. These features include: (1) a large fillet radius at the corner of the upper support; (2) increased width and thickness of the upper support; (3) sharp edges eliminated; and (4) a larger root radius of the tie rod nut threads. Additional details of the improvements made are provided in Attachment (5). The original tie rod installation required that cutouts be made in the shroud head flange to accommodate the upper supports, which hang over the shroud flange. The width of the cutouts will be increased to accommodate the increased width of the modified upper supports.
