DRAFT FOR
NRC Awaiting
PORC APPROV

IR 0553792-02, Drywell Structural Integrity Basis from 1R21 Inspections

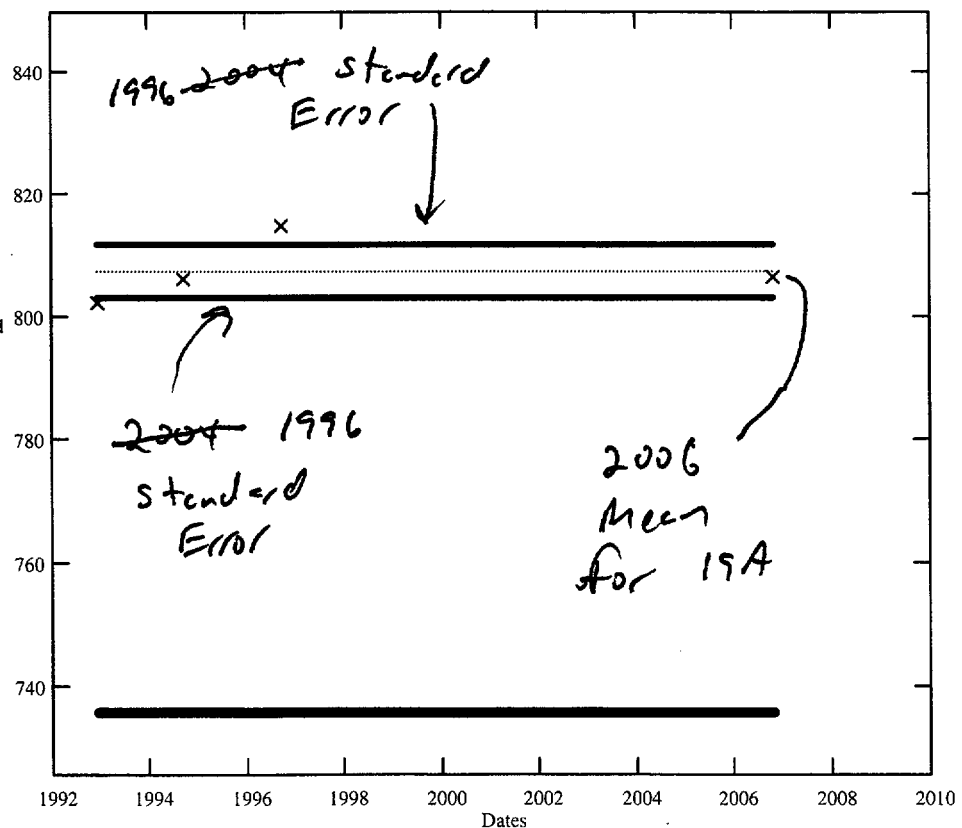
Calculation C-1302-187-5300-030 identified location 19A as the most critical since it was the thinnest area in the sandbed. However the calculation concluded with 95% confidence that this location and the other sandbed region locations were not experiencing corrosion. Figure 1 provides a trend of the mean values for this location. Figure 1 also provides curves showing the calculated standard error of plus or minus 0.0034 inches for the means. The 2006 mean is also plotted on figure 1 and shows that this value is well within the standard error band.

Therefore the curve fit of the means does not have a slope and the grandmean is an accurate measure of the thickness at this location

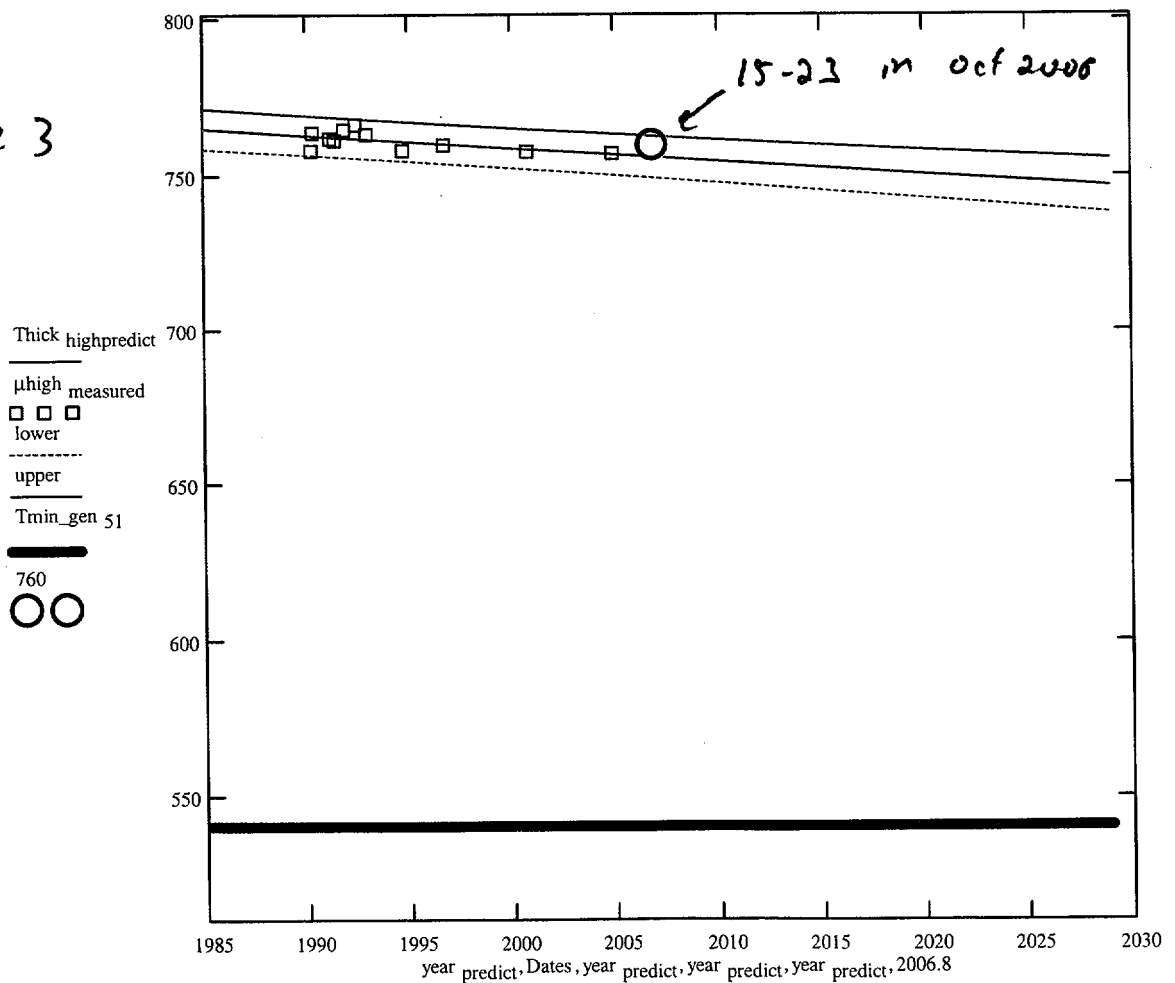
The 2004 calculation identified locations 5-5HI and 15-23HI as the most critical since they were the thinnest at this elevation. The calculation concluded that these locations are experiencing corrosion rates of 0.0003 and 0.0004 inches per year with 95% confidence. Figure 2 and Figure 3 provide trends of the means of data collected from 1987 through 2004 for these locations taken from calculation C-1302-187-E310-037 Revision 2. The 2006 means for each location are plotted on these figures. These show that the 2006 means are consistent with and are bounded by the 2004 projections. Therefore the margins and projections from 2004 remain valid and bounding. Table 1 provides the means and margin calculated in 2004.

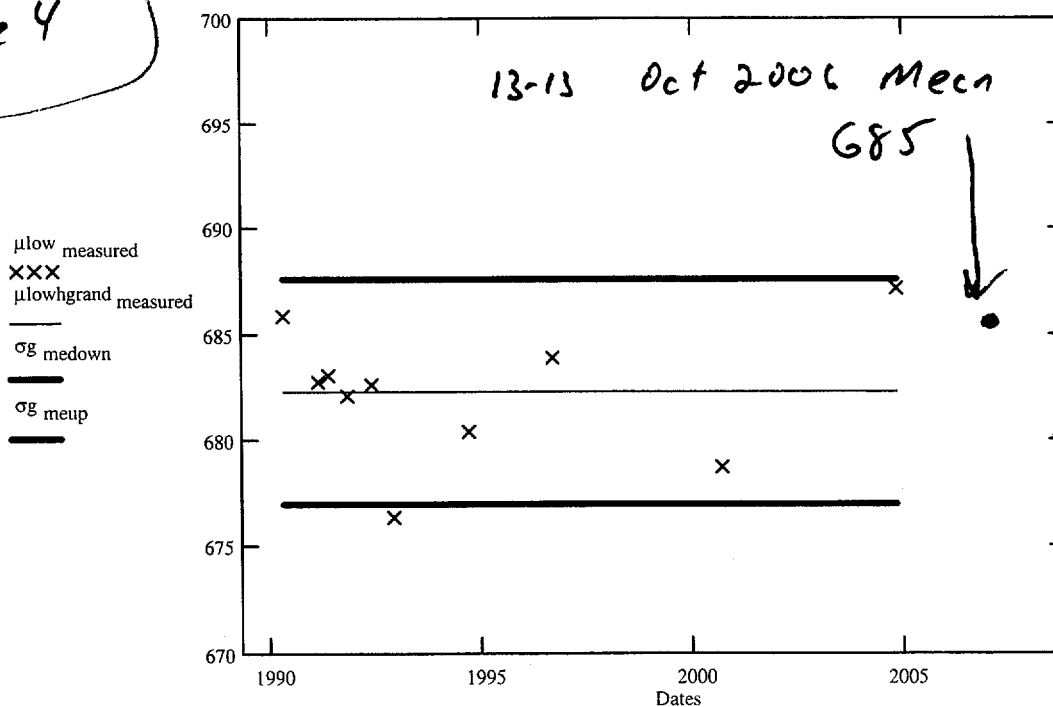
The 2004 calculation identified location 13-32 as the most critical since it was the thinnest at this elevation. However the calculation concluded with 95% confidence that the location was not experiencing corrosion. Figure 4 provides a trend of the means of data collected from 1987 through 2004 for this location taken from calculation C-1302-187-E310-037 Revision 2. The 2006 mean for this location is plotted on this figure. Figure 4 also provides curves showing the 2004 calculated standard error of ± 0.0053 inches for the data from 1987 to 2004. The 2006 mean is well within the 2004 standard error band.

This shows that the 2006 mean is consistent with and bounded by the 2004 projection, which concluded that this location is not corroding. Therefore the margin and projection from 2004 remains valid and bounding. Table 1 provides the means and margin calculated in 2004.

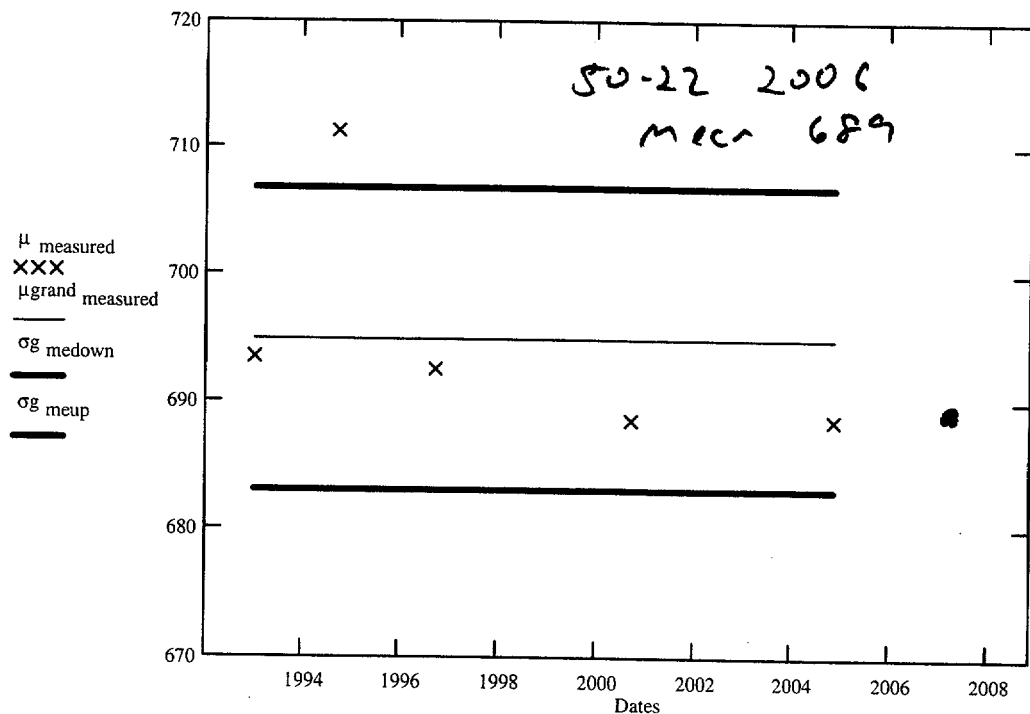
The 2004 calculation identified location 5-22 as the most critical since it was the thinnest at this elevation. However the calculation concluded with 95% confidence that the location was not experiencing corrosion. Figure 5 provides a trend of the means of data collected from 1992 through 2004 for these locations taken from calculation C-1302-187-E310-037 Revision 2. The

2006 mean for this location is plotted on this figure and shows that this value has virtually not changed since 2004.

Figure 4 also provides curves showing the 2004 calculated standard error of the data from 1987 to 2004. The 2006 mean is well within the 2004 standard error band.

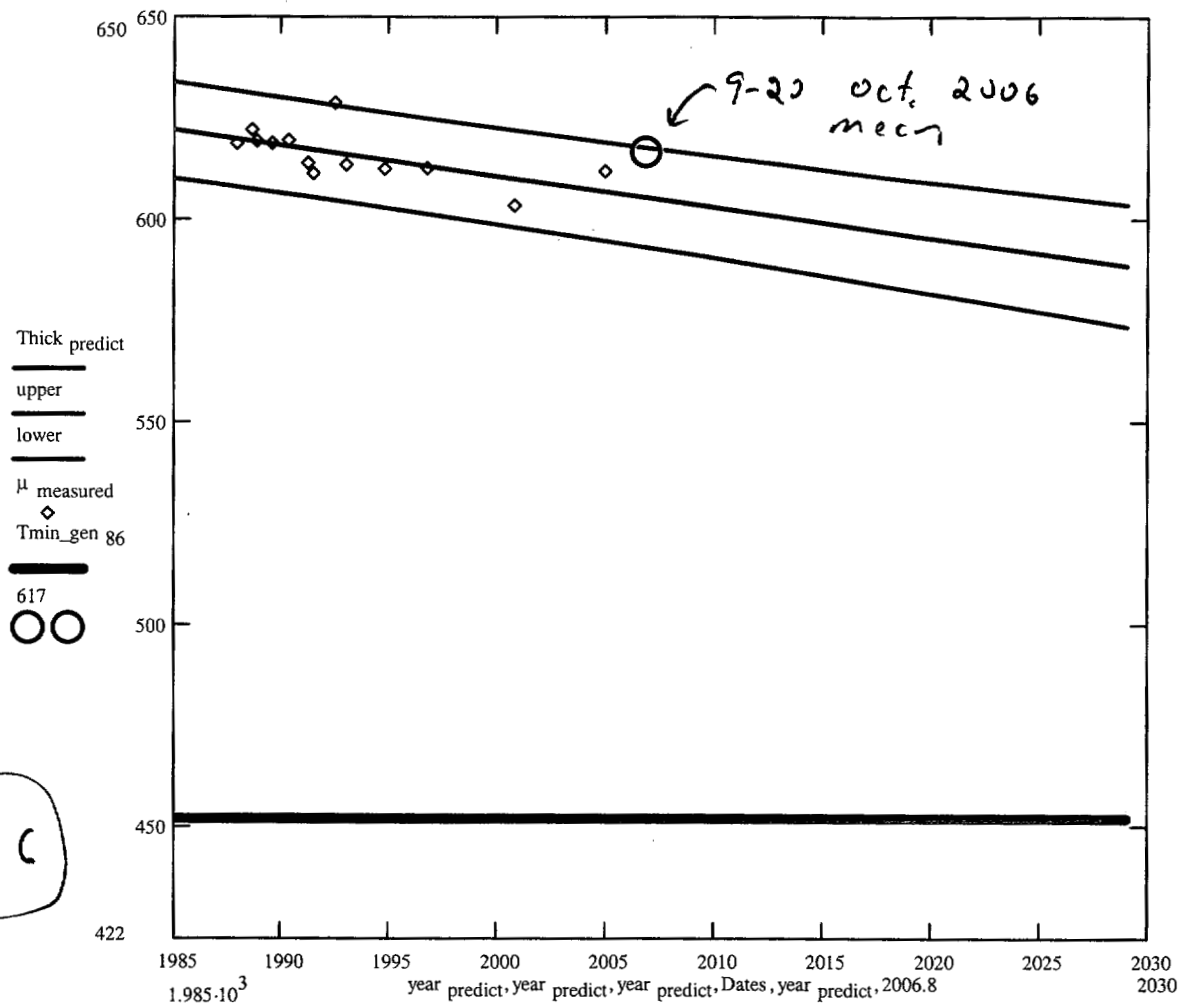
Figure C

The 2004 calculation identified location 9-20 as the most critical since it was the thinnest at this elevation. The calculation concluded that this location was experiencing a corrosion rate of 0.00075 inches per year with 95% confidence. Figure 6 provides the trend of the means of data collected from 1987 through 2004 for these locations taken from calculation C-1302-187-E310-037 Revision 2. The 2006 mean for this location is plotted on this figure. This shows that the 2006 mean is consistent with and is bounded by the 2004 projection. Therefore the margin and projection from 2004 remain valid and bounding. Table 1 provides the means and margin calculated in 2004.

Therefore the regression model shows that even at the lower 95% confidence band this location will not corrode to below Drywell Vessel Minimum required thickness by the plant end of life.

No Pits have been identified for this location

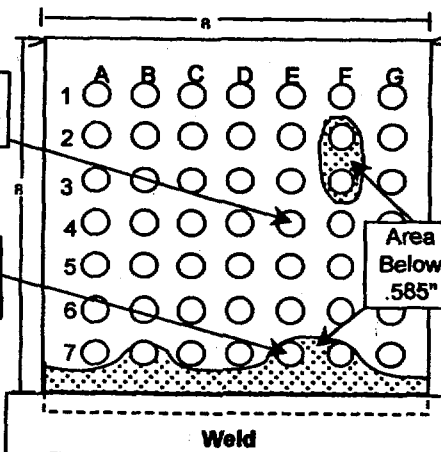
In 1R21, Oyster Creek performed first time inspections of two 6" by 6" areas above the transition weld at elevation 71' 6". The results of the 6" by 6" area in bay 15 showed several local readings less than the inspection specification acceptance criteria (ref. 4). The intent of the criteria in the specification was to provide a low threshold for inspection results so that unexpected readings would be evaluated. As a result IR 00556049 was issued. Review of the inspection results showed that the thinnest local reading was 0.449 inches.

The inspection specification criteria were purposefully set well above the design basis criteria. The minimum required design basis local thickness for this elevation is 0.300 inches (reference 2). Therefore the as found thickness at this location meets the design basis requirements. In addition even when assuming a 1 mil per year corrosion rate, this location will continue to meet design basis until well past 2008. Comparison of this new location to an existing monitored location that has been determined to be the most critical for the plates at this elevation (location 9-20) shows that the projections for the previously monitored location are bounding (refer to attachment 3 page 11).

Max.
0.678"Min.
0.449"

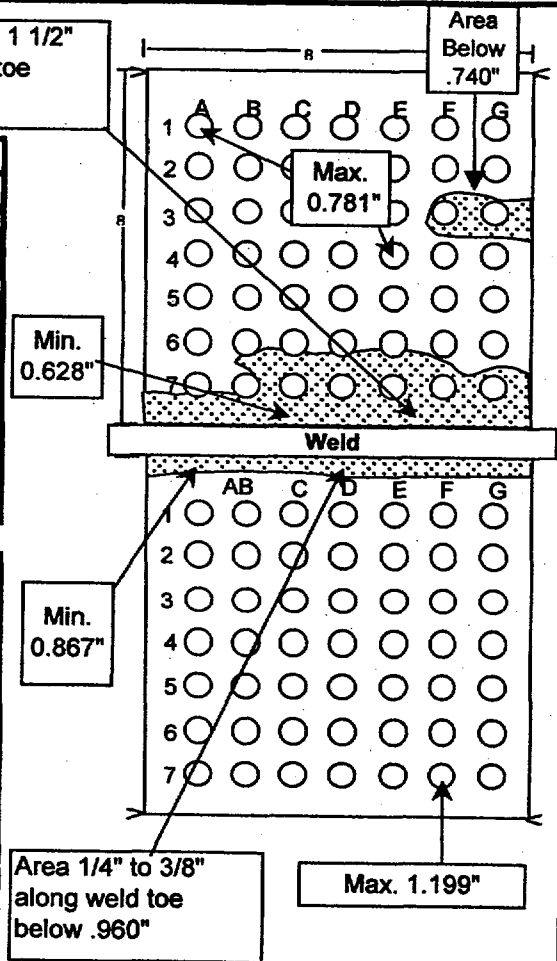
In 1R21 Oyster Creek performed first time inspections of two 6" by 6" areas above the transition weld at elevation 23' 6". The results of the 6" by 6" area in bay 17 showed several local readings

less than the inspection specification acceptance criteria (ref. 4). The intent of the criteria in the specification was to provide a low threshold for the inspection results so that unexpected readings would be evaluated. As a result IR 00548459 was issued. Review of the inspection results showed that the thinnest local reading was 0.628 inches.

The inspection specification criteria were purposefully set well above the design basis criteria. The minimum required design basis local thickness for this elevation is 0.360 inches (reference 2). Therefore the as found thickness at this location meets the design basis requirements. In addition, even when assuming a 1 mil per year corrosion rate, this location will continue to meet design basis until well past 2008. Comparison of this new location to an existing monitored location that has been determined to be the most critical for the plates at this elevation (location 15-23) shows that the projections for the previously monitored location are bounding (refer to attachment 3 page 14).

Forty nine (49) readings were taken using the 8"x 8" template to determine the average reading.
100% scan of the weld and 100% scan within the 8"x 8" area to determine the minimum and the maximum thickness.
Minimum reading on weld was 0.689", Maximum reading on weld was 0.918".
